Preventing Distribution Transformer Bushings Gasket Erosion

Bushing Gasket Erosion

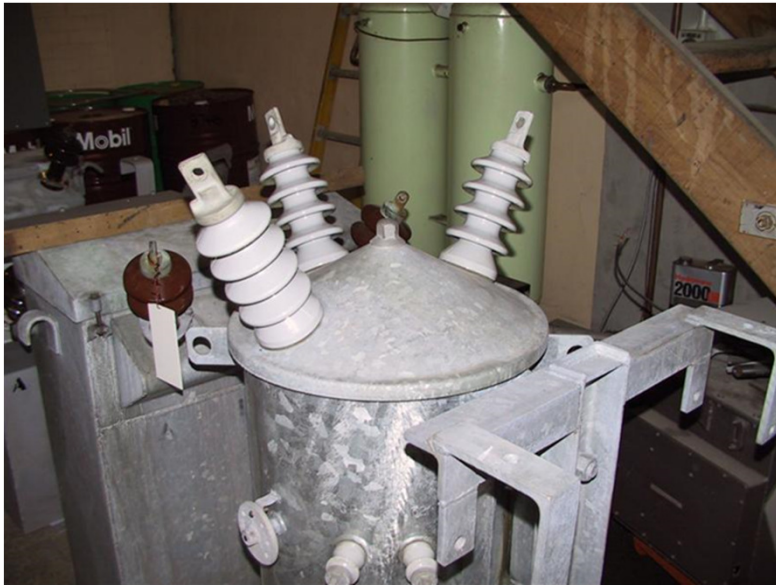
- Westpower's transformers were blowing up!
 - No apparent external cause
 - Water was found in tanks
 - Gaskets were eroded
 - Only affected new style transformers (older T&J transformers were not affected)

Bushing with problem

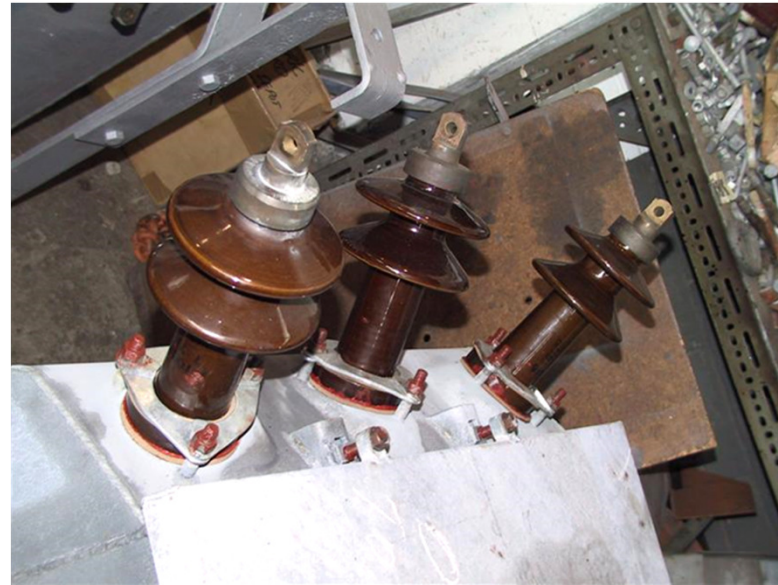
Bushing without problem

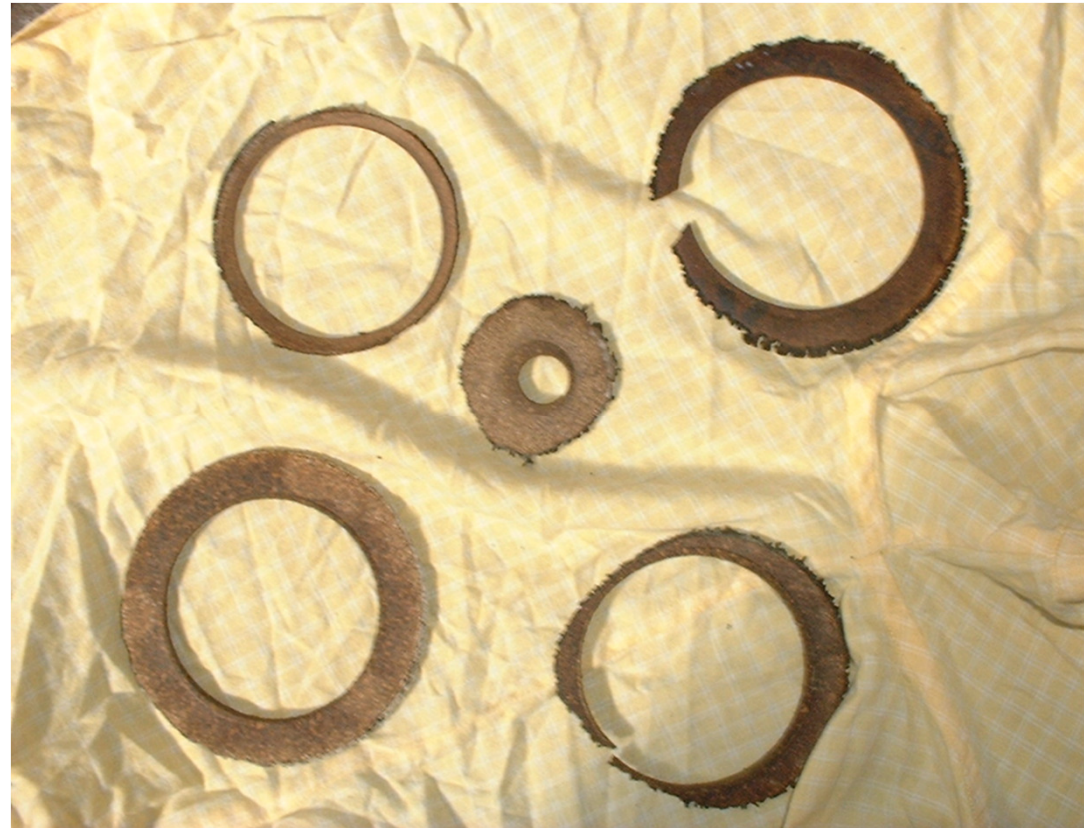
Eroded Gaskets

- Near new gasket shown on bottom left
- Various stages of erosion were found on the in-service gaskets

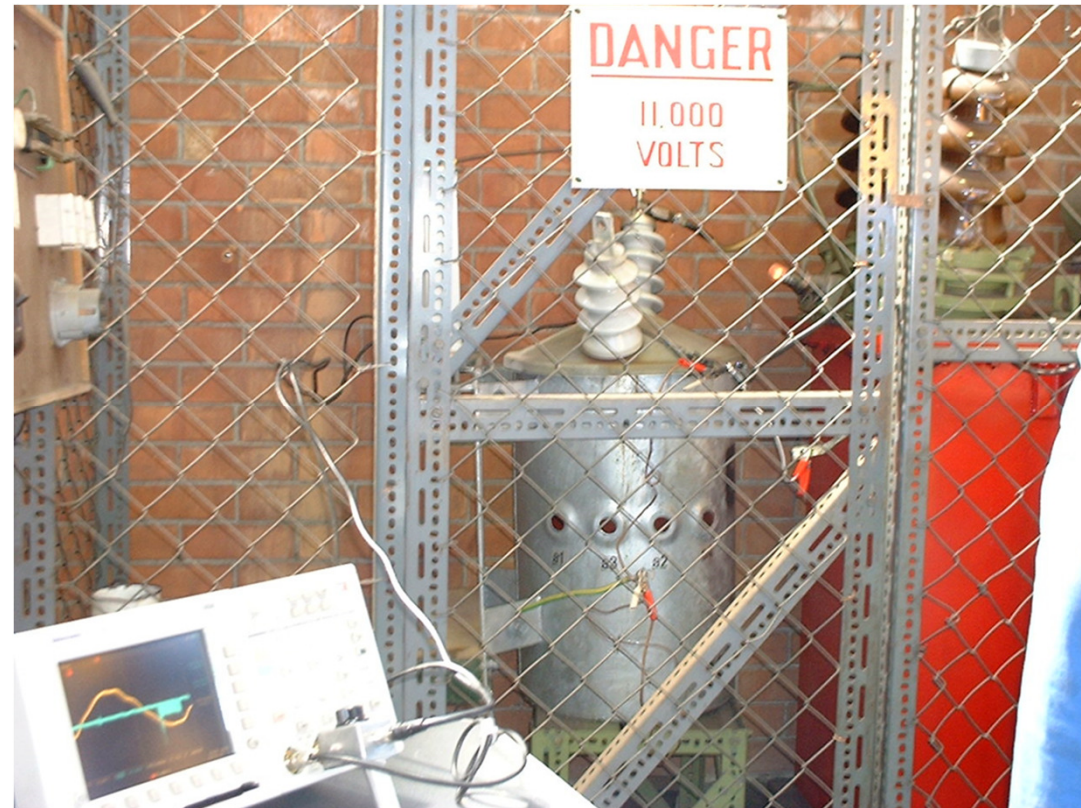
- One possibility was that partial discharge was occurring across the air gap between the insulator and the tank.
- This was assessed using the following test and carried out by Dr Yafei Zhou of IRL.

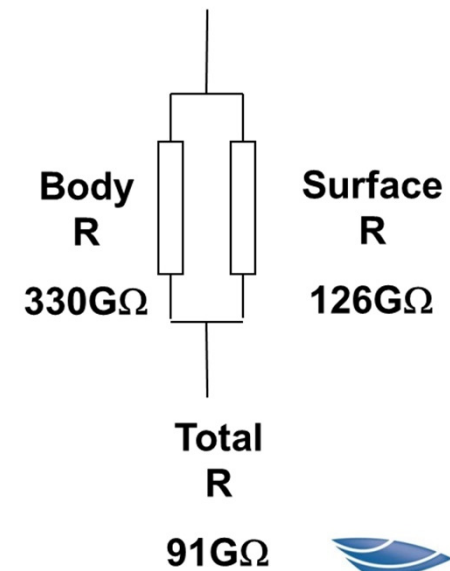
At dry condition

Voltage (kV)	3	6	9
AC total (μ A) dry	10.3	18.6	26.2
AC surface (μ A) dry	2.6	4.7	7.1
AC surface (μ A) wet	14.2	25.4	38.4
