Conductor Condition Assessment

***EEA Asset Management Forum
20 – 21 June 2017***

***Russell Watson
Network Engineering Manager***

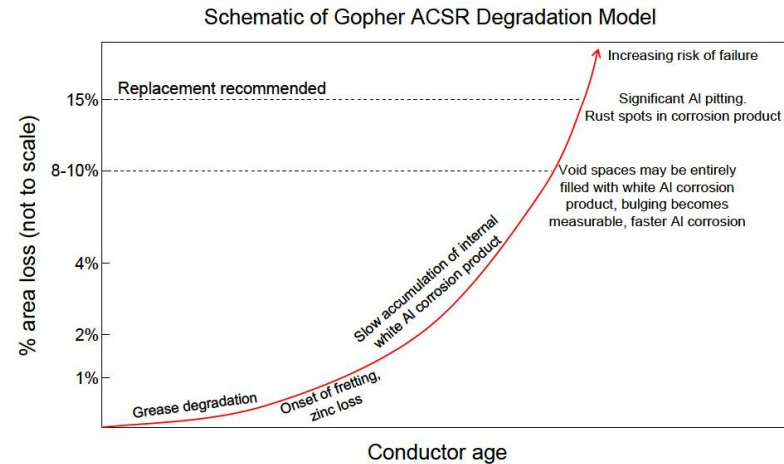
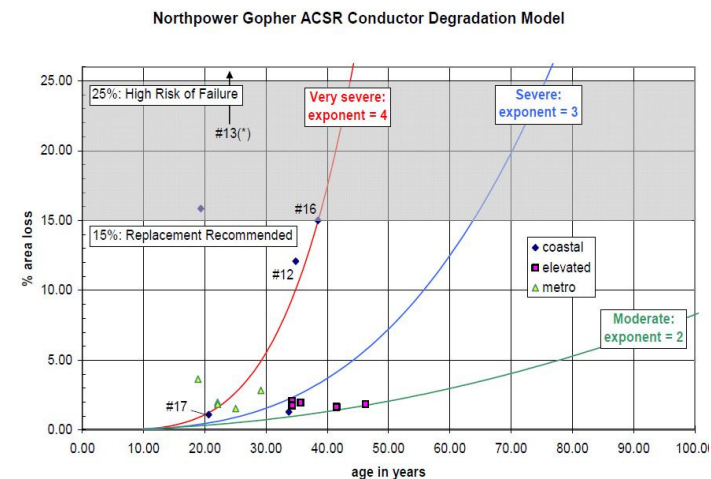
Figure 30. Northpower condition assessment data and Gopher ACSR conductor degradation model.

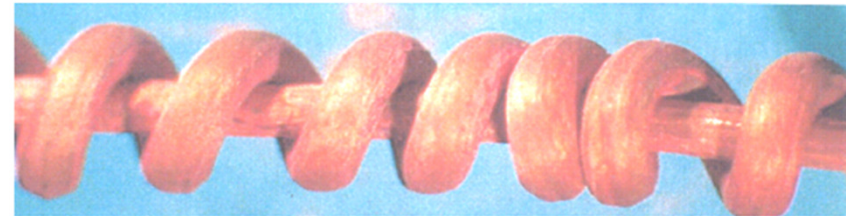
(a) No Visual Damage - Pass

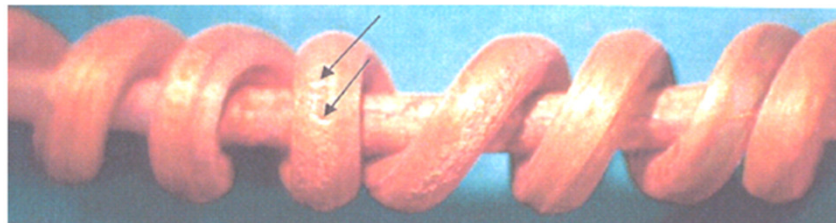
(b) Very Superficial Fine Cracking Indicated by Arrows - Pass

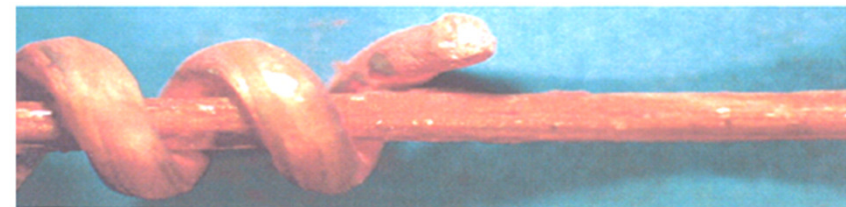
(c) Wire Break - Fail

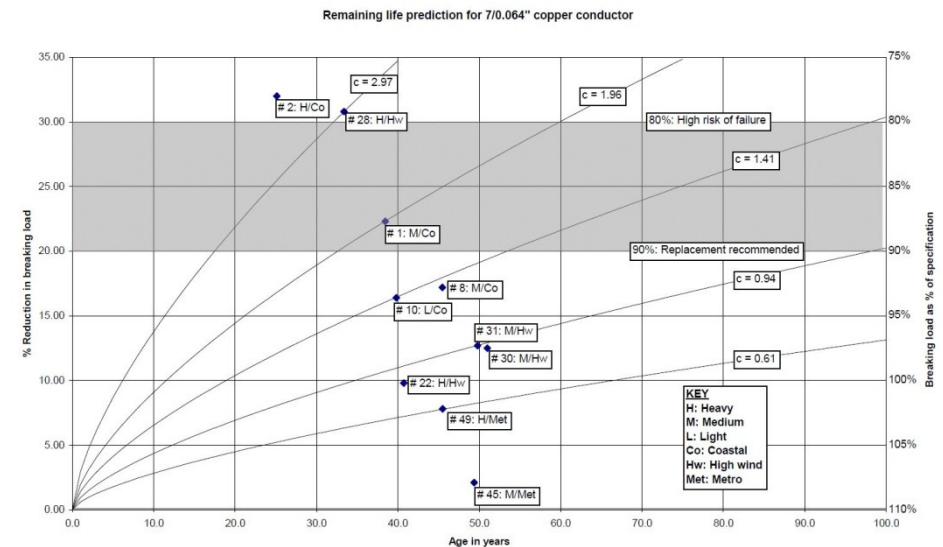
Figure 17. Northpower condition assessment data and model of Copper HDBC conductor degradation used for remaining life prediction.

- ❑ The conductor may be replacement on the failure of any one of the tests
- ❑ The priority for conductor replacement is likely to be risk based, which conductor strength is a factor
- ❑ The acceptable degree of conductor degradation may also consider the present line design standard rather than a fixed level of degradation
