# Aged Concrete Poles

Michael Whaley, Powerco

21 June 2017

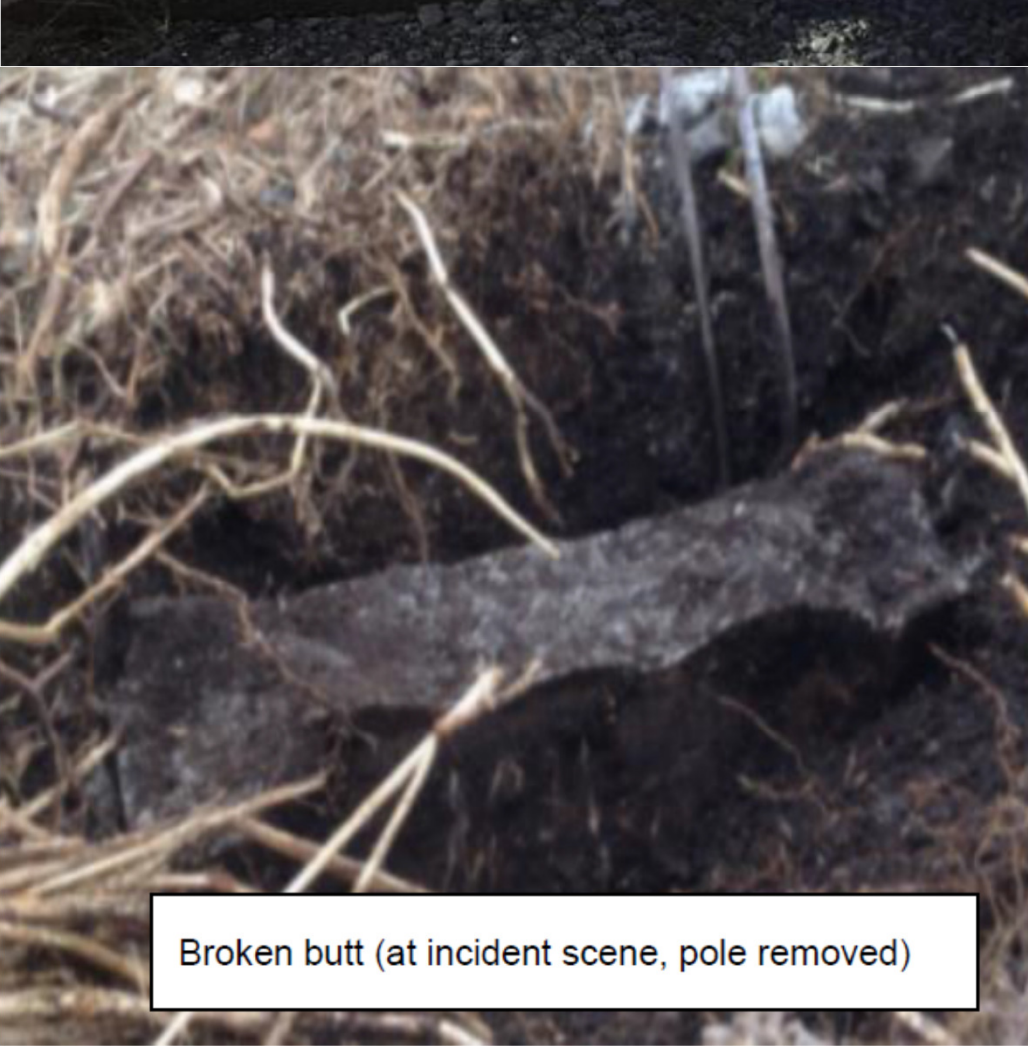
Broken butt (at incident scene, pole removed)

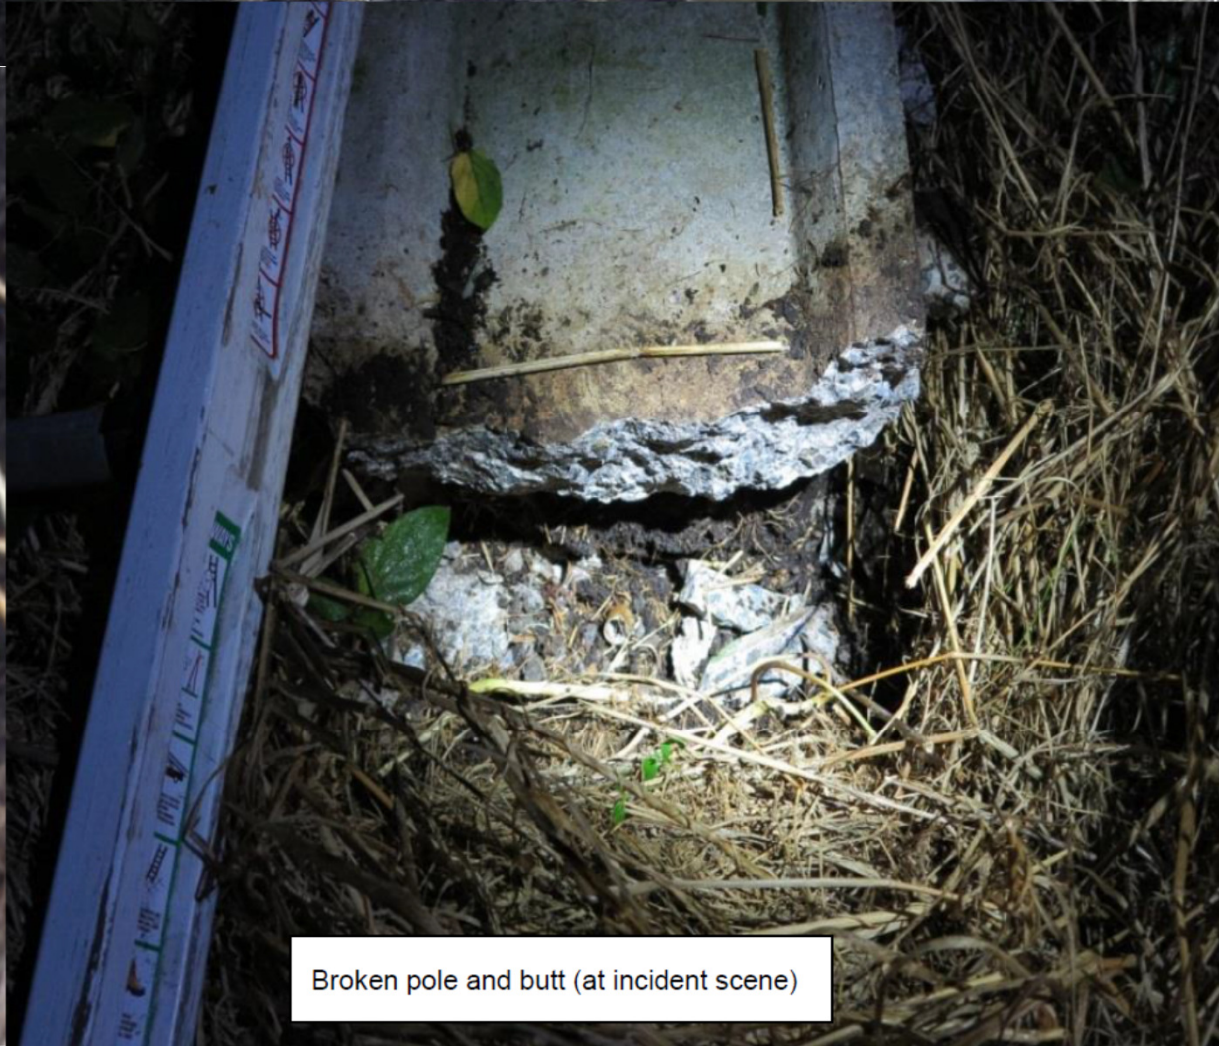
Broken pole and butt (at incident scene)

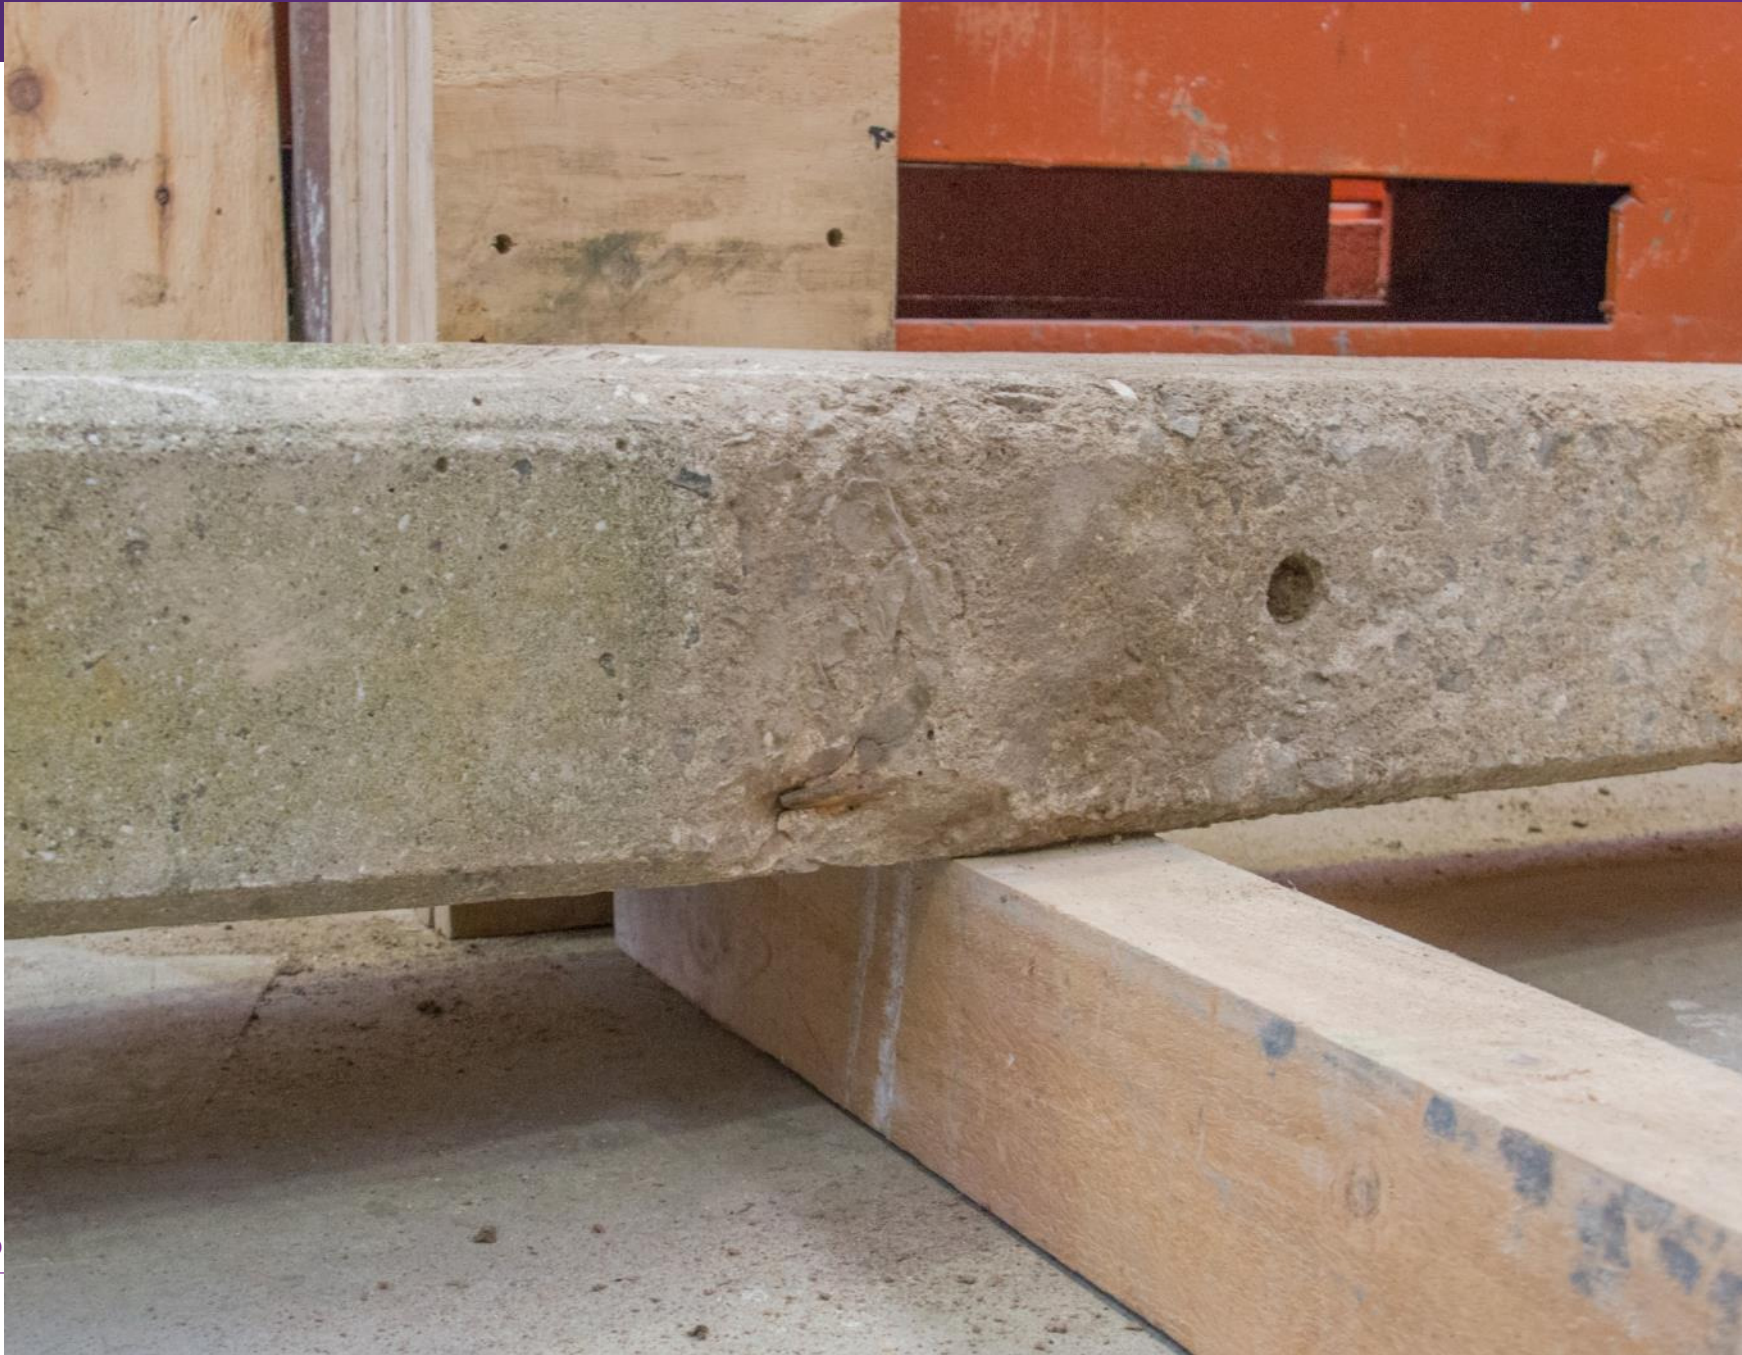
## Below ground line tendon defect on I0888

| Test ID | Pole ID | Cast Date | Age | Test Orientation | Breaking Load (kgf) | Deflection (mm) | Comments |
|---|---|---|---|---|---|---|---|
| PC82 | I0888 | 1968 | 49 years | Cross Line | 580 | 380 | Exposed tendon below ground line |

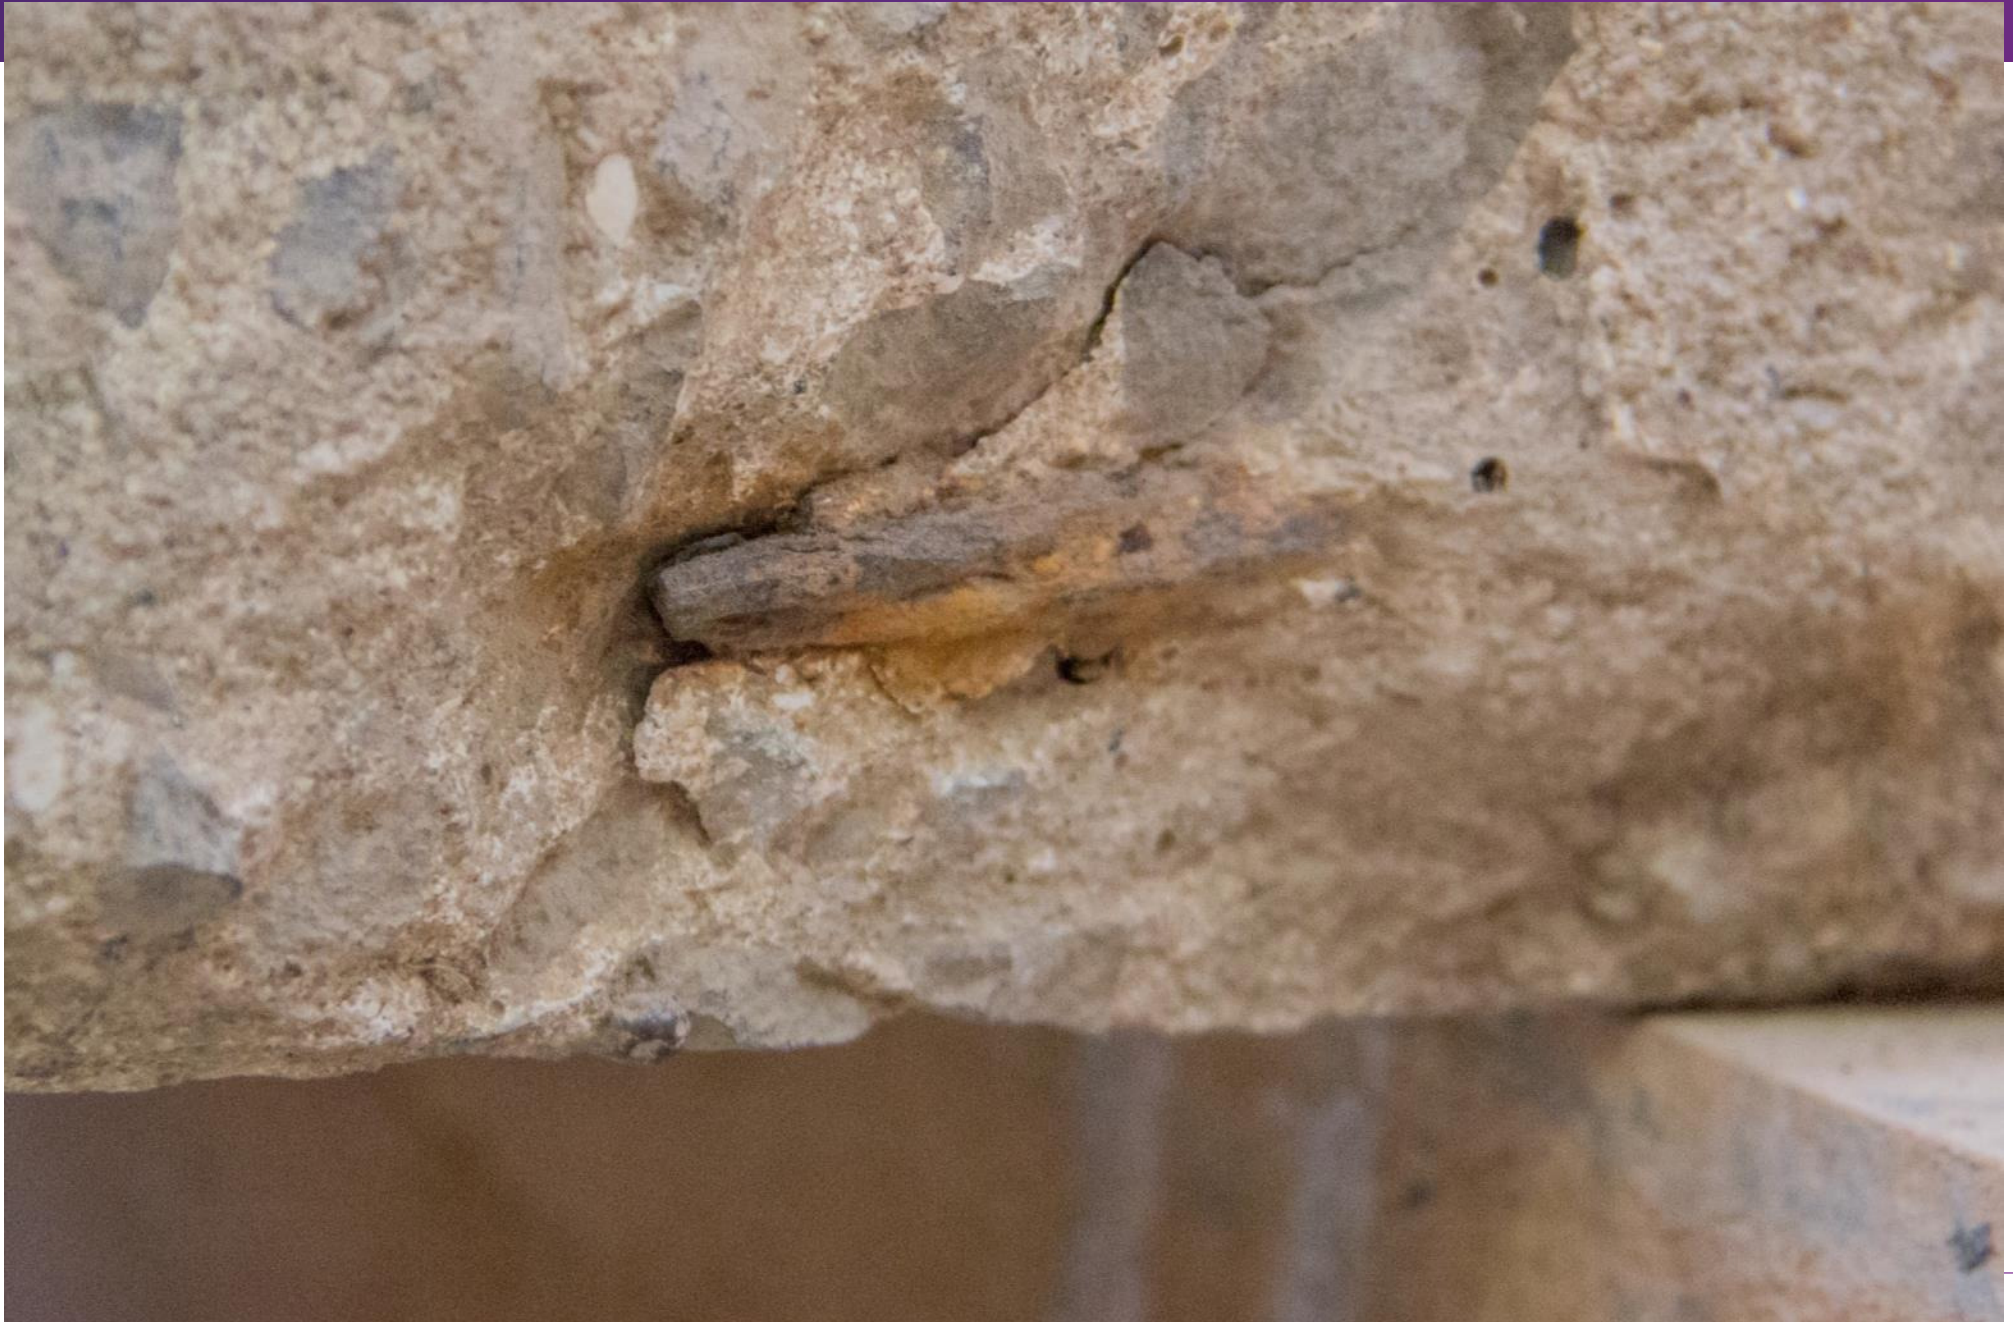
## Below ground line tendon defect close up

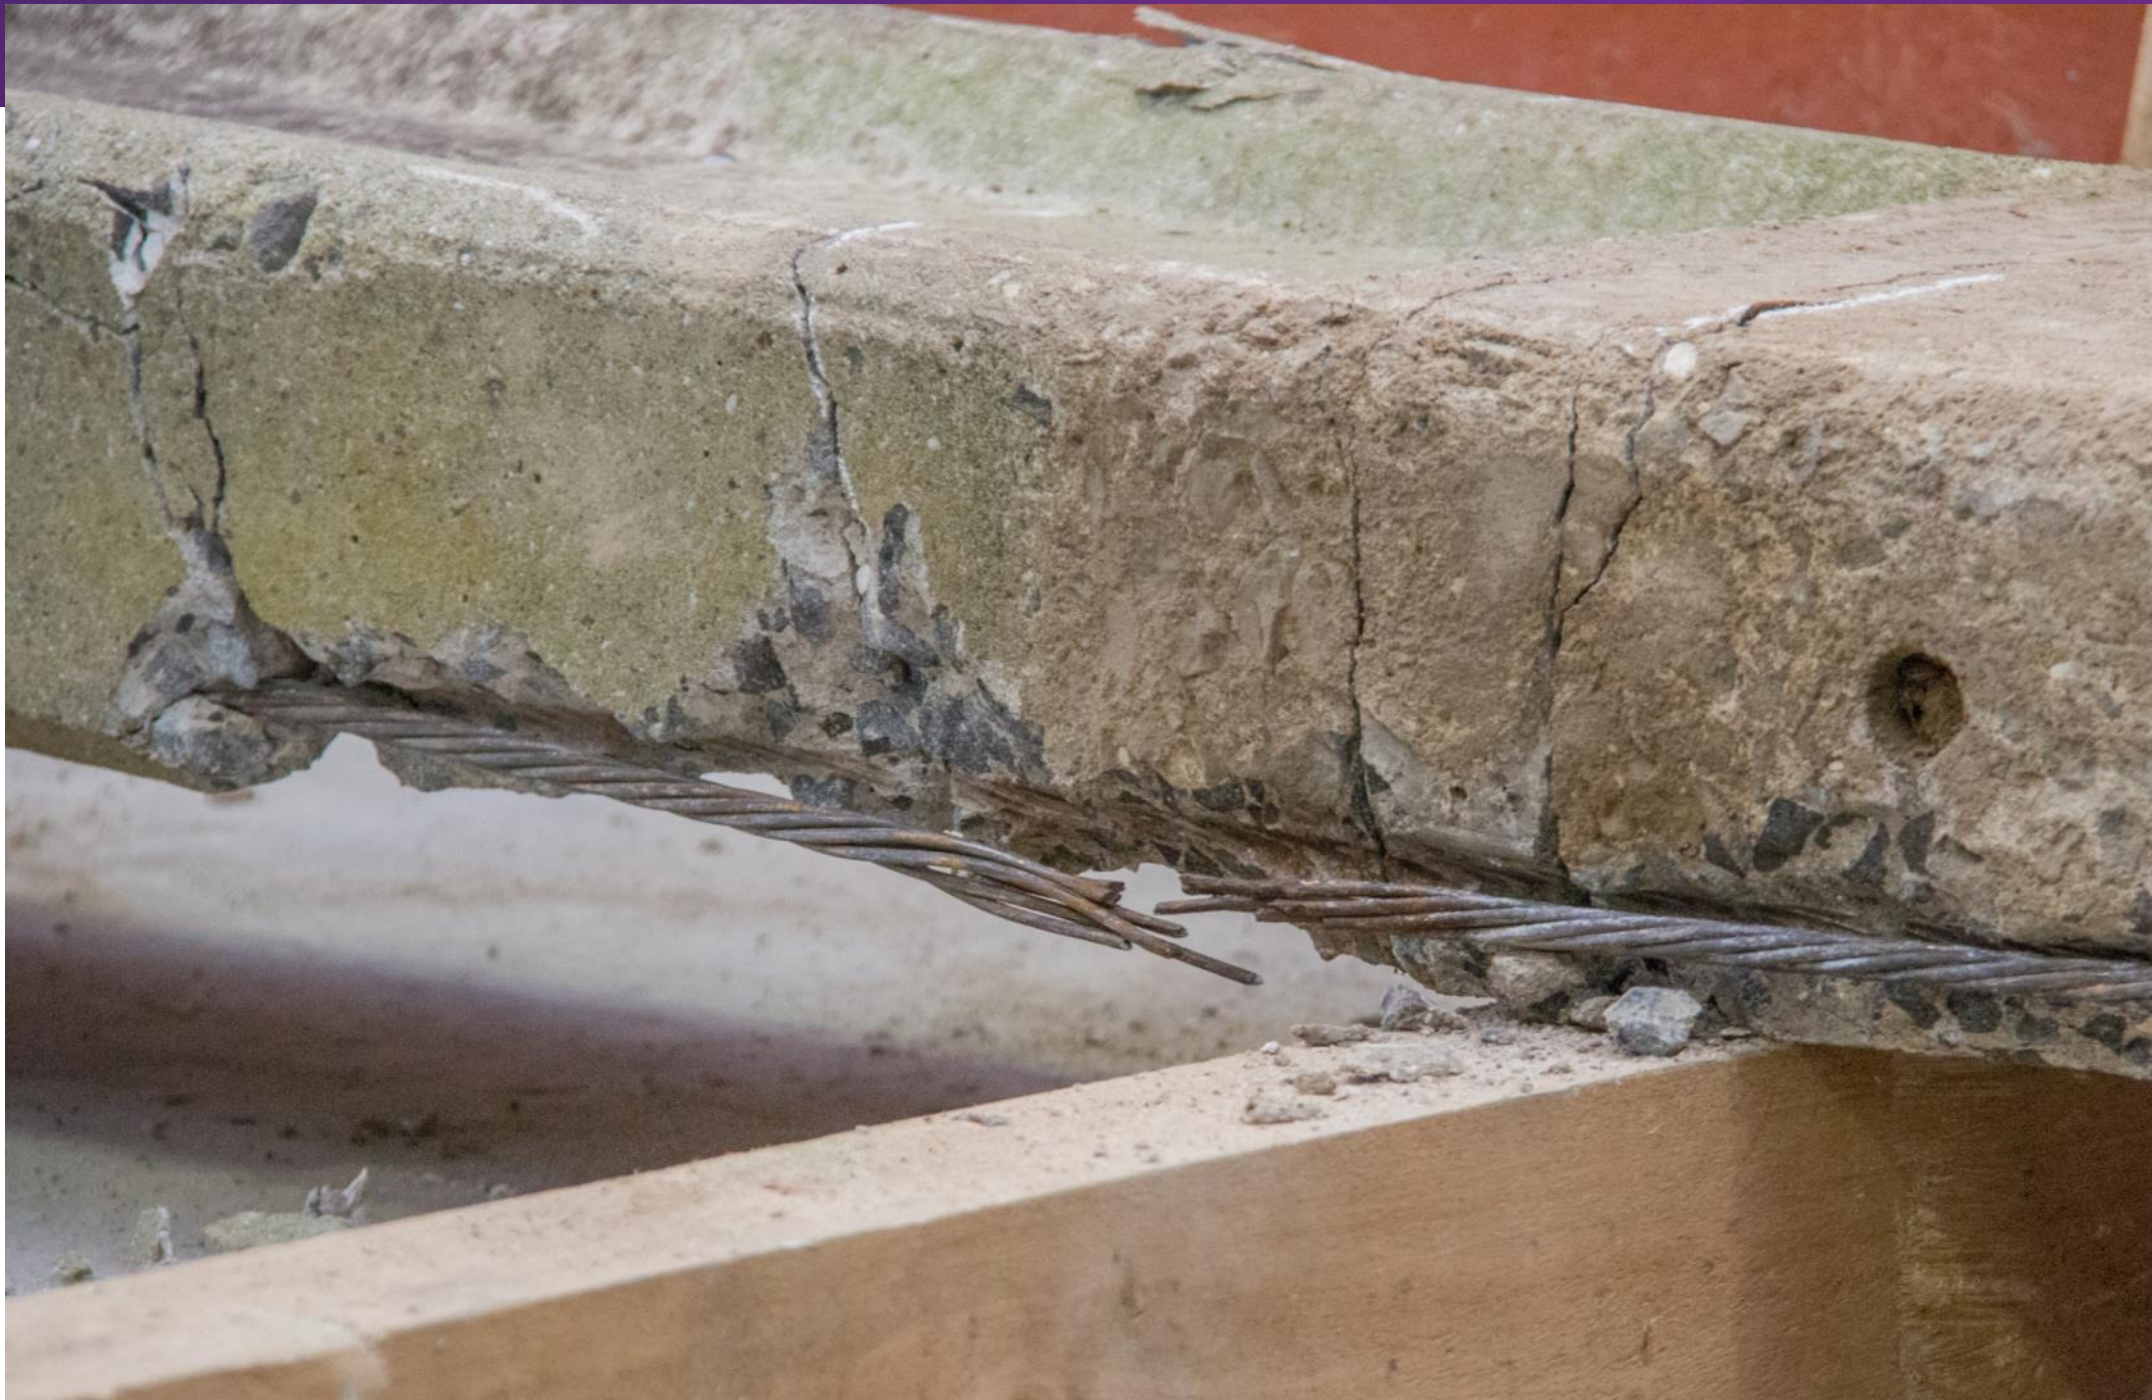
## Below ground line tendon defect became point of breakage

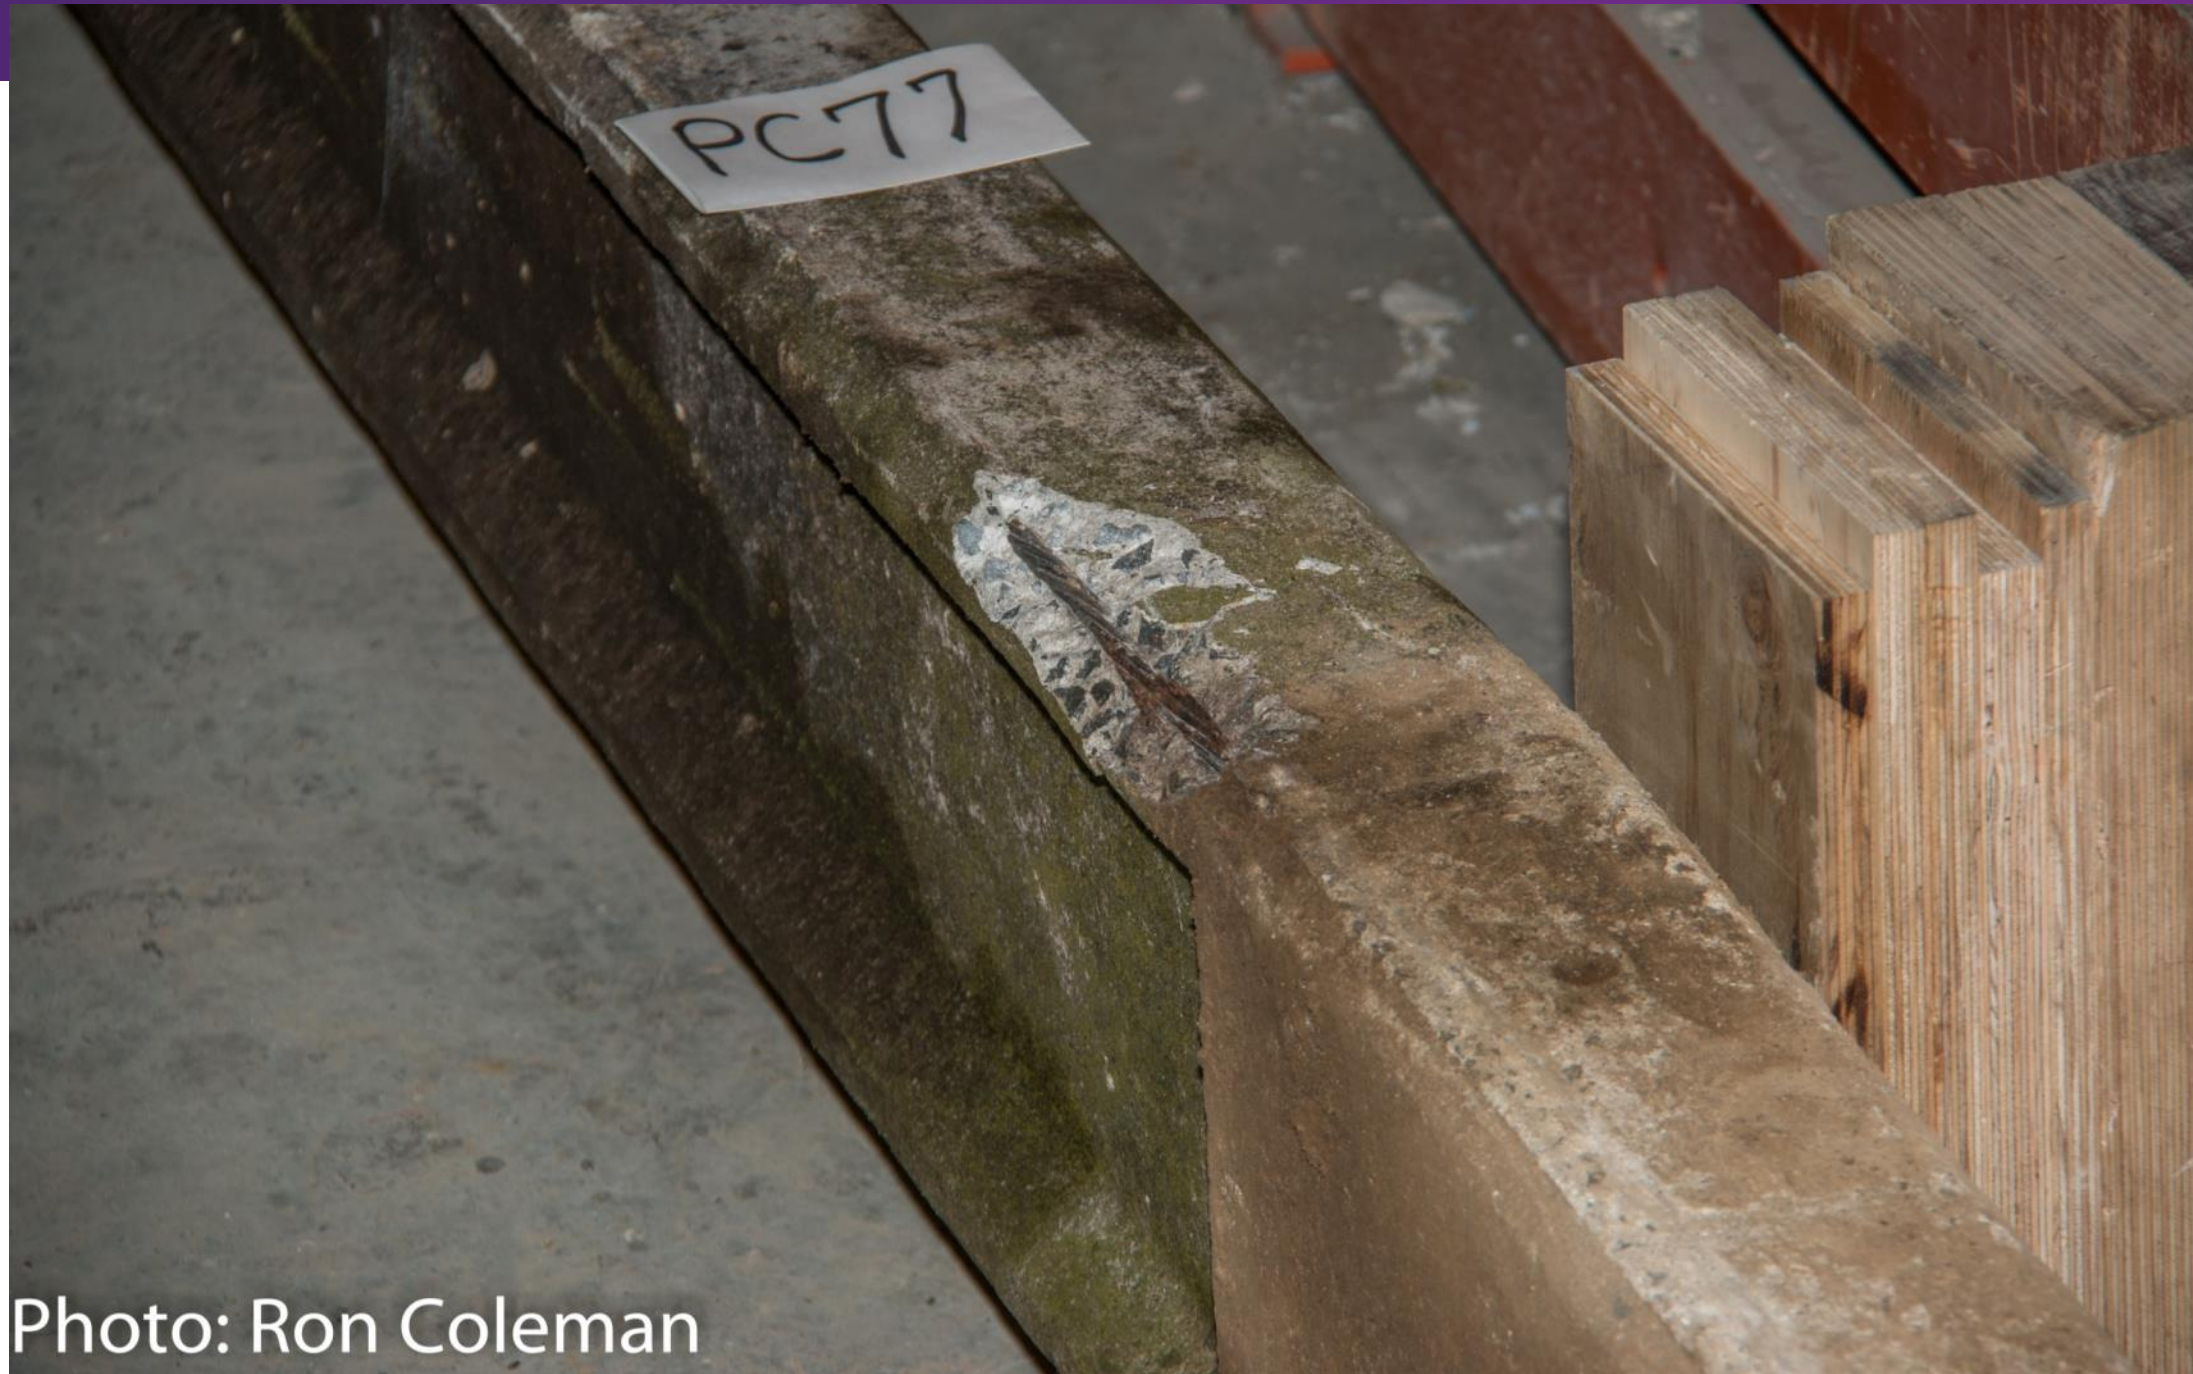
# Damaged tendon at ground line on pole 10885

| Test ID | Pole ID | Cast Date | Age | Test Orientation | Breaking Load (kgf) | Deflection (mm) | Comments |
|---|---|---|---|---|---|---|---|
| PC77 | I0885 | 1998 ???<br>More likely<br>1958 | 59 years? | Down Line | 180 | 655 | Chip exposing tendon at ground line |

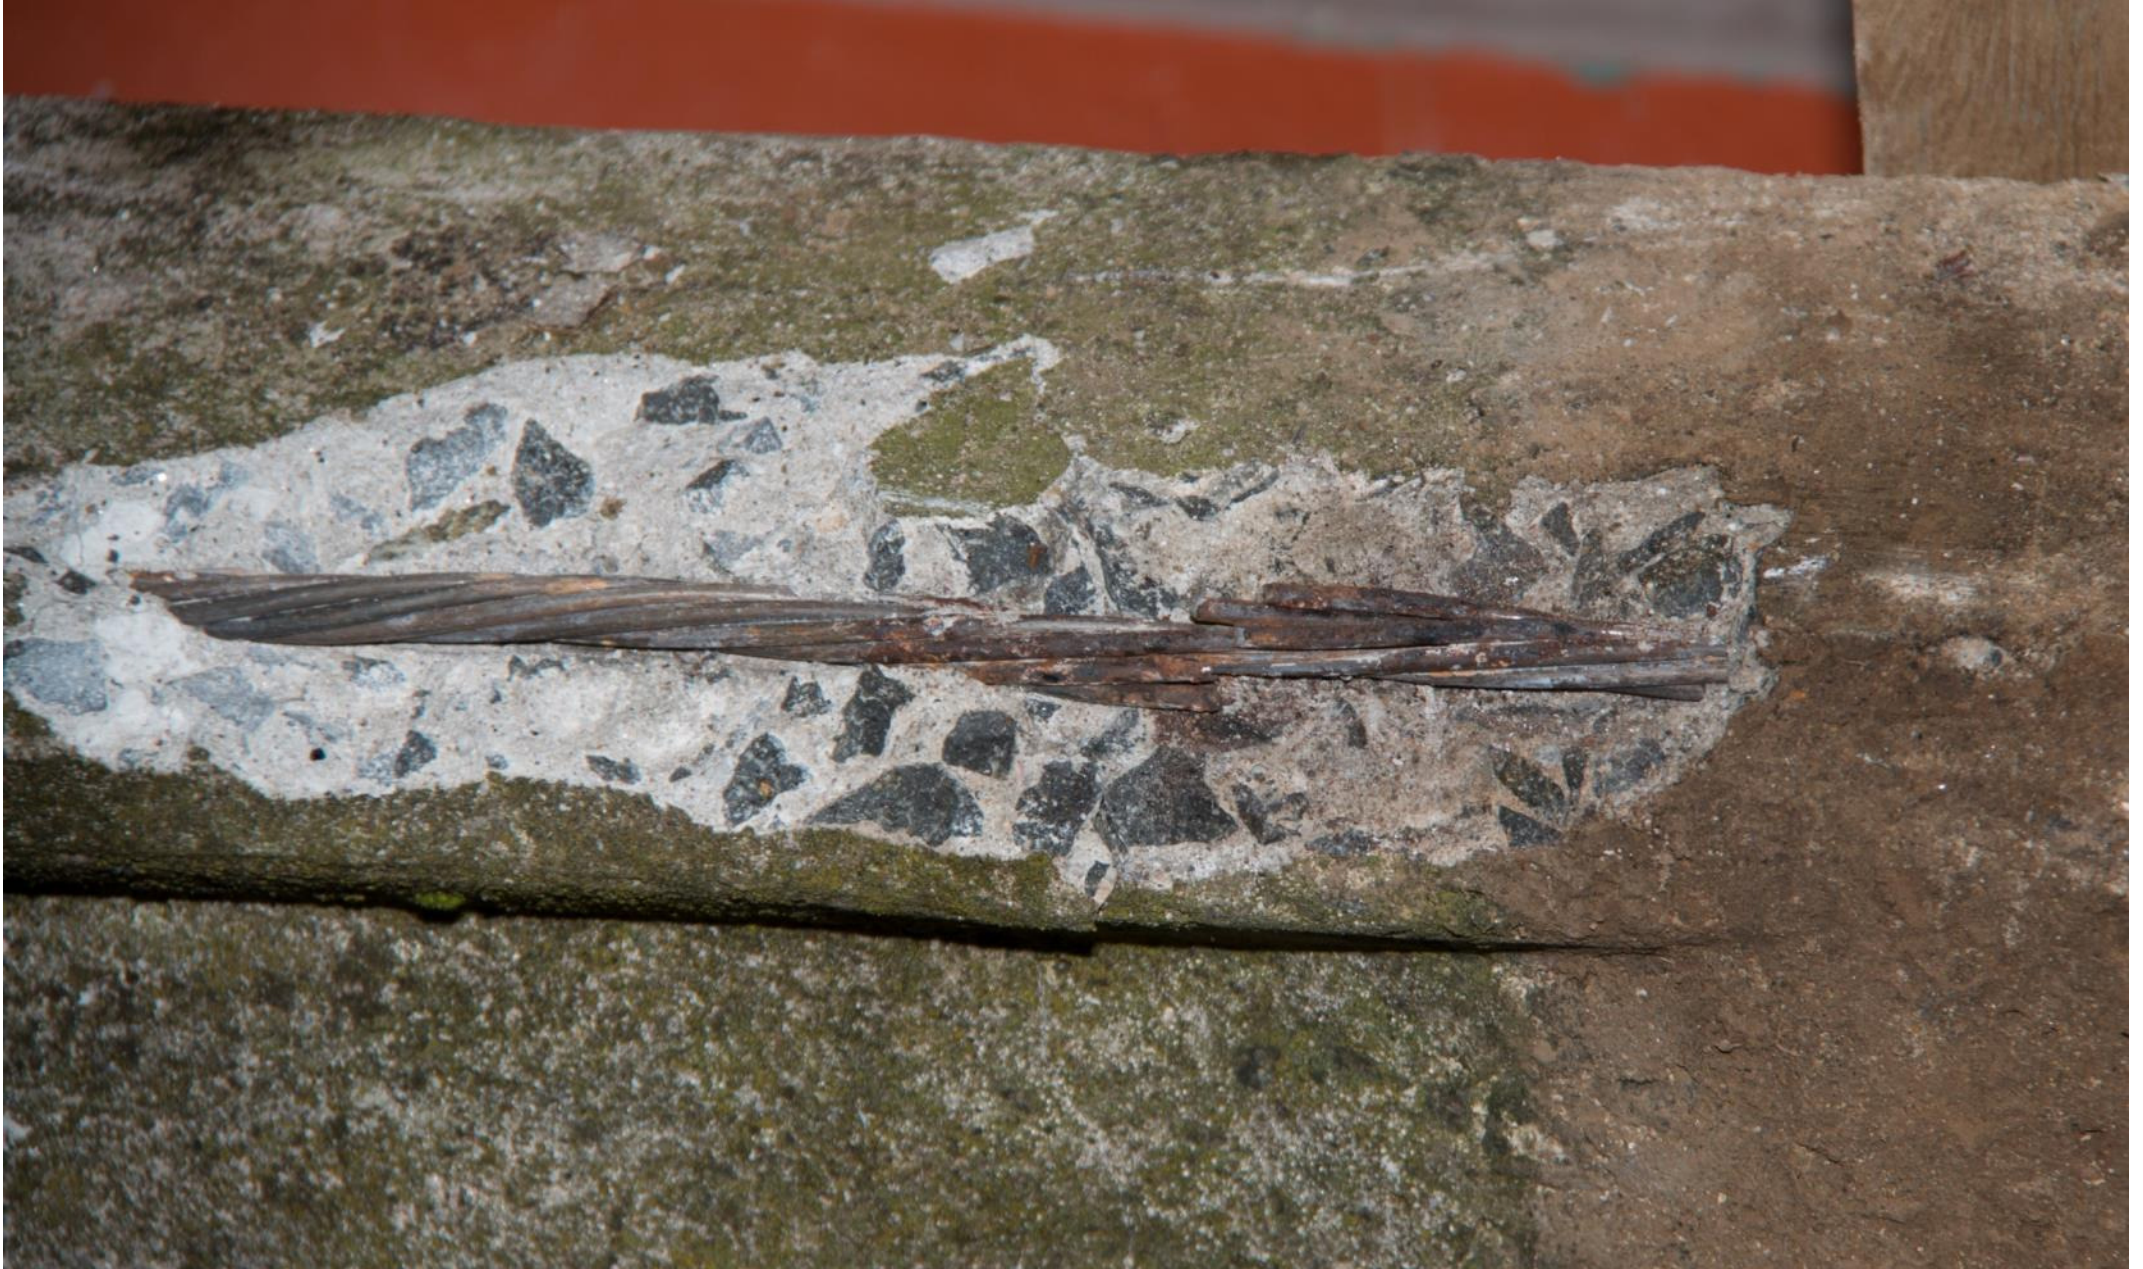
# Damaged tendon at ground line on pole 10885

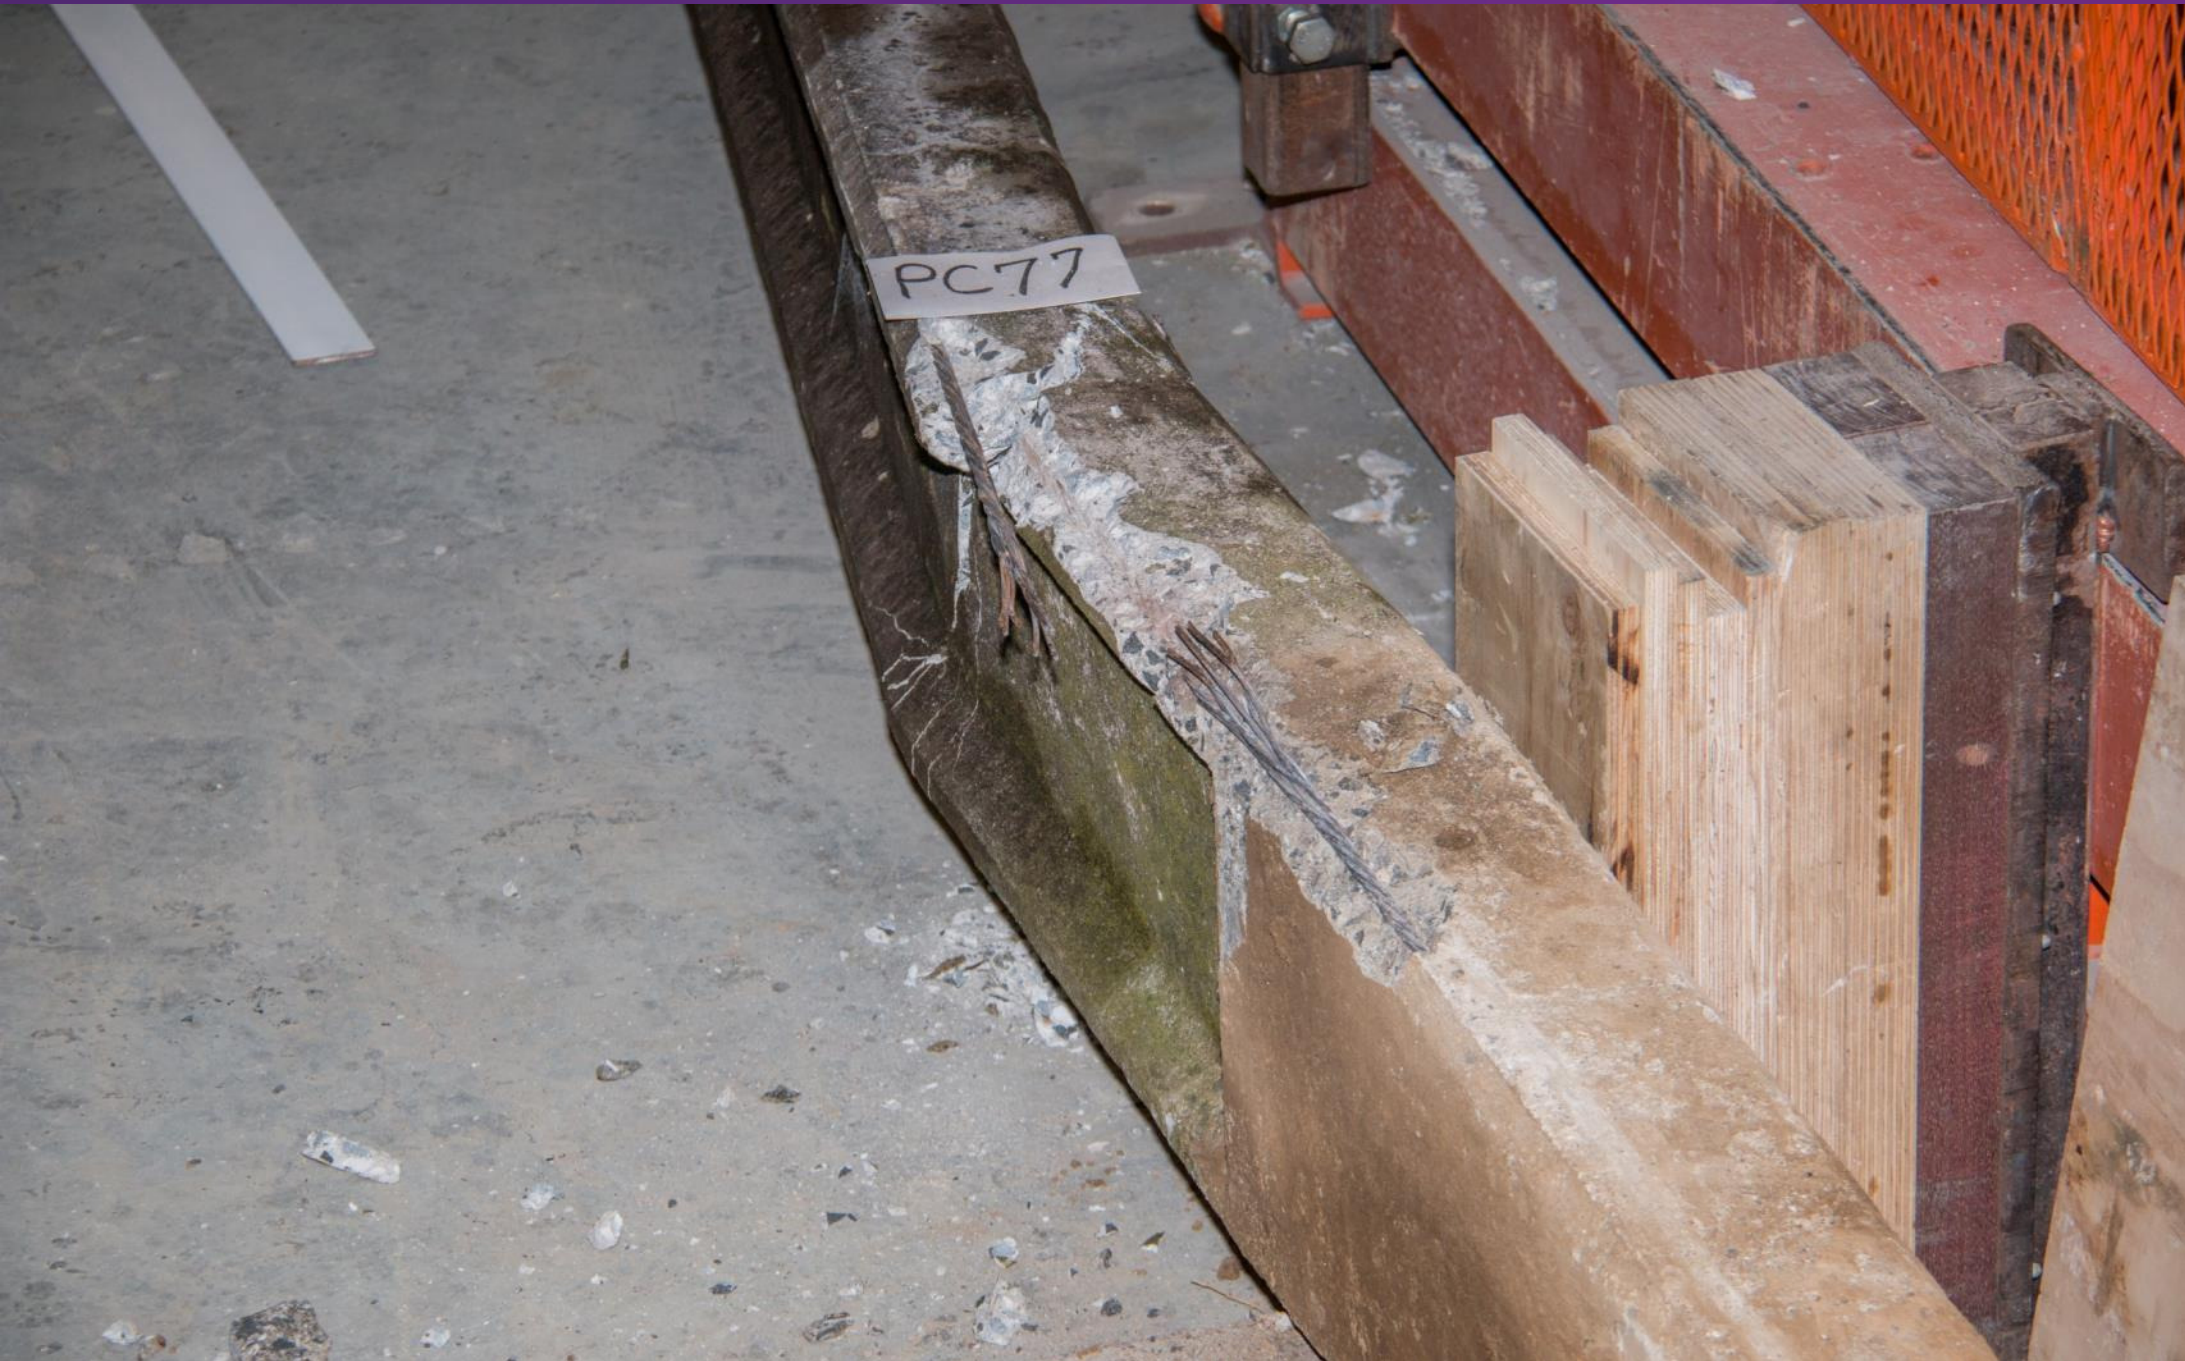
# Damaged tendon became point of breakage
