Safety Alert

INCIDENT TITLE: Manapouri Communication Room
Electric Shock Incident

TIME AND DATE OF INCIDENT: 14th July 2016

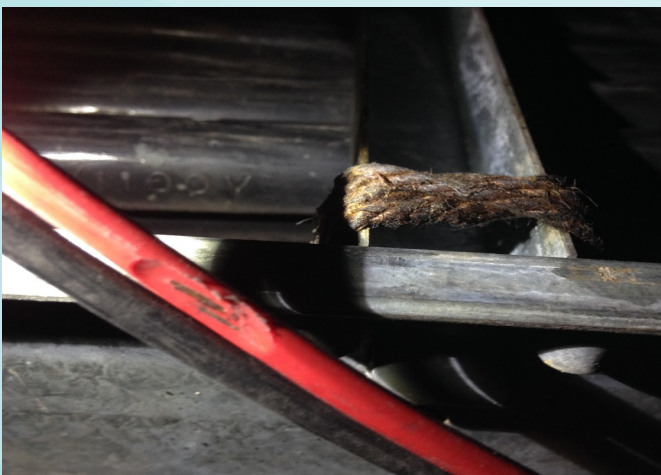
A contractor was in the process of attaching a new cable to an existing cable tray section in the Manapouri Communications Room. The contractor received an electric shock by providing a path to earth from his hand to his forearm through contact with an exposed 230V conductor and an existing cable tray.

The exposed conductor is a result of damage to an existing cable which is likely to have occurred through some form of abrasion (wear from cable installation/removal or a neighbouring cable tray). The exposed conductor was not visible from the contractors working position and access to gain full visibility was not possible (cramped working conditions).

The exposed conductor has been located and repaired, therefore removing the risk from this area.

A wider audit of cables in this area has been initiated which will generate a progressive forward work plan to address findings.

Communicate the importance of the use of protective barriers during any cable installation/removal works (this safety alert). Note that your work impacts the safety of others.
