SAFETY ALERT

Aviemoire Unit 2 Trip

16th March 2017, 0845hrs

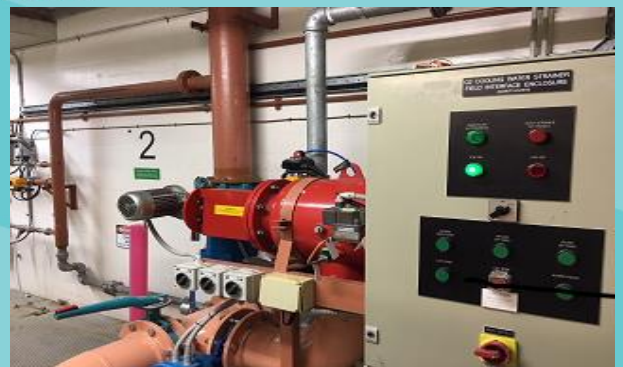
PHOTO:

Unit 1 at Aviemoire Power Station had been isolated and an access permit issued for a planned service. One of the maintenance crew descended stairs down to the turbine floor to commence work but isolated the flow control valve on Unit 2, instead of Unit 1. Unit 2 was in service, and this action caused the unit to trip. Once the error was realized, Unit 2 was restarted and successfully returned to service approximately 6 minutes later. The impact of this event was not significant, but if working on incorrect and un-isolated equipment occurs in a different situation then the consequences can be very severe.

An EA investigation revealed that safe working practices were not followed due to the equipment not being clearly identified prior to working on it. A lack of clear signage did not help the staff member to pick up the mistake. Disruptions and interruptions in undertaking work occur nearly every day. Work practices are what we put in place to minimize the effect of these. Always identifying the equipment prior to working on it is one of the key safety measures that we have and must be undertaken prior to any work. Any improvements we can make to signage on and around the units for identification purposes is important.

1. Identify the equipment you are working on.
2. Communicate this incident for learning purposes across the maintenance teams in hydro and wind.
3. Update the non-negotiables to include identification of equipment you are working on in the Stop, Take 5.
4. Review other signage and labels around the stations to ensure adequacy.

“Stop, Take 5, Reassess” - Identify the correct equipment
