SAFETY ALERT

Obsolete tag

March 2018

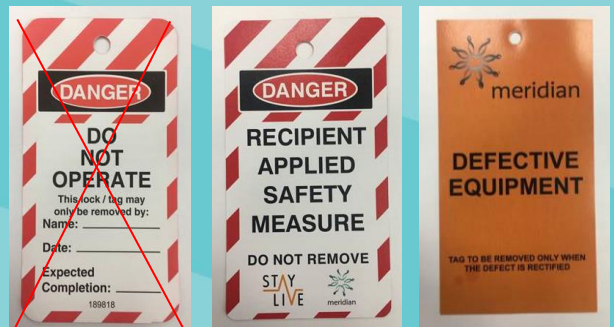
PHOTO:

The power supply for lighting in the Construction Sump at Manapouri has historically been supplied from an extension cord connected to a Reyrolle plug in the service gallery. This power supply was identified as being unsafe in 2015 and tagged out using a 'Do Not Operate' tag (see below photos for reference). In February 2018, the tag was found beside the extension cord. The cable tie connecting it to the extension cord had been severed.

The tag used to identify the unsafe power supply was incorrect. This type of hazard should be identified using a 'Defective Equipment' tag (see below photo for reference).

The 'Do Not Operate' tag used to tag out this equipment is out of date. These tags should have been removed from site when the new 'Recipient Applied Safety Measure' tags were supplied as part of Meridian's work control procedure implementation.

The power supply was originally tagged out due to a hazard associated with the Reyrolle plug that provided the electrical connection to the extension cord. These have been identified as unsafe due to the conductive plug housing.

All red and white 'Do Not Operate' tags should be removed from across all hydro sites. Refer attached overview for examples of the three types of tags that should be used on site.
