# Diagnosing with Data

Robin Pittwood

Powerco / June 2018 / EEA AMG Workshop

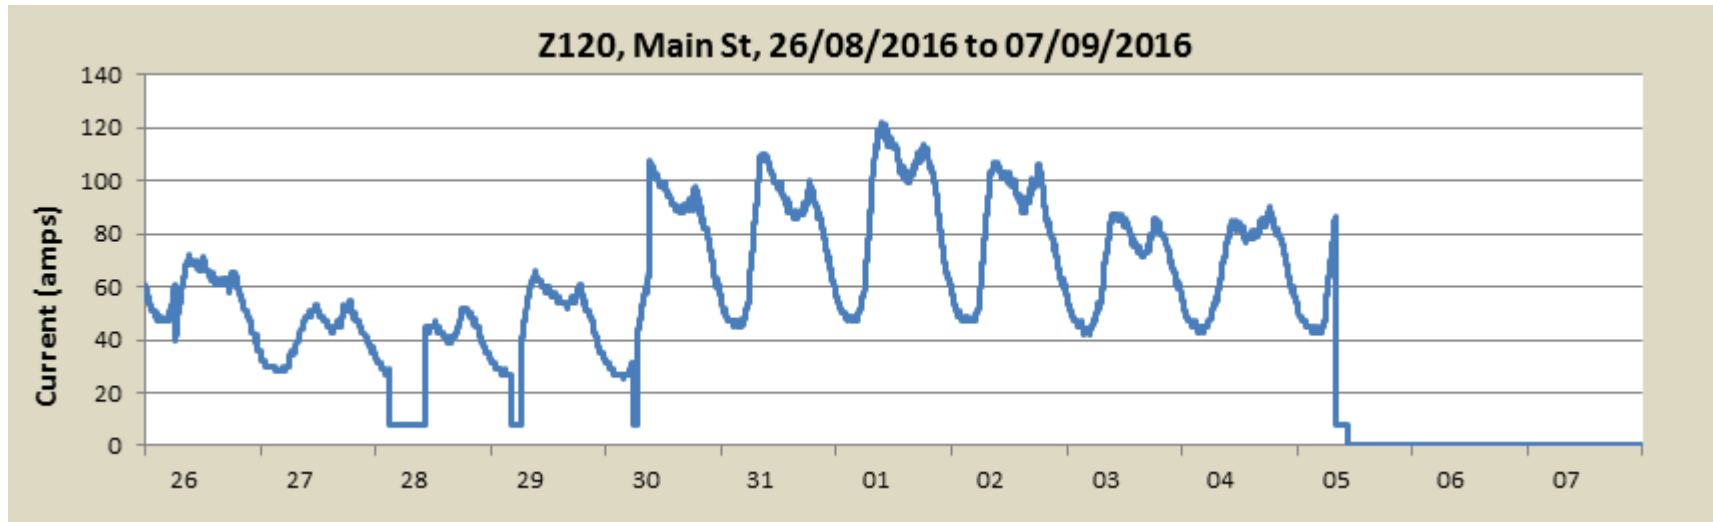
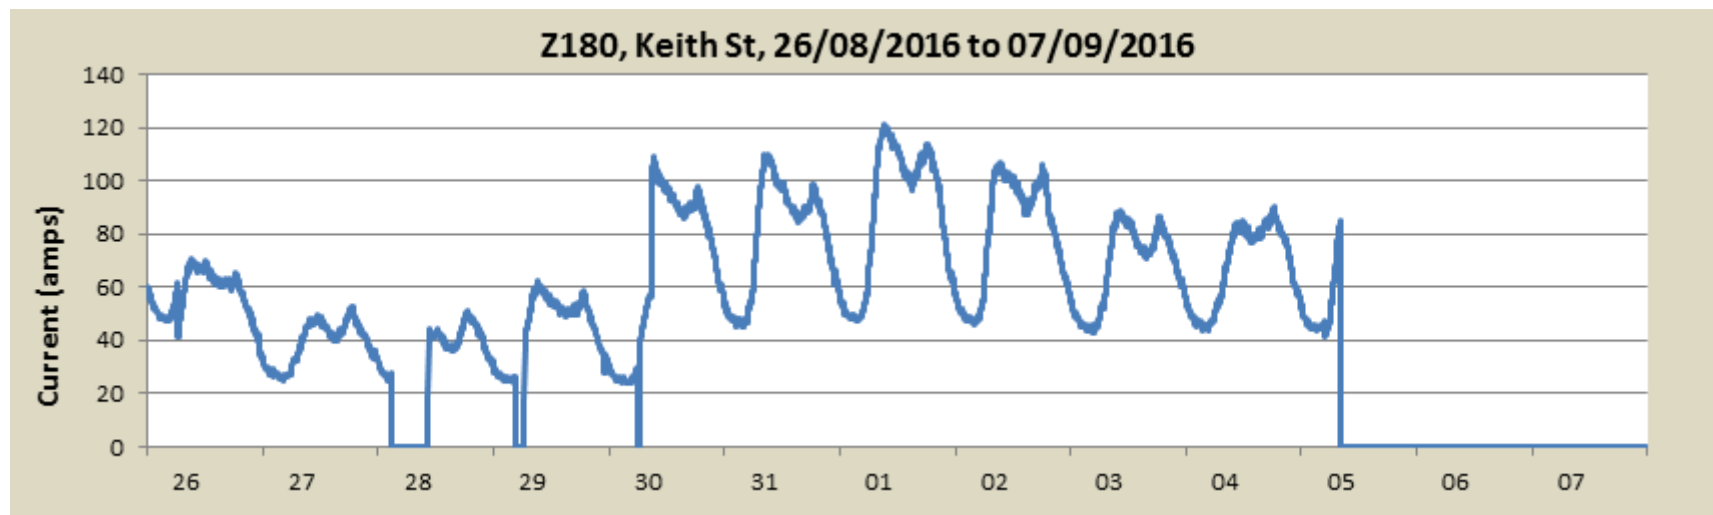
Palmerston North cable fault – these are old oil filled cables with leaking joints  
– PI reported the current on one phase of one cable doing this ...

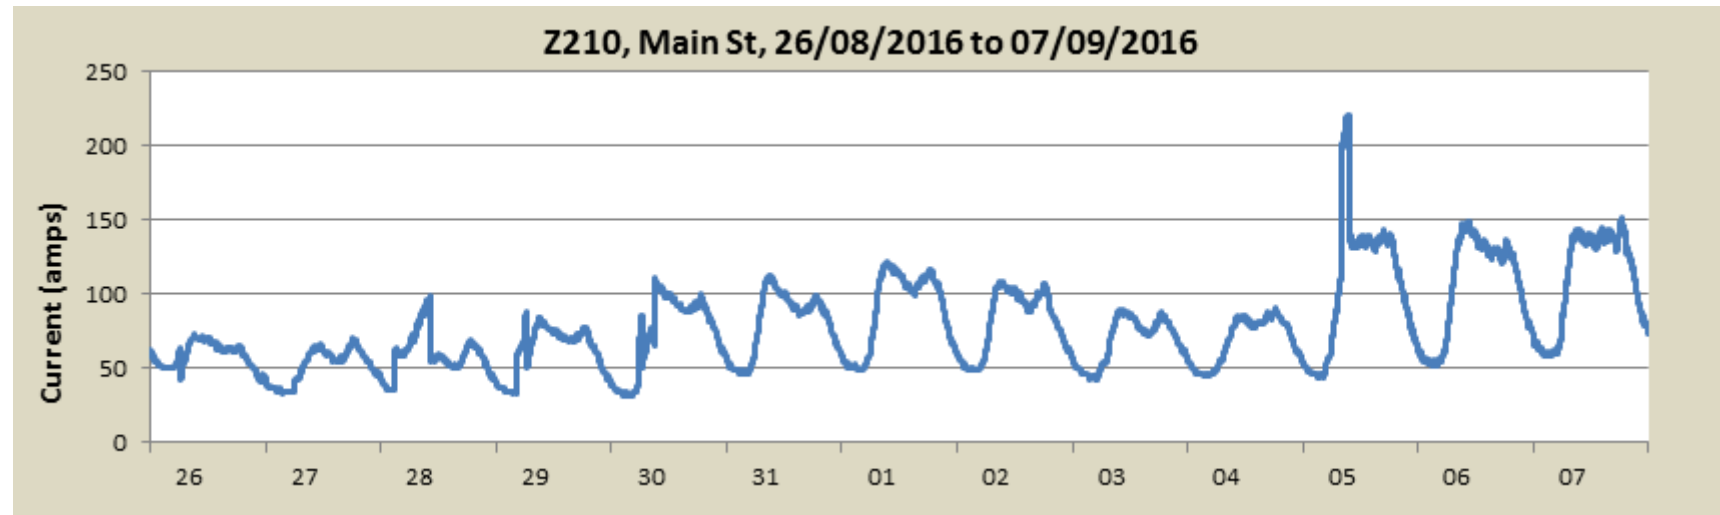
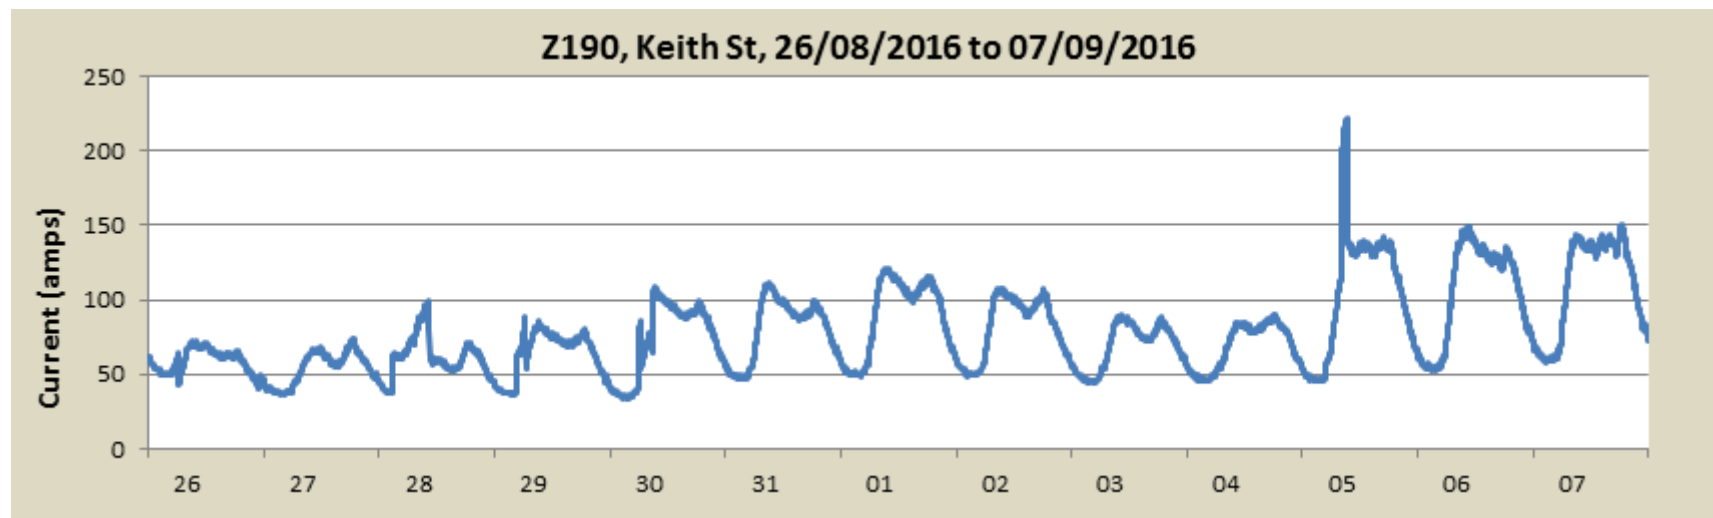
# Palmerston North cable fault – and PI reported the other cable doing this – picking up the load when the other cable opens

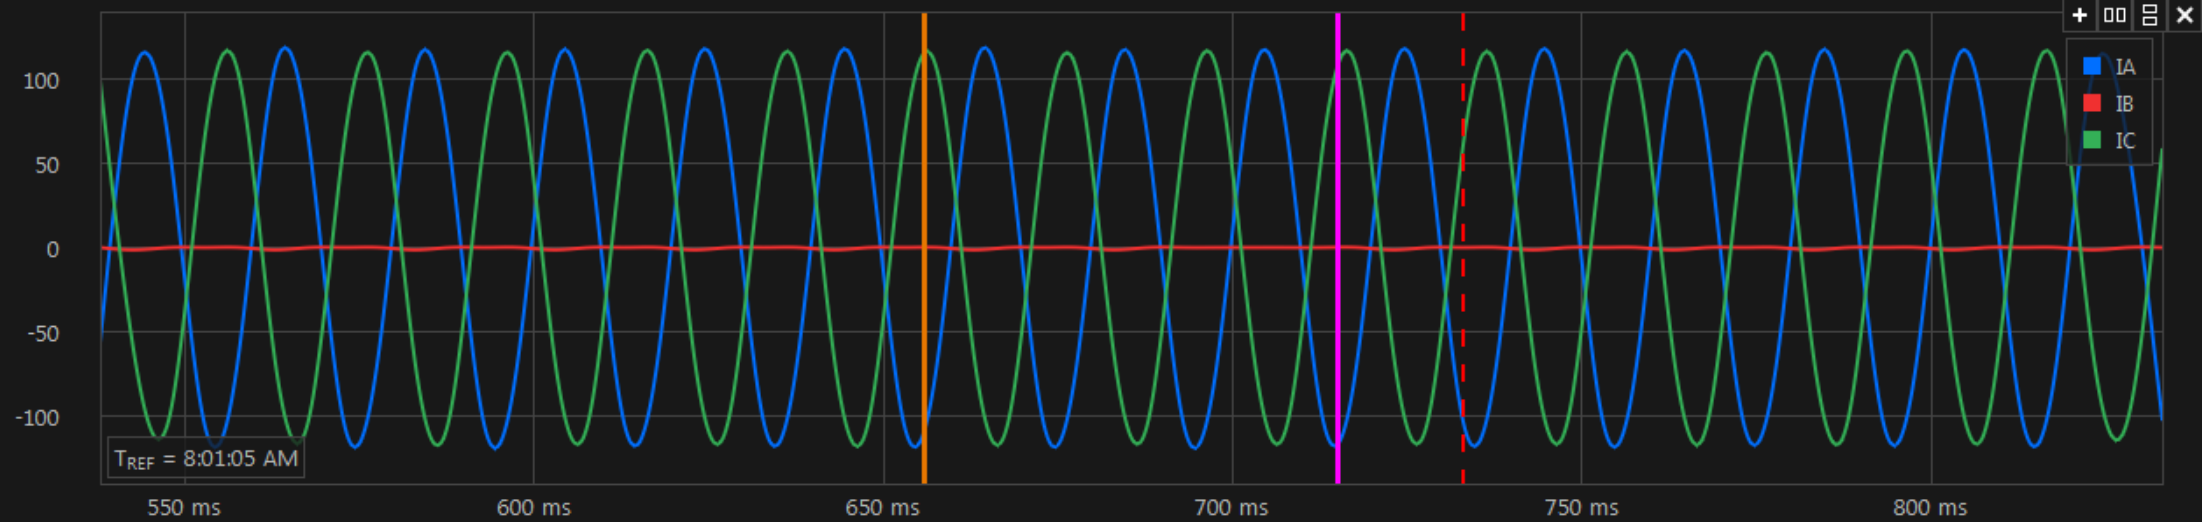
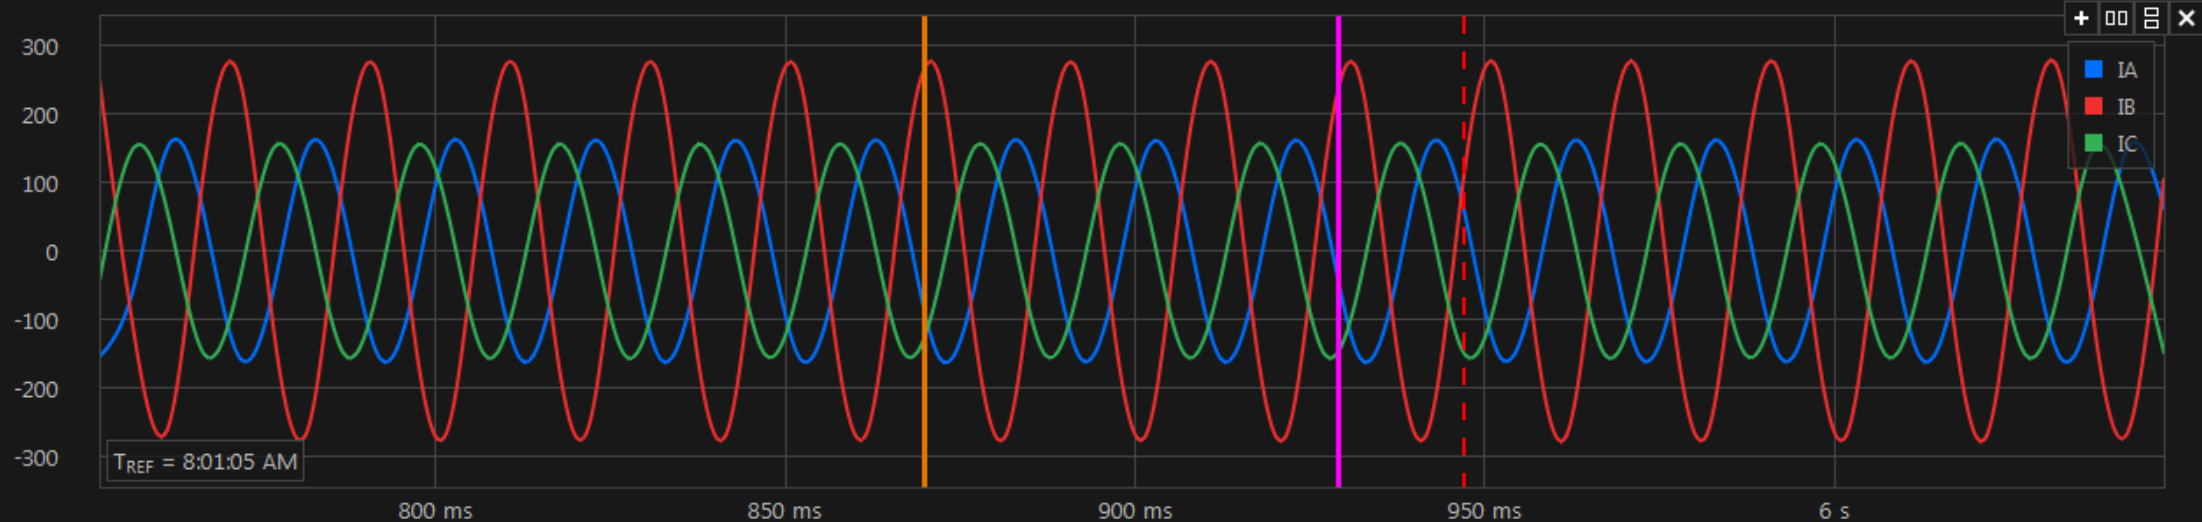
# Palmerston North, SEL traces from both cables 2 seconds before Z180 opens

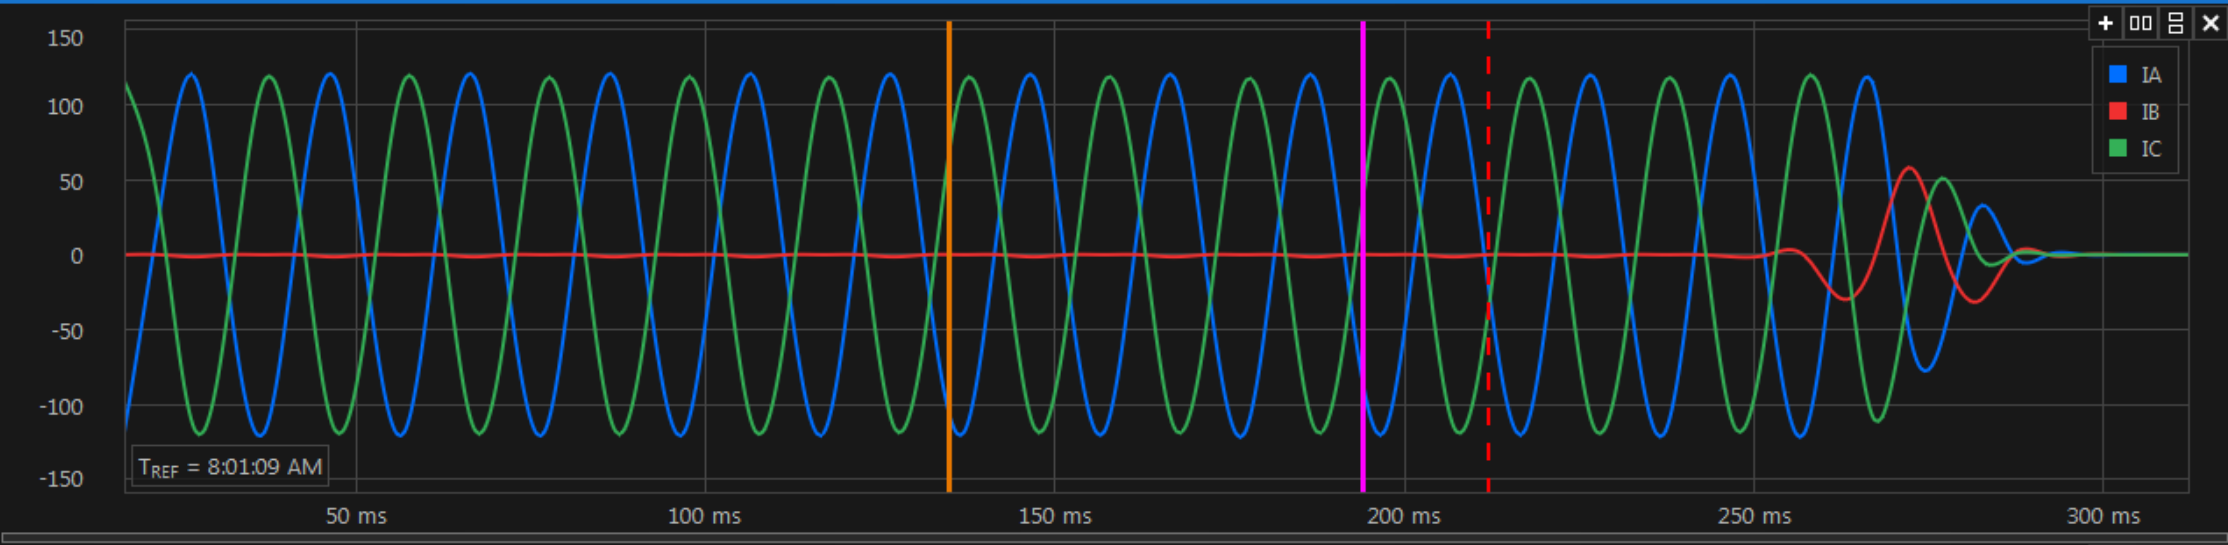
# Palmerston North cable fault – and the SEL trace of the trip of Z180

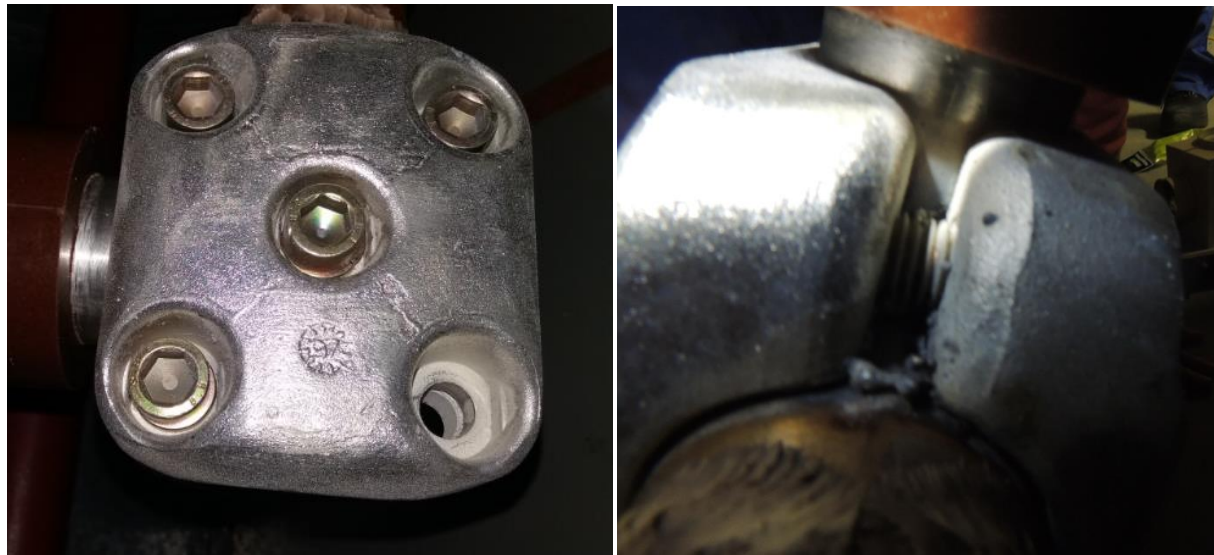
## Palmerston North cable fault ... turned out to be a bus connector

- These are old oil filled cables with leaking joint problems.
- PI shows an intermittent open circuit on one of the cables, and the other cable takes up the load.
- PI shows that when the open circuit occurs the capacitive charging current is supplied from the Main St end, implying the open circuit is near the Keith St end.
- The SEL traces show A and C phases sharing current roughly equally.
- While B phase current was carried on only one cable.
- And an observation that 1.5 cycles of current flows on B phase just before Z180 opens.
- The Z180 circuit breaker was then checked thoroughly - and it was fine.
- The panel and bus connections were checked – and the fault was found – poorly installed bus knuckle joints.

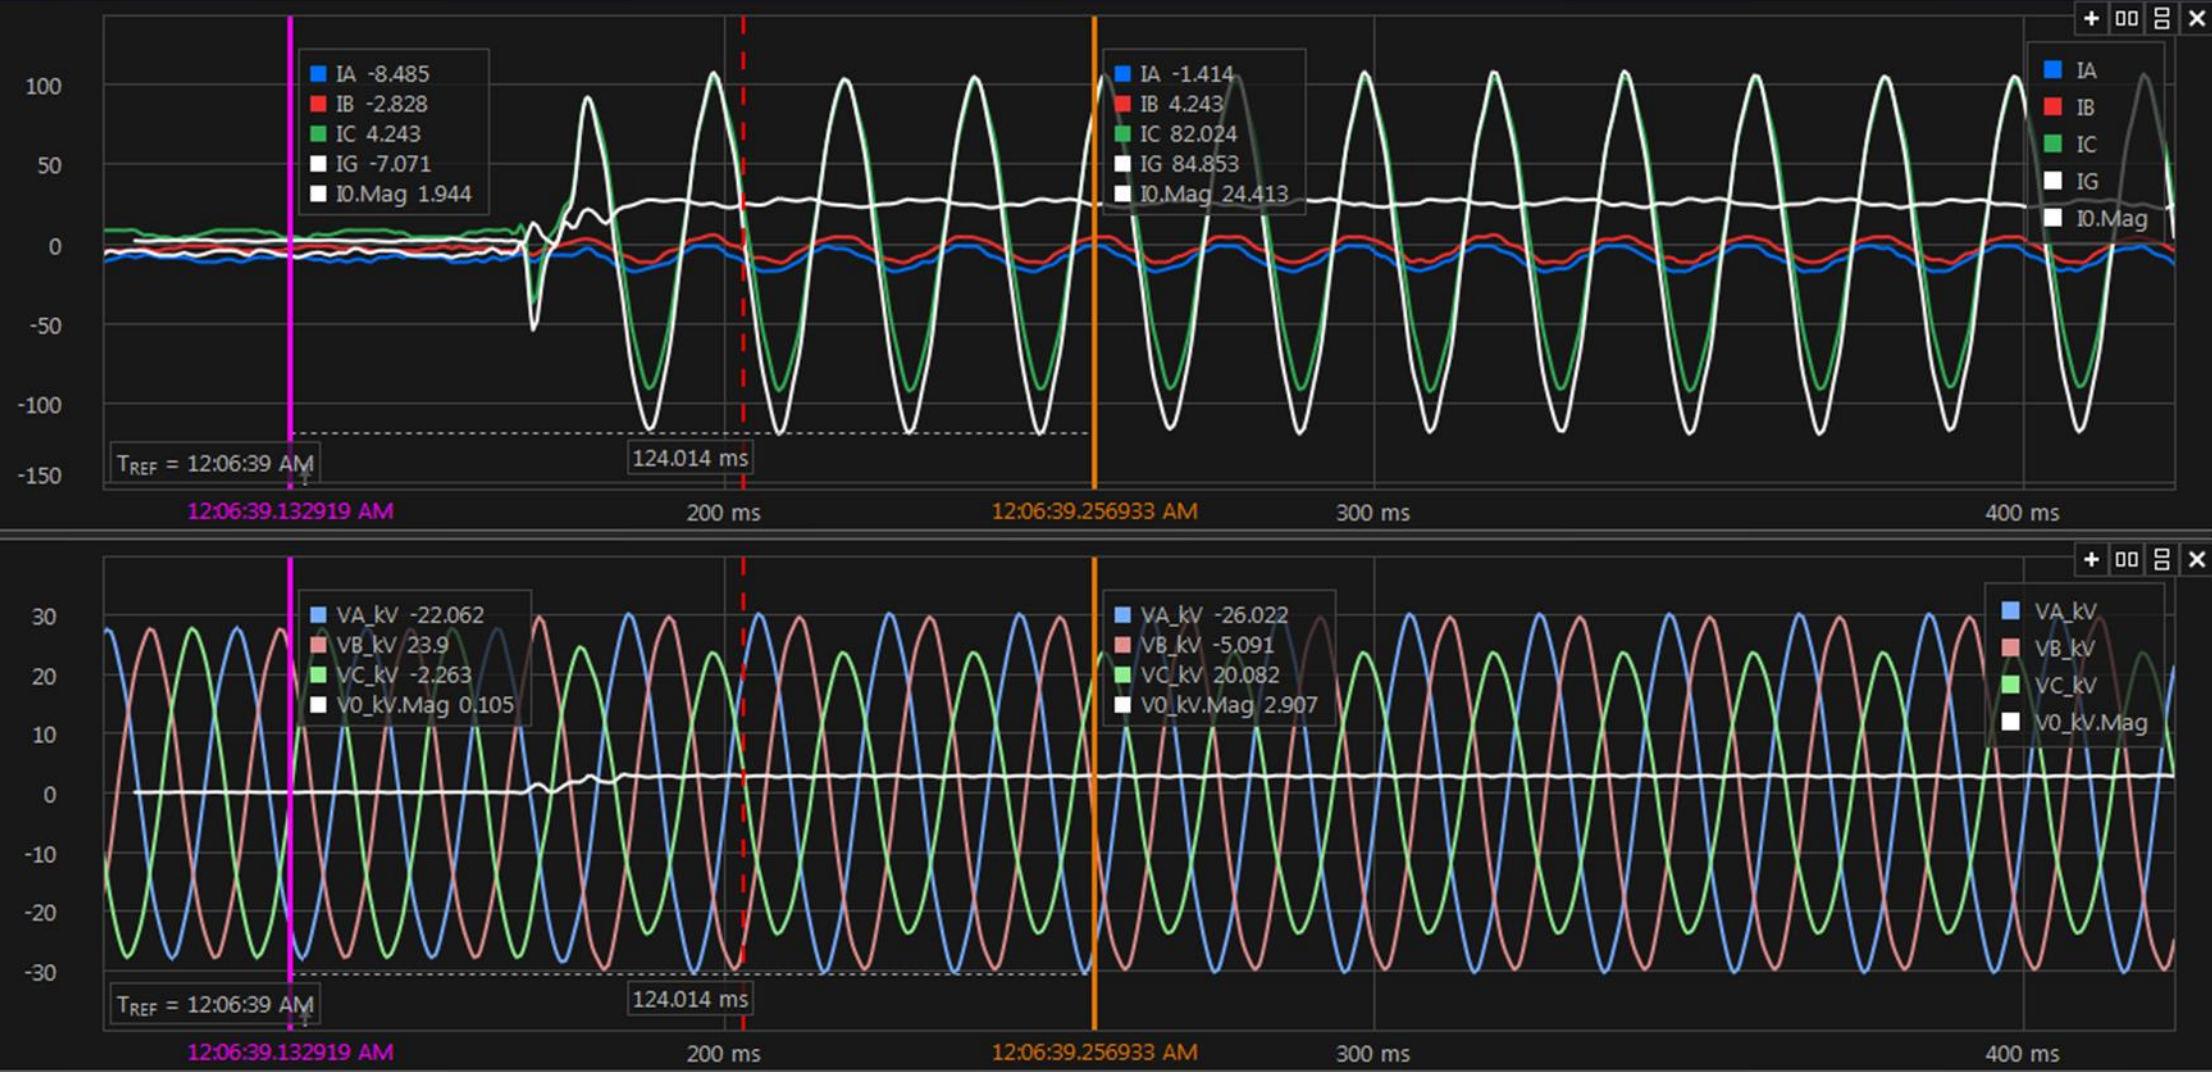
SEL SQI010aa Greerton CB182 CG T 22Jan2018 00 06 39 203 CEV\_R\_L15\_3.CEV - SynchroWAVE Event

# CB182, the substation circuit breaker that tripped

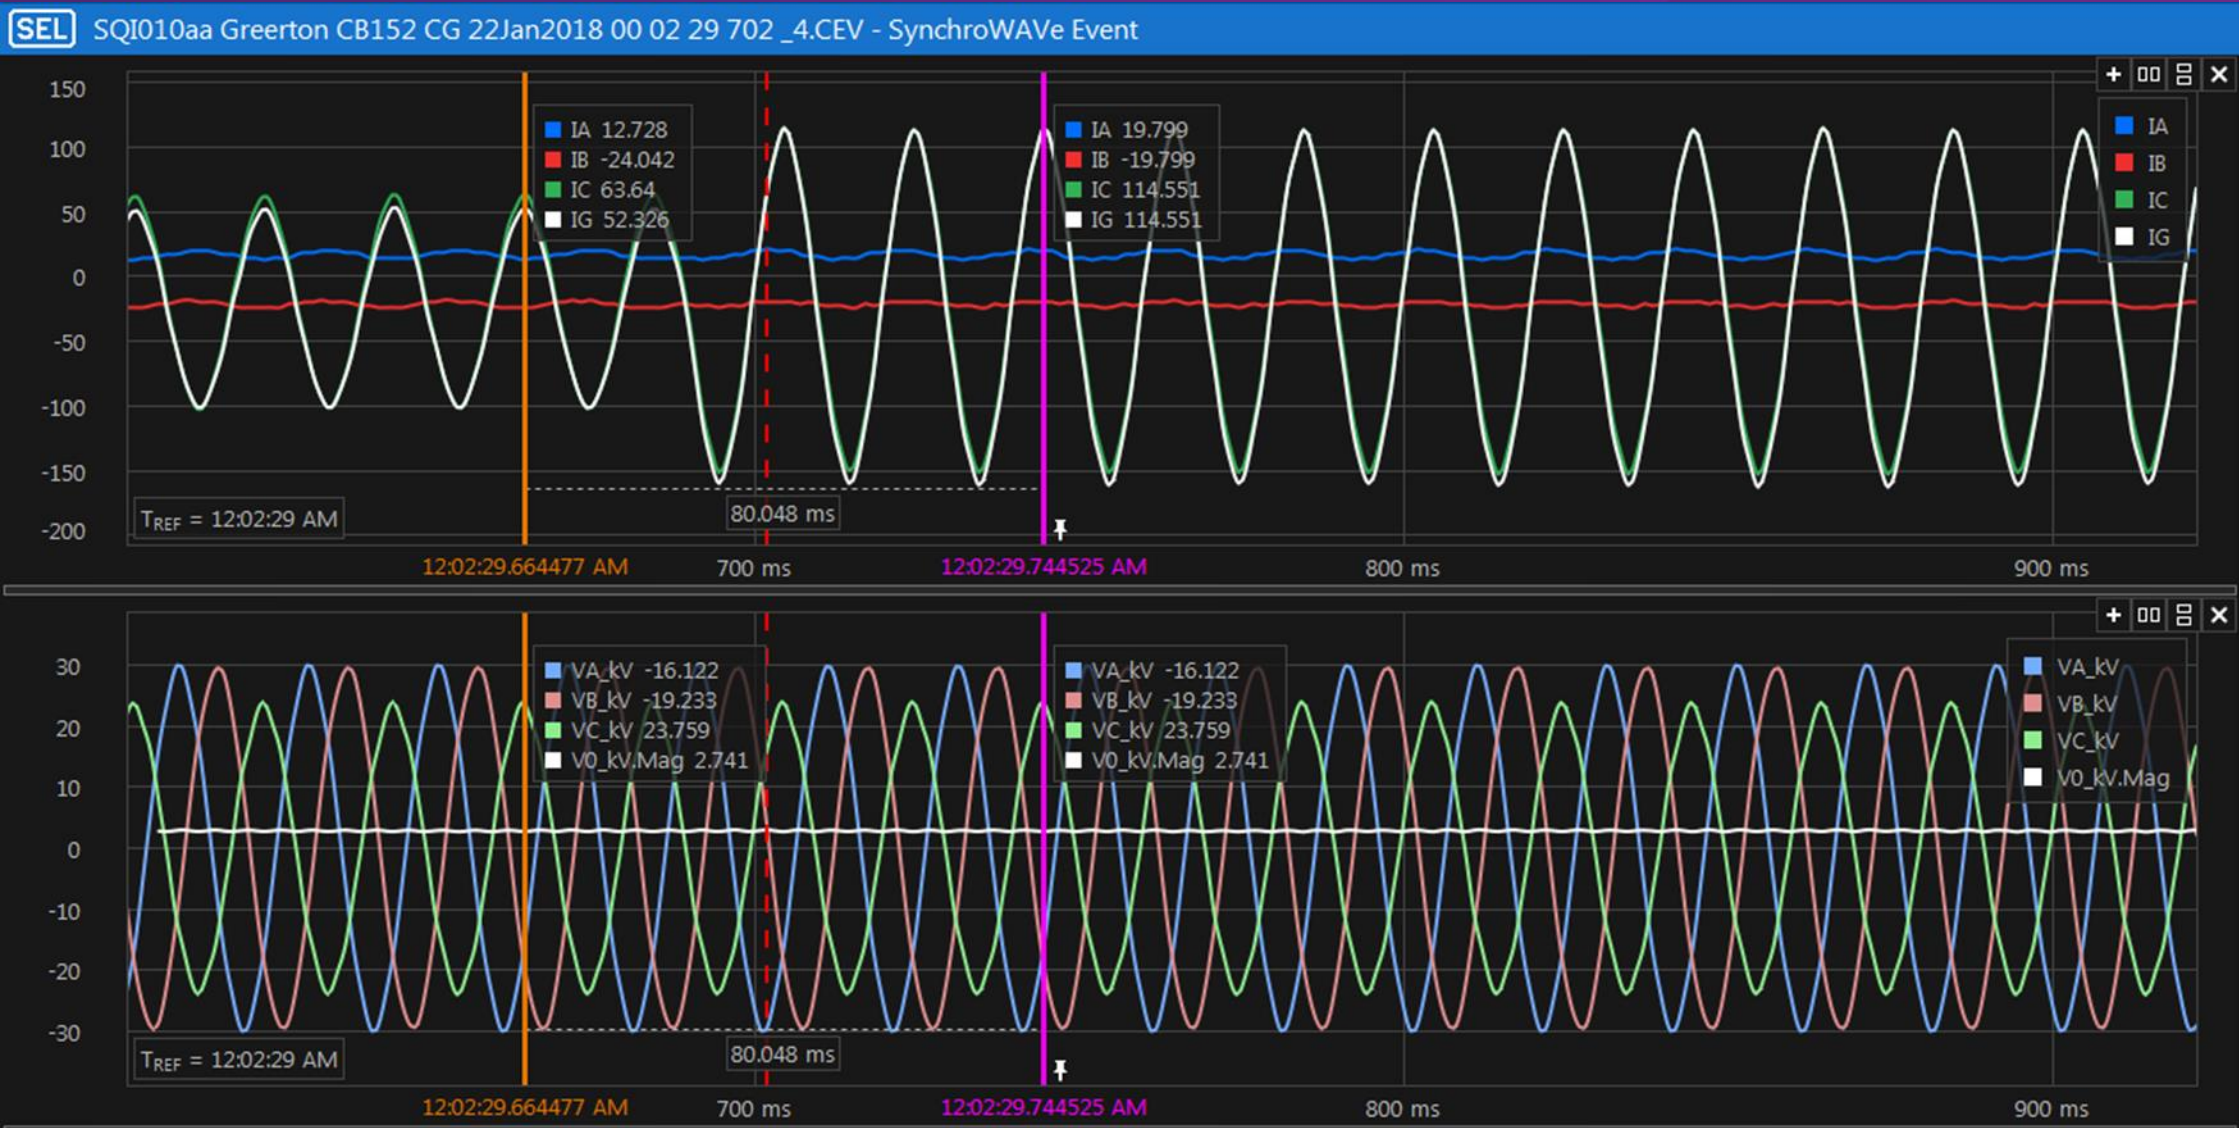
CBs 152 and 162 did not trip. They did see  $I_o$  increase which started relay timing ... however, notice that there was no increase in  $V_o$ .

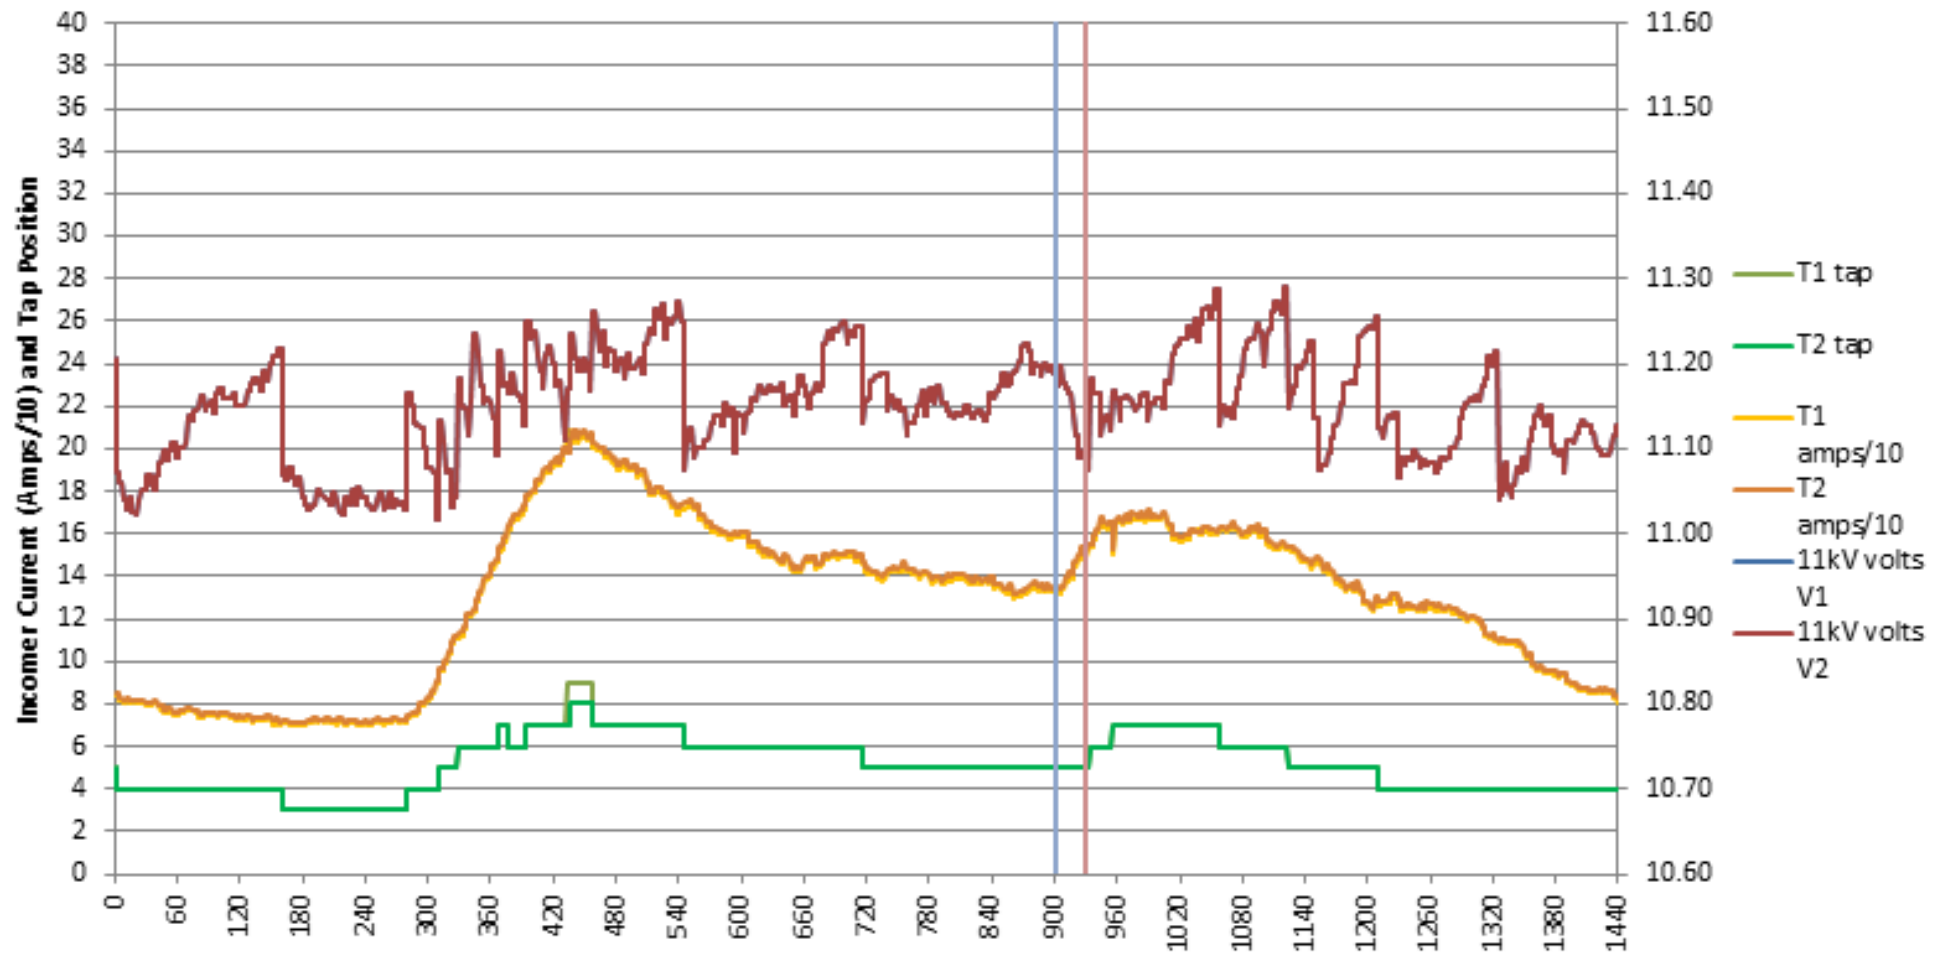
Kerepehi 24-1-2018 T1 Lower limit too high, Check if LDC active, Check for oversensitive BW setting,

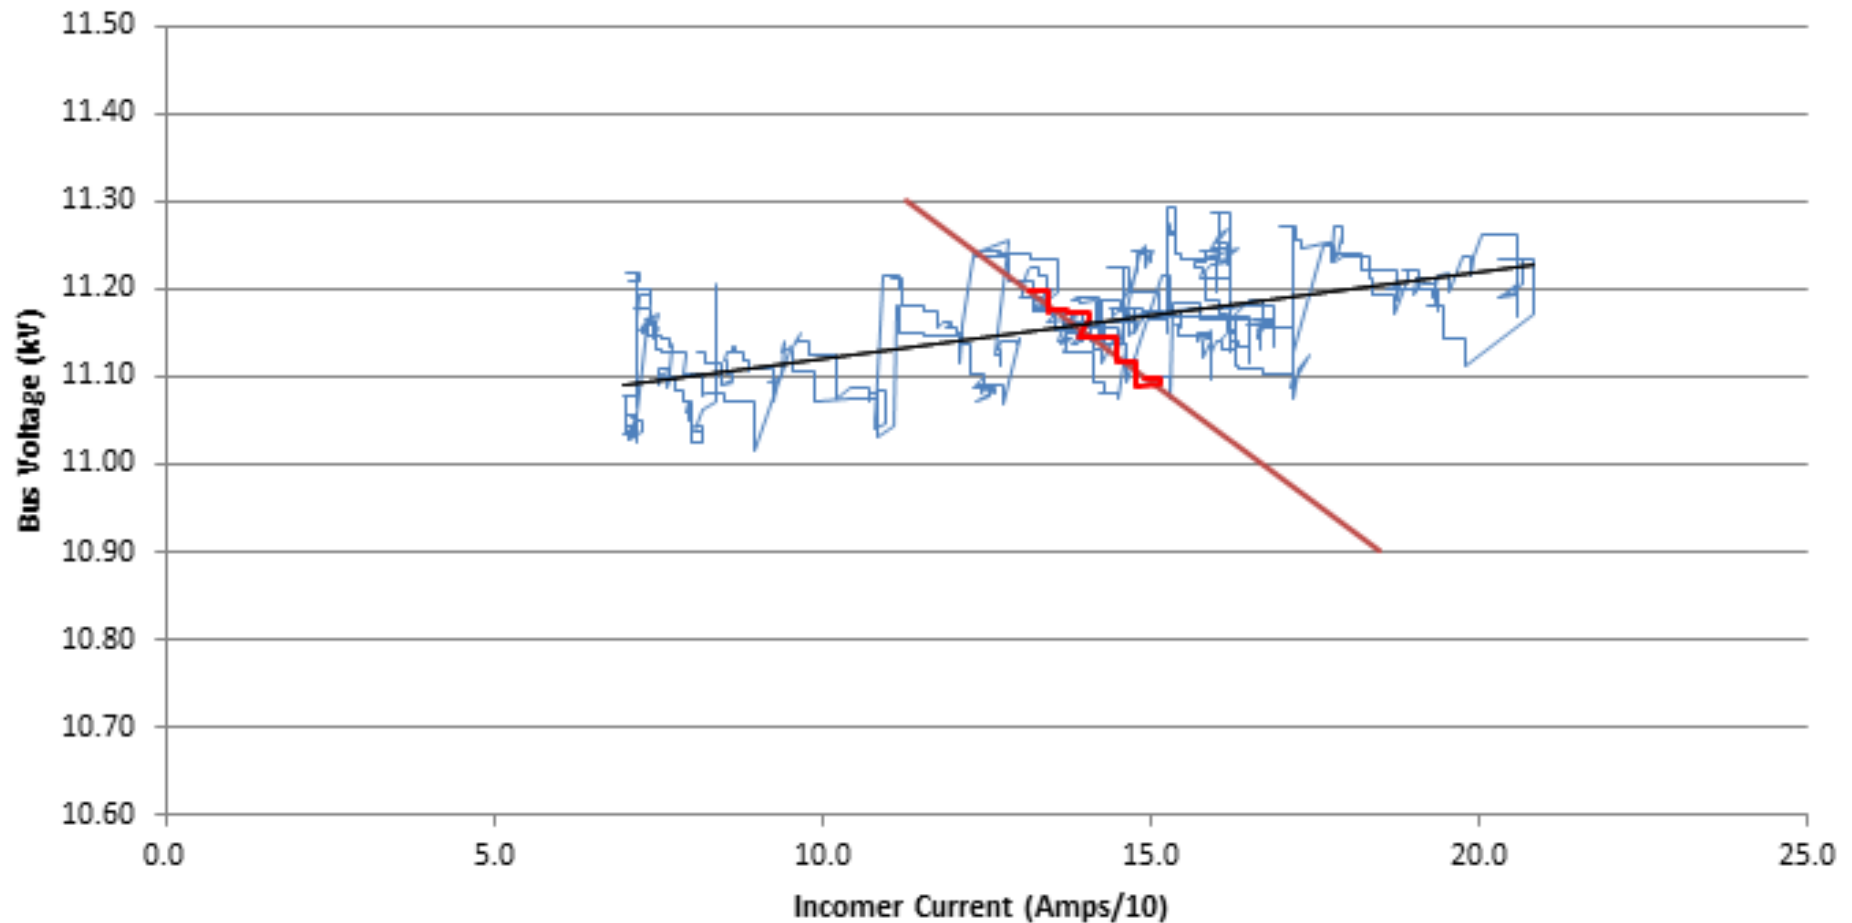
Kerepehi 24-1-2018 T1 Lower limit too high, Check if LDC active, Check for oversensitive BW setting,
