**SAFETY
ALERT**

Waikaremoana, G4 Turbine Pit, 19th June 2018

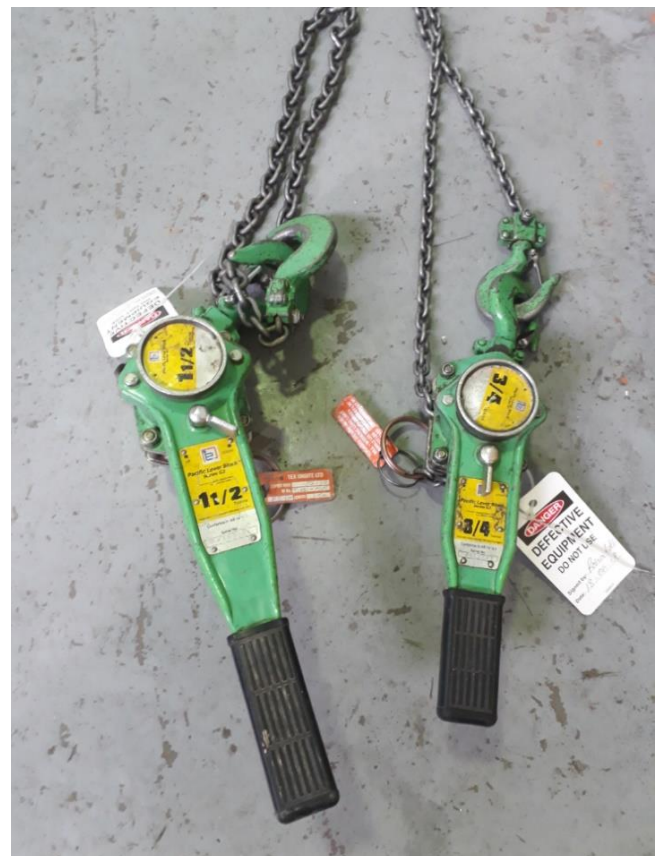
The Turbine bearing was being removed when one of the lever hoists disengaged under load. A secondary lever hoist was in place, so the load didn't drop far. All the lever hoists used were under current test and tag.

If there had been no secondary hoist attached, the load would have fallen into the pit causing damage and potential injury.

Investigating to check for the reason for the failure.

- This Safety Alert is a reminder that equipment can fail unexpectedly.
- Remember, where ever possible, to ensure secondary levels of protection are in place to prevent failure.
- Ask yourself as you plan and prepare for your work **“What extra measures can be put into place to make sure that even when things go wrong, they go right?”**
