SAFETY ALERT

Shared Learning's

Importance of HUB Checks

13th June and 20th June 2018

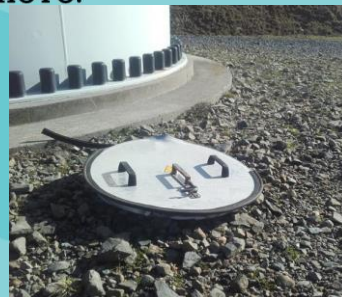
The second event resulted in an approximately 3 kg hub hatch being found on the ground very close to the tower at West Wind. This hatch had become loose and fell to the ground from 70 meters.

The hub hatch was found on the ground the day after a work party had visited the turbine. The turbine was inspected that day to ensure the other two hatches were engaged correctly and no further damage had occurred to the fibre glass covers.

Hatch found on hardstand

The hub hatches currently in use at 75% of WWD, 100% at Mill Creek and 100% at Te Uku are all of the similar 5 pin locking type. These hatches must be fully placed into the hatch opening, pushed down to squash the gasket in and the locking handle turned to fully engage the pins into the hub grove. The safety latch must also be fully engaged.

The most important thing to complete is the double handed pull check. Once the hatch is fully closed. Grip both plastic handles tightly and giving them a good tug therefore in theory trying to pull the hatch off. This final check ensures that all five pins are engaged and the hub hatch is secure.
