## **SAFETY ALERT**

Near Miss - Dropped object from met mast

4 July 2018 at 14:30

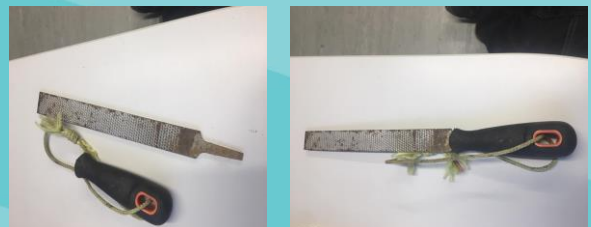
### **PHOTO:**

A contractor was performing planned maintenance on an 80-meter guyed met mast on a wind farm. During this work a file that was being carried and attached externally on the harness dropped 78 meters. The moulded handle was secured to the harness via a corded loop. The steel part of the file separated from the handle, fell and was blown clear of the tower approximately 25 meters.

This incident highlights the importance of properly securing tools. The tool had a tight press fit but was not secured with any adhesive. It was assumed that this would have been sufficient during the pre-use check.

It is inconclusive how the file had become loose from the handle however it has been assumed that during use it may have worked its way loose.

- Once it was discovered that the tool had dropped, personnel and vehicles were checked for safety. There were no issues resulting from the dropped object so the work continued.
- Upon completion of work the issue was discussed on site then reported as a Near Miss.
- The file was found downwind imbedded into the ground approximately 25 meters away.
- An initial investigation was completed and witness statements taken.
- The steel part of the file weighed approximately 200 grams.
- A corrective action has been to review all similar tools and make sure they are epoxy glued together to prevent reoccurrence.
