SAFETY ALERT

Open Brake Pit Access – Near Miss

August 1st 2018

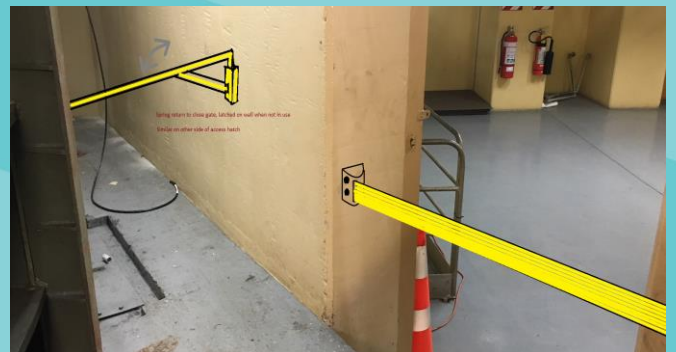
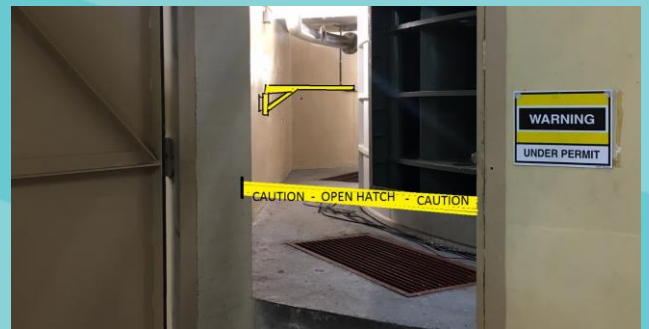
PHOTO:

Barrier options (see photos below) currently being investigated include self-closing gates either side of these access ways inside the stator enclosure and a retractable caution tape on entry point into the enclosure.

Access ways must be covered over at the completion of work.

Loose material which could become dislodged should not be used above open access ways.
