SAFETY LESSON LEARNT

Glove catches in grinder

16 August, 2018

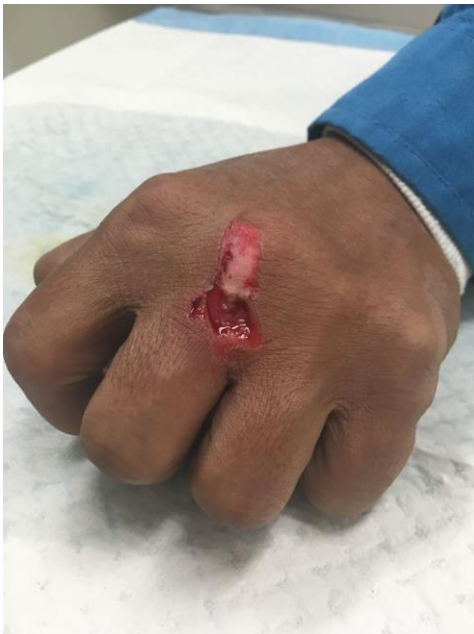
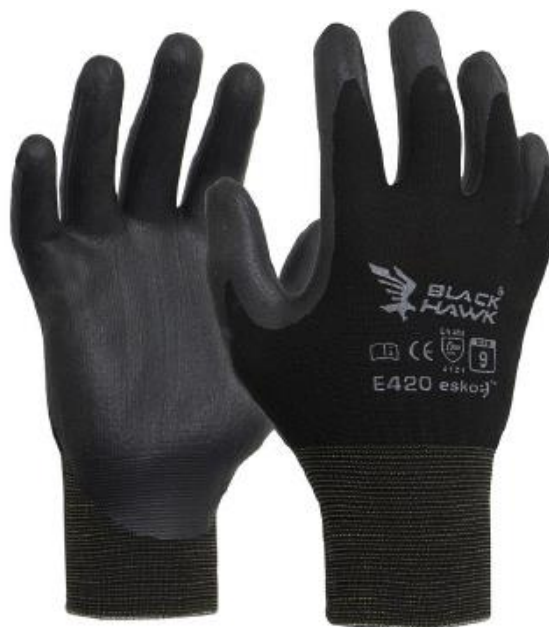
An employee was using an angle grinder to grind paint from a metal surface with a flapper disk when the back of his glove caught in grinder. The grinder caught in the fabric back of the nitrile type glove (Esko Black Hawk E420) and drove the grinder in the back of the employee's knuckles. The resulting flesh injury required medical treatment and was considerably worse than what would be expected had he not be wearing gloves

The root cause is incorrect usage of the angle grinder. Two handed operation is required for correct operation of an angle grinder. Handles must be fitted and used.

EN388 is a standard that ranks gloves for protection from mechanical risks, including abrasion resistance, with 1 the worst and 4 the best (this is the first number of the 4 digit code). The gloves being used were rated 4 (the best) but are only protecting the palm, with a light material on back.

Required handles to be fitted and used for two handed operation. Changed to leather riggers gloves when using grinders while alternative glove options could be assessed.

A knuckle dip glove is to be trialled for better back of hand protection <https://www.lynnriver.co.nz/products/hand-protection/general-purpose-gloves/67071-ultra-grip---knuckle-dip>.
