SAFETY ALERT

Shared Learning's

Minor electric shock from extension lead in Manapouri switchyard

15th May 2019 at approx.17:15

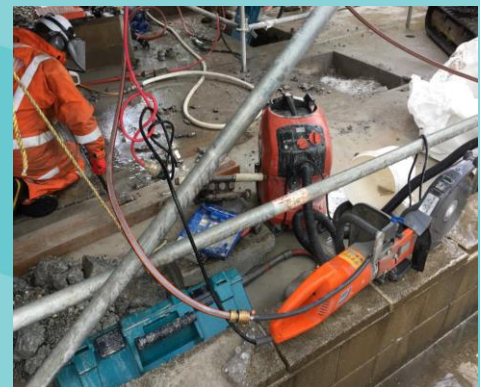
PHOTO:

The worker picked up the plug to unplug the saw to change position. He felt a tingle when he touched the plug. The supervisor was assisting him and touched the same plug and also experienced a minor shock from the plug as well.

Both experienced the electric shock when touching the plug, not the extension lead.

The connection point was wet, but clean and not covered in cutting slurry.

The work crew identified that the RCD did not provide protection to the extension cord on the supply side of the RCD.

The inline RCD has now been removed from the saw allowing an RCD at the supply end of the extension lead to be used.

The work crew also dried and elevated the extension lead plugs off the ground and implemented a protocol where all leads will be turned off at the supply end before unplugging the tool at the work site.

1. All electrical equipment must be supplied from an RCD protected circuit that is fixed at the switchboard – this is a requirement of AS/NZS 3012: 2010
2. The following protocols are recommended where using electric power tools in wet environments:
 - Turn off at the supply before unplugging.
 - Test RCDs daily before starting work to ensure they trip and disconnect power
 - Inspect leads daily for damage
 - Remove leads from worksite at end of shift and place in a warm & dry location
 - Ensure male plug ends are dry before connecting
 - Ensure plugs are elevated from the ground and protected from water sprays from tools
3. Ensure lead with correct level of IP Rating are to be used on site (Plug-cover clam shells are to be used between extension leads and appliances).
