SAFETY ALERT

Unexpected release of fall arrest lanyard from double action hook from dorsal attachment point

1400 hrs Wednesday 2nd Dec 2015

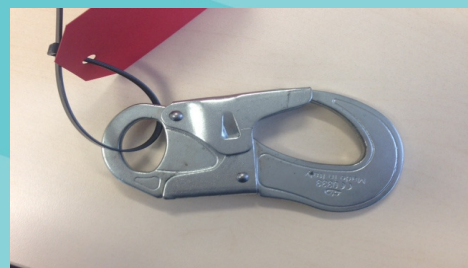
PHOTO:

During working at height training, a Wind Technician was undertaking a ladder rescue approximately 6-7 meters up. His dorsal double action hook managed to unlock itself from the dorsal attachment point on his harness.

As his back made contact with the tower the hook became disengaged from his harness. This resulted in the technician having no protection in an event of a fall.

Hook to be removed and tagged out. Do not use until further notice.
