## **SAFETY ALERT**

**Timely Reminder of the Importance of the Pre-Use Vehicle Check**

**13<sup>th</sup> and 20<sup>th</sup> June 2018**

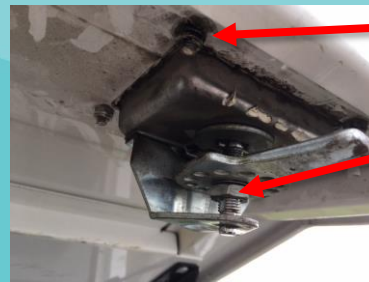
In the first event the vehicle safely stopped straight away. Retrieved the broken prop valve and screw drivers. The left hatch had a loose catch that caused it to accidentally open. This has now been fixed. It is unknown if the other latch was accidentally left open or not engaging correctly.

Nyloc latch holding nuts X4

Latch adjustment locking nuts

Please use this as a timely reminder to carry out a quick pre-use check of your vehicle before every journey. This check should include your Ute tool box latches where applicable. It is also recommended that all nyloc nuts are checked on the latches and re tightened. The adjustment locking nuts should also be setup correctly to ensure the correct fitting of lock.

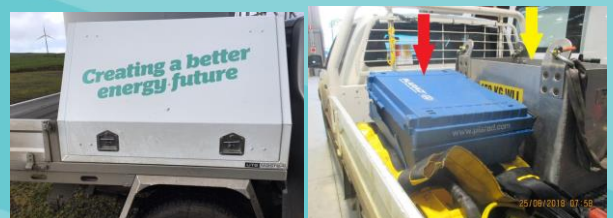
The second event identified a steel box sliding on the steel deck of the Ute pushing the Hi Torque unit off the vehicle. The main contributing factor was that the equipment was not tied down.

Photo 1 Wind Ute Toolbox

Photo 2 Ute set up not tied down

In the second event recommendations have been made to ensure all site vehicles are fit for purpose, have adequate tie downs, a cargo net provided to fit over the deck and a rubber mat to be fitted to all deck Utes.
