SAFETY ALERT

A slip resulting in a back sprain whilst carrying a very heavy kit bag over the shoulder up some external stairs

Monday 23rd May 2016 10.00

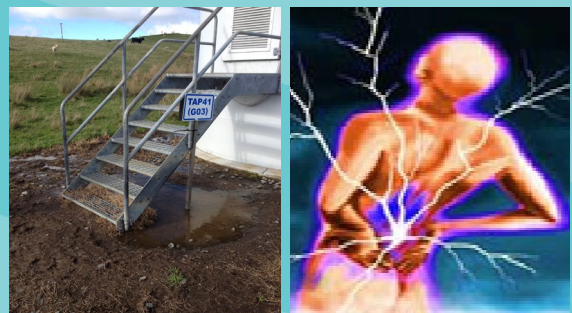
PHOTO:

There was a recent incident at one of our wind farms where a technicians slipped whilst climbing the entrance steps to a turbine. At the time he was carrying a heavy bag of tooling by himself weighing 52 kg over his shoulder. Fortunately his work mate caught him preventing further injury. However he still sustained a strain to his lower back resulting in a LTI and restricted duties. The severity of the injury only became apparent a day and a half later.

As a direct result of this incident the technician was lucky to come away with only a minor injury. A high level of training had occurred and guidelines were in place but not followed. A failure to identify the hazards involved with the job, a secondary goal of trying to keep the bags down to a minimum to avoid a second crane lift also contributed. Muddy slippery conditions were present and not considered, and a single lift was performed when a two man lift would have been more appropriate.

At the next appropriate opportunity use this learning as a reminder on the importance of how a quality Manual handling risk assessment can prevent injury.
