## **SAFETY ALERT**

# **Shared Learning's**

Electric motor dropped on hand

Friday 8<sup>th</sup> May 2015 1400hrs

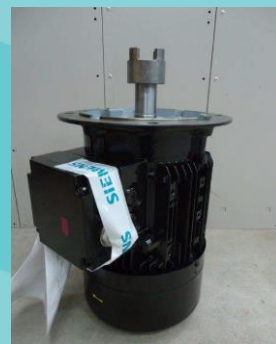
### **PHOTO:**

While removing the motor from the lifting bag in the nacelle the motor rolled and dropped, a distance of 150mm, onto one of the technicians hands.

- Documentation process explained/refreshed to all.
- Lifting eye for hydraulic motor to be available at Te Uku Wind Farm
- Van Houte land owner to ensure his gate is not locked for use in an emergency.
- Used first aid kit to be restocked.
- Ensure there is an ice pack in the vehicle first aid kits and enough spare gel ice packs in the service building freezer.
