SAFETY ALERT

Near Miss - Yaw Brake Hydraulic Hose Failure

22nd September 2017

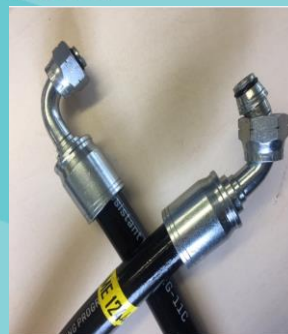
The isolations were removed and checked off prior to re-energising the system. The pump was run to raise the pressure up to the working amount. It was at this point that whilst inspecting for leaks, an un-crimped fitting burst apart releasing 140 bar of pressurised oil.

The un-crimped hose caused the stored energy to force the oil out of the fixed point elbow fitting. An emergency stop (E stop) was pushed within a second of the technician shouting. If the hose would have flailed at the other end this would have caused a whipping effect with the potential to cause injury. A visit was made to the manufacturer to determine why the hoses were missed and the following was confirmed:

Photo 1 Uncrimped

- The manufacture have agreed to improve their QA process with the addition of a final check that includes a check sheet that will follow the parts
- The manufacture were receptive to suggestions about fatigue management and will ensure adequate breaks are taken
- The hoses will be checked when received into stock at site as an internal double check before being assigned to a job
- A crimped fitting and an un-crimped fitting were shown to the Project Team to identify the difference
- The technician in charge of future works will be responsible for the final triple check to make sure the system is fit for returning to service
- For all technicians to understand what the difference between an un crimped and a crimped hose looks like (See photos below)

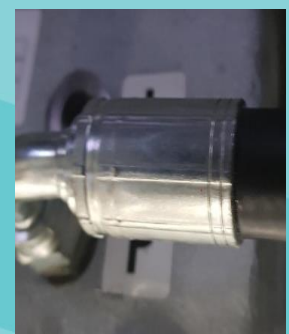
Photo 2 Crimped
