SAFETY ALERT

Safety Barrier Failure Leading to Fall and Significant Injury

24th July 2019, 9.40am

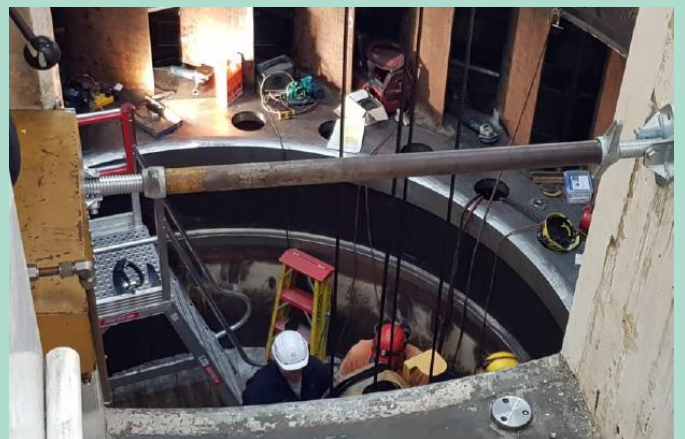
PHOTO:

A temporary barrier had been installed across the edge of the upper pit access area to allow a safety observer full visibility of the work party welding in an enclosed space below.

In attempting to retrieve an item from the staff in the area below, the contractor leaned against the barrier which resulted in it giving way and the contractor falling approximately 4.5m to the wooden turbine platform below.

- Limited or no risk assessment resulted in an inadequate barrier being selected.
- Incorrect barrier installation.
- Poor communication between the team members with regards to the intent and limitations of the barrier.

The key learning identified by both MB Century and Meridian was the requirements for installation of edge protection were not adhered to leaving the contractor exposed to the risk of fall.
