Condensate Tank Lifting Lug Failure

Mercury Kawerau Power Station

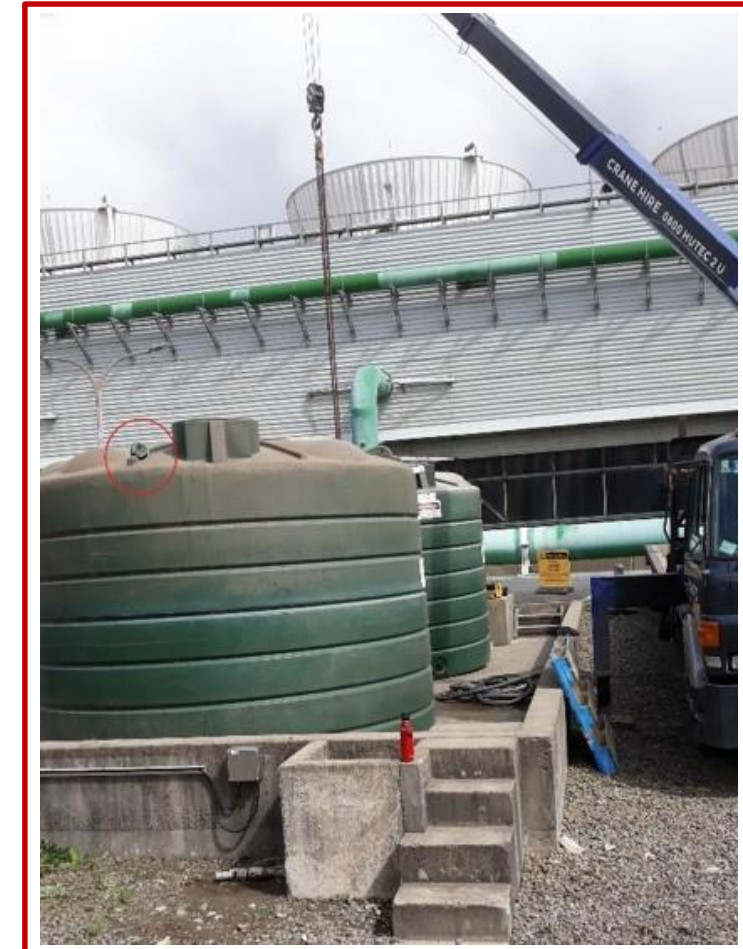
Whilst decommissioning a geothermal condensate tank a contractor was potentially exposed to high concentrations of H₂S. To fully drain the remaining condensate from the tank, a hiab was used to attach a strop to one of four lifting lugs on the top of the tank, to elevate one side and drain the remainder of the tank. The lug failed, tearing a hole in the top of the tank. The contractor was potentially exposed to gas escaping from the tank, resulting in nausea and subsequent overnight hospitalisation for observation.

- ✘ Polyethylene tank had UV degradation making the lifting lugs 'brittle'
- ✘ Accumulation of high concentrations of H₂S gas are possible in the vapour space of a geothermal condensate tank due to cyclical nature of operation
