Excavation Incident

Thermal Generation Site

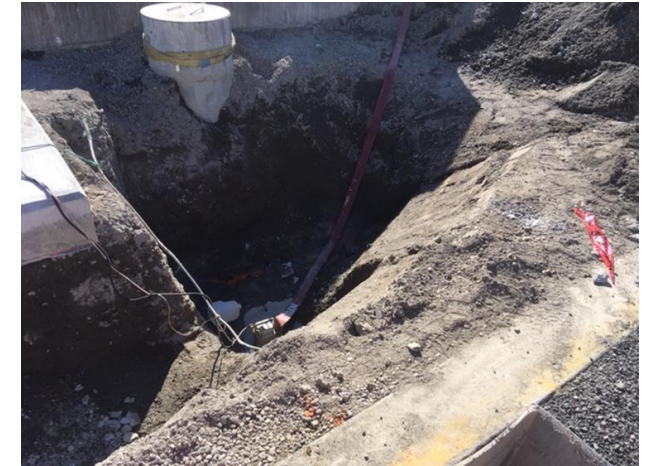
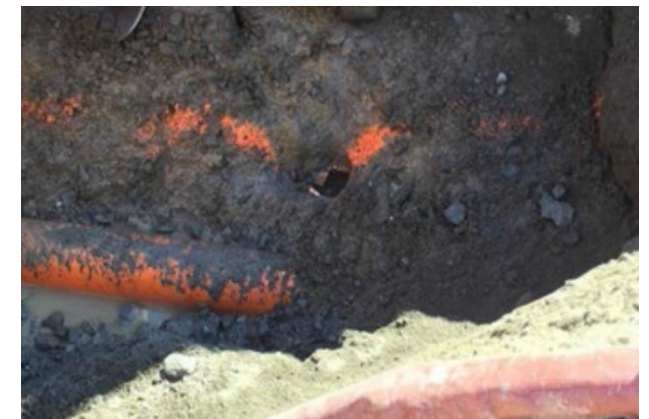
Excavation work was required to locate and unearth an 11kV cable. The 11kV cable was found to be encased in a layer of concrete. During removal of the concrete layer with a rock breaker power tool, water was spotted coming out of the cracked concrete. On closer inspection it was revealed that another cable conduit containing a live 400V cable had been damaged. The damage was caused by a large piece of concrete breaking off during the concrete breaking activity and impacting on the 400V cable conduit (not through direct impact of the rock breaker). The live 400V cable was not contacted and the job was immediately stopped, scene preserved, and permits returned.

The 400V cable details and location were not clear on underground drawings or through detection services. Where any doubt exists a second form of detection should be considered.

Work Control Procedures were not fully adhered too in this case. Ensure Job Risk Assessment is completed >7 days prior to the task being undertaken.

Pre-Work Meeting should be conducted >1 day prior to the work commencing and greater time given to risk assessment and controls.
