Site: Waipipi	Incident Title: Blade Trailer Tip Over	Incident Date: 05/06/2020	
Ref #: 393	Actual Severity: 2- Minor

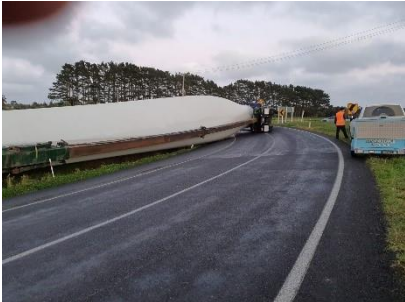
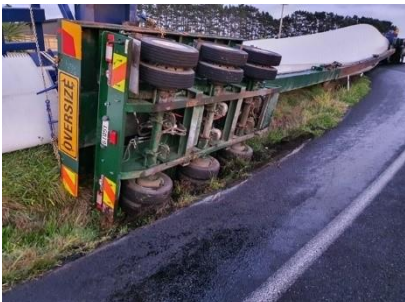
<b>Major Hazard Category:</b> Driving and Transport
Category: Asset	Potential Severity: 4 - Major		
<p><b>Details:</b>            The trailer of the first SGRE 64 m blade tipped over while travelling to site. The incident occurred along the State HWY 45 route on a 90 degree left hand bend in the town of Okato.</p> <p>Initial assessment of blade appears to be surface paint damage only. Further investigations of the blade are ongoing. There was also minor damage to the trailer which was easily repaired.</p> <p><b>Immediate Actions:</b></p> <ol style="list-style-type: none"> <li>1. Assessment for any injuries to personnel.</li> <li>2. Traffic management at site. D&amp;A testing.</li> <li>3. Halting of all component deliveries to the project site pending investigation outcomes and corrective actions.</li> </ol>

<p><b>Root Cause:</b></p> <ol style="list-style-type: none"> <li>1. The transport crew failed to adhere to the details of the Transport Management Plan (TMP) for the corner at State Highway 45 (South Road) intersection of Hampton Road. <i>The TMP specified for the trailer to travel onto the right-hand side of the road during the turn (north bound lane). "Truck is to undertake this procedure at walking pace. Spotter is to keep an eye on the inside of the load and the tail swing at the rear. Escorts to control local traffic"</i>. Trailer unit has entered the corner and travelled a path which is further to the left than that suggested in TMP.</li> <li>2. The rear trailer steersman conducted a turning circle that had inadequate clearance along turn circle which caused the trailer to move to the left of the road and off the tarmac surface.</li> </ol>

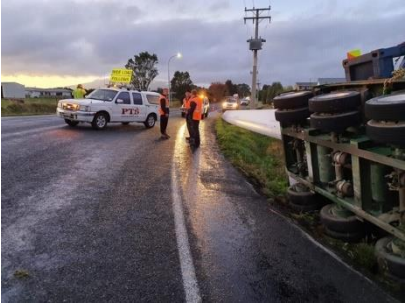
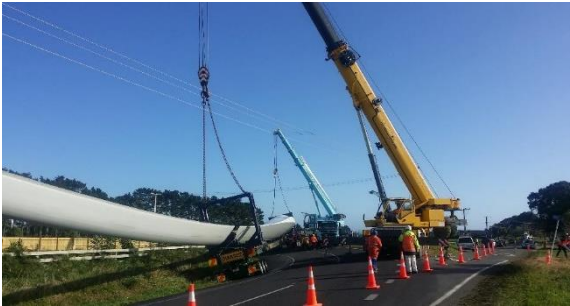
Site: Waipipi	Incident Title: Blade Trailer Tip Over	Incident Date: 05/06/2020
<p><b>Contributing Factors:</b></p> <ol style="list-style-type: none"><li>1. The transport crew failed to adhere to the details of the Transport Management Plan (TMP) for the corner at State Highway 45 (South Road) intersection of Hampton Road. Final report to be discussed at HSEC Committee Meeting.</li><li>2. The rear trailer steersman conducted a turning circle that had inadequate clearance along turn circle which caused the trailer to move to the left of the road and off the tarmac surface.</li><li>3. Load position on trailer. The position of blade frame on the rear of trailer contributed to the unbalancing of load. Note: it is presumed, if the trailer travelled as per TMP and pinch point specification, the potential for a rollover event is significantly reduced.</li><li>4. TMP did not treat the corner with full swept path analysis.</li><li>5. Positive Communications - Pilots have not communicated to PM driver that trailer unit was not tracking in the agreed (TMP) path.</li><li>6. On Road Supervision - Subcontractor team failed to provide adequate on road supervision during 1<sup>st</sup> delivery execution.</li><li>7. COVID-19 restrictions of team mobilisation preventing mobilisation of personnel.</li></ol>
