Uncontrolled Pipe Movement

Geothermal station

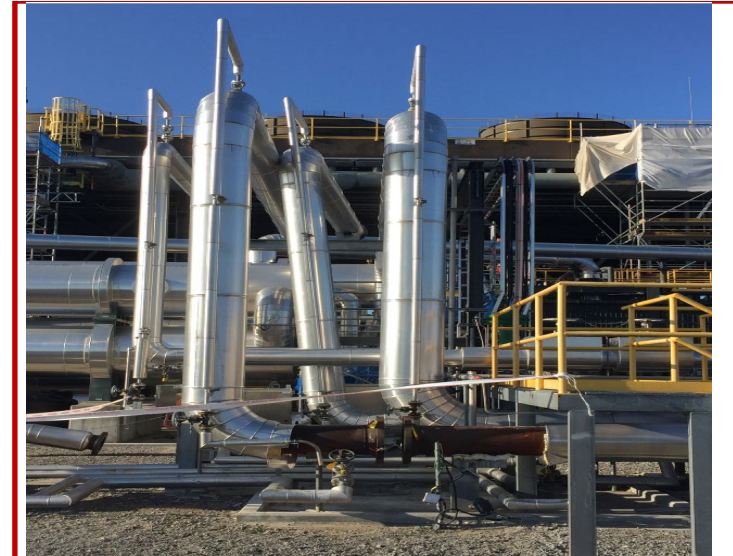
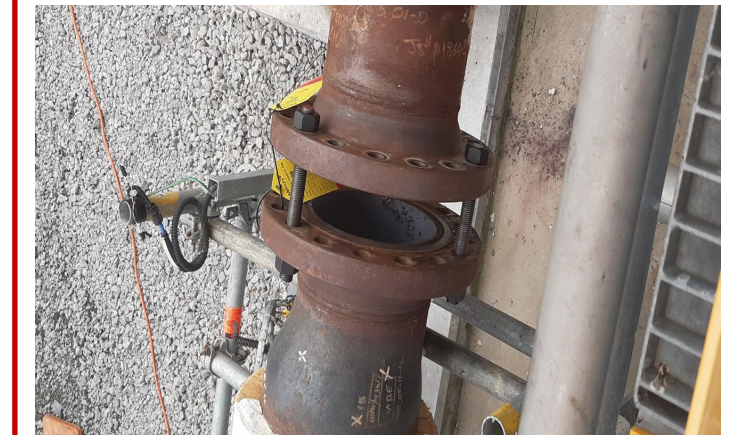
During the annual shut two separate contractors were working on the OEC -3 brine outlet pipe (middle pipe in picture). One contractor disconnected the lower heat source control valve and supported it with scaffolding to stop the pipe tilting to “the right” and moved onto the next OEC unit.

The upper C end cap was then removed by a second contractor, leaving both ends of the pipe unsecured.

Unbeknown to both contractors the 10 tonne piping then tilted slowly to “the left”, coming to lean against the outside piping, which prevented it from falling to the ground. This also occurred at the OEC-2 site.

- When planning ensure you involve all other parties whose work may be adjacent to yours.
- When carrying out the work ensure good communication between adjacent work parties.
- Both ends of the piping had not been removed at the same time before. It was not expected the pipe would “lean” the way it did, as it was scaffolded at the bottom prior to start of work to prevent movement, however the piping tilted to the other side different from what was identified.
- Flange bolts were used to secure the remaining brine outlet pipes and supported with strops prior to commencing further work
