# Asbestos in the Electricity Industry

## Shared Learnings

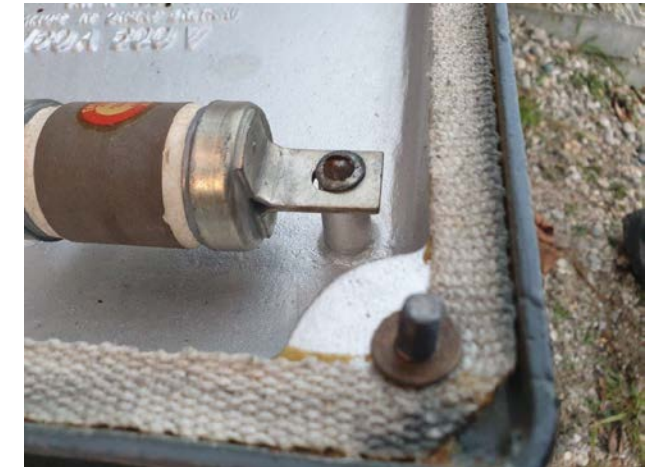
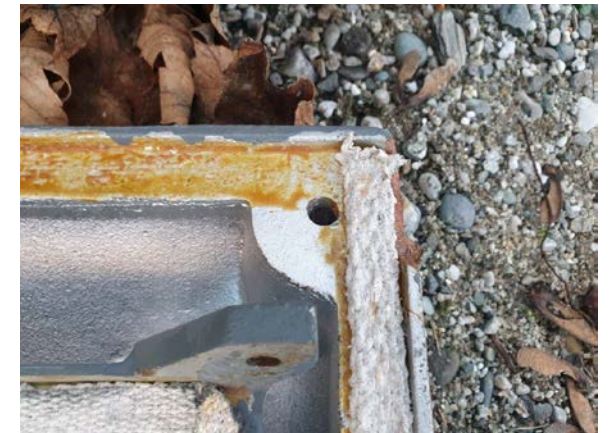
## Panel Door Seals

We were removing and replacing original 1950's plant and suspected the door seals on the terminals cabinet were made of asbestos. Samples were taken which confirmed this.

As we were removing the plant for replacement the cabinets were disconnected externally, wrapped and disposed of as asbestos containing waste. All other similar cabinets were labelled and entered into the asbestos register.

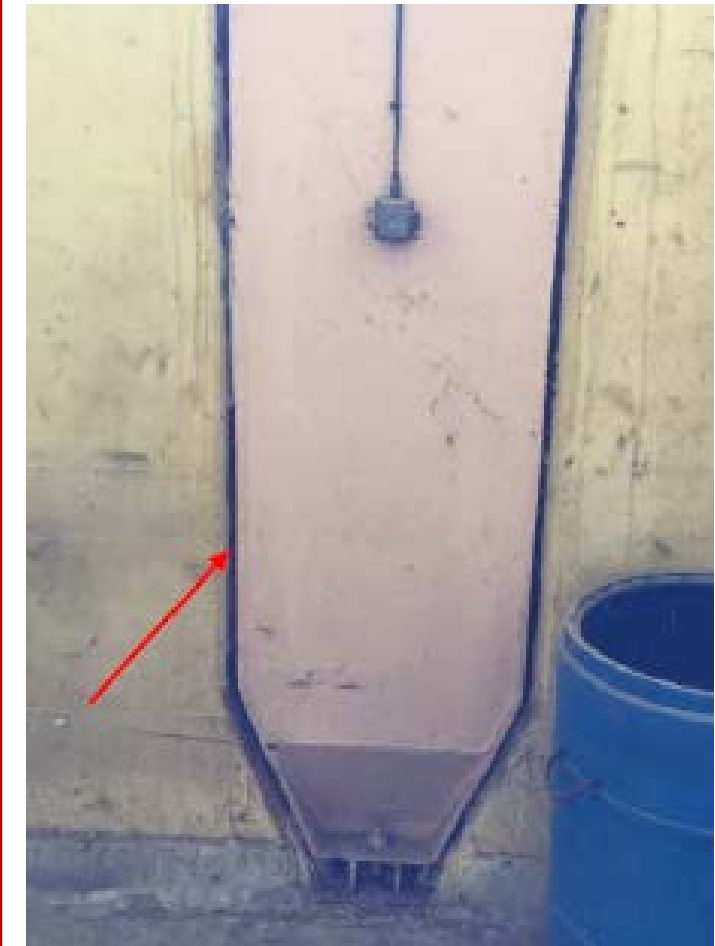
## Mastic

Asbestos Survey identified presence of asbestos within Mastic Jointing.  
The mastic was labelled and entered into the asbestos register.

Many mastics and construction adhesives used up until the 1980's contained asbestos. These are generally non friable and not an issue unless they need to be removed or begin to deteriorate.  
Be mindful of these products, particularly when demolishing old plant and buildings.

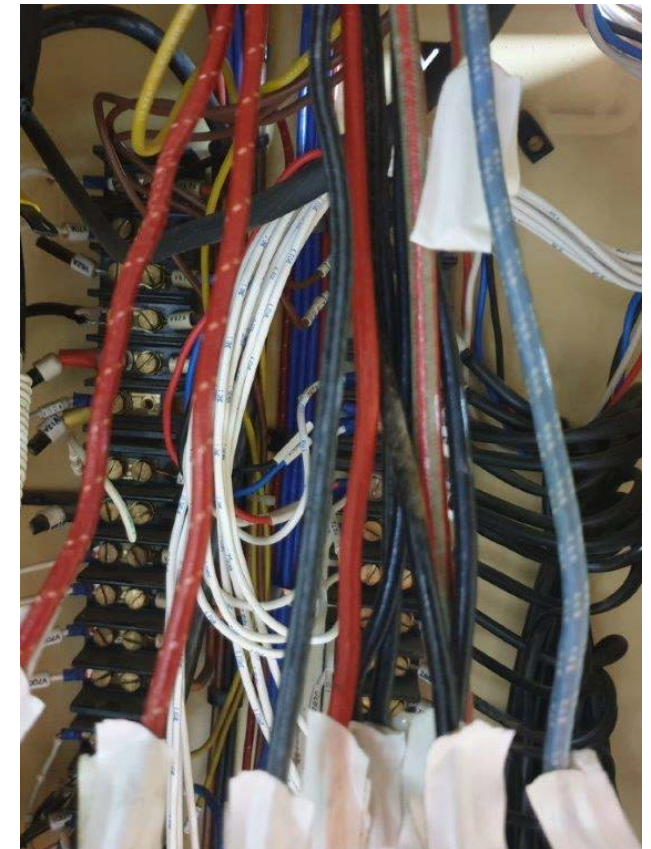
## Wiring in Panel

We were removing and replacing original 1950's plant and noticed Fabric Insulation on some of the wiring in the panels. Samples were taken to determine if it was Asbestos containing. The blue wiring tested positive, the other wiring was OK.

The wiring insulation is in good condition and the panel needed to remain in service. The panel has been closed, labelled and entered into the asbestos register.

Some fabric insulation contains asbestos but as it's impossible to tell by sight. Treat all of this insulation as asbestos containing until clarified through testing.

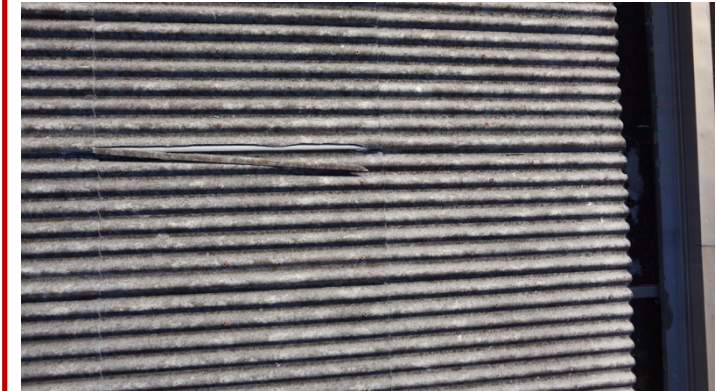
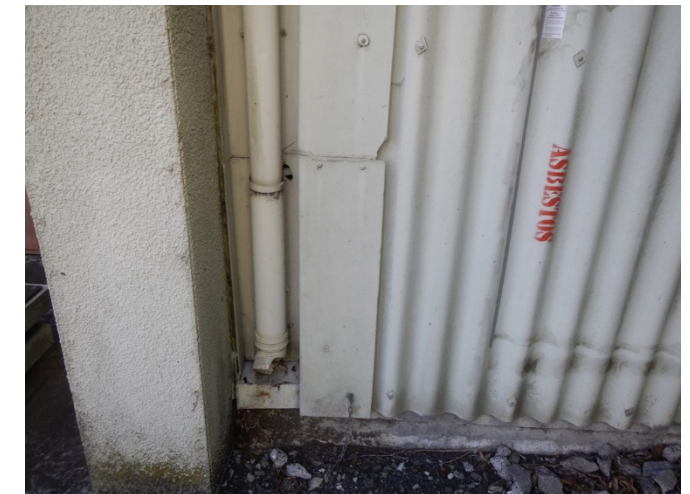
## Roof deterioration

Super Six Cladding was commonly used for both walls and roofing. Once it starts to deteriorate with weathering fibre can be lost to the environment. This generally occurs as a result of high rainfall

In high rainfall events the stormwater overflows the drains and the soil in the immediate area can become contaminated with asbestos fibre posing a risk when it dries out.

Once in the stormwater system the fibre floats on the water surface. In this instance it was being captured in the oily water separator and was able to be sucked out and disposed of. Sampling determined the extent of soil removal around the storm water drains.

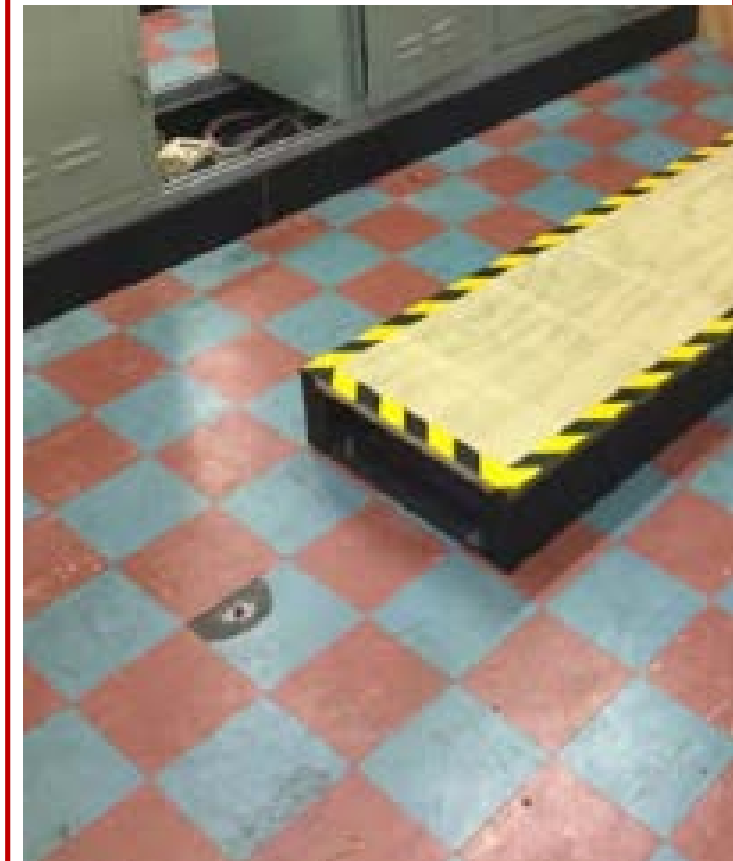
## Vinyl Tiles

Asbestos Survey identified presence of asbestos on backing of vinyl floor tiles.

Many types of vinyl flooring products up until the 1980's contained asbestos material in the backing layer which provided the surface for the adhesive to adhere to. The main risk is that when the vinyl is removed this layer, normally white, remains on the floor and is then sanded off creating asbestos dust.

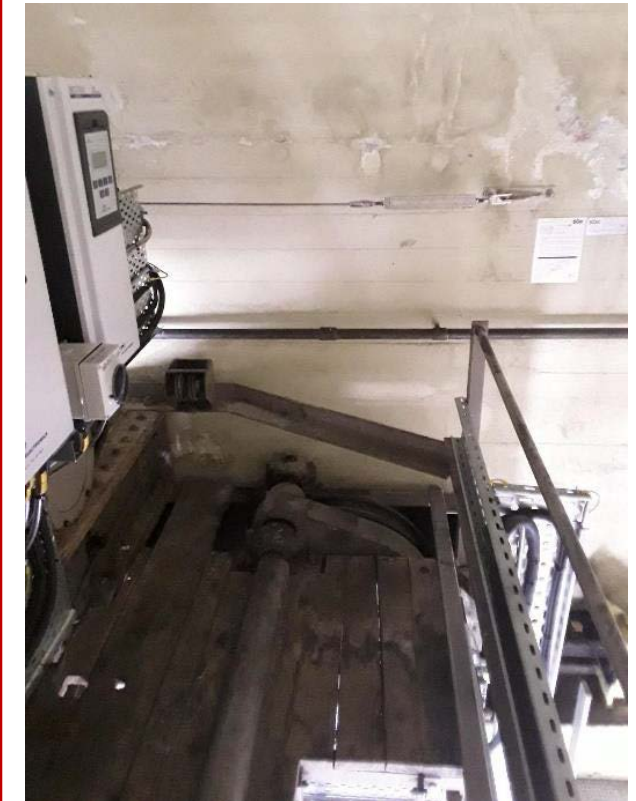
## Asbestos Contaminated Dust on Ledges around Cranes (from Crane Brake Pads)

During Site Surveys we identified asbestos contaminated dust in areas where asbestos products had been in use. The example shown here is an overhead gantry crane which historically had asbestos brake pads in place. These brake pads had been removed, but during their use asbestos fibres were released into the environment and settled on the different flat surfaces.

Working around Asbestos Contaminated dusts can be as hazardous as working with asbestos. In dusty areas it is imperative to ensure a sample is taken and confirmed as negative for asbestos prior to work commencing. If confirmed as positive the area should be cleaned prior to work commencing, or the area be treated as asbestos contaminated and safe methods of work undertaken.

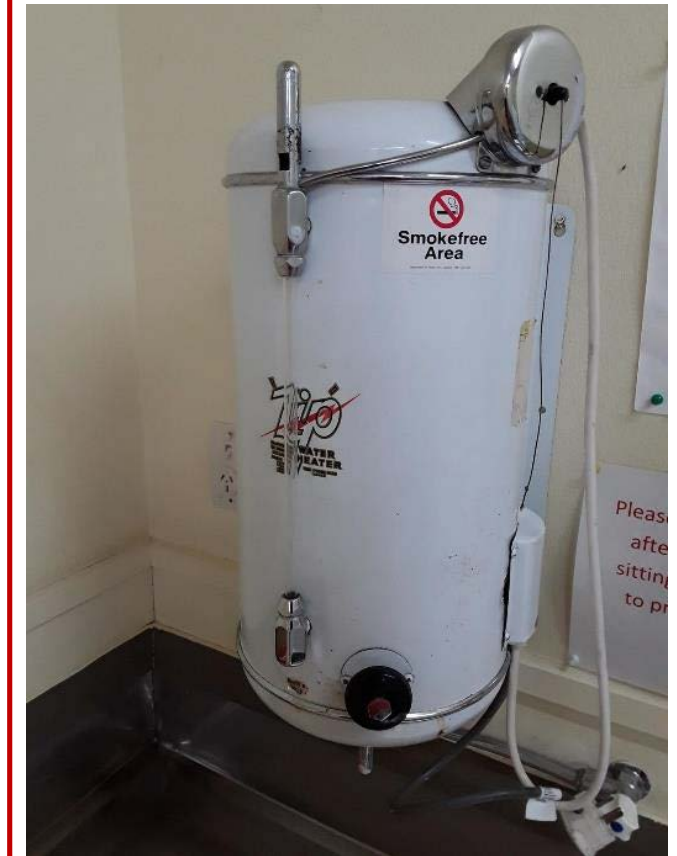
## Asbestos containing ZIP – Thermal Insulation

During Site Surveys we identified asbestos likely to be present as thermal insulation in our old kitchen water heaters.

Because this is fully encapsulated it poses no current risk. If it is needing to be removed or replaced or if it gets damaged it should be disposed of as asbestos waste.

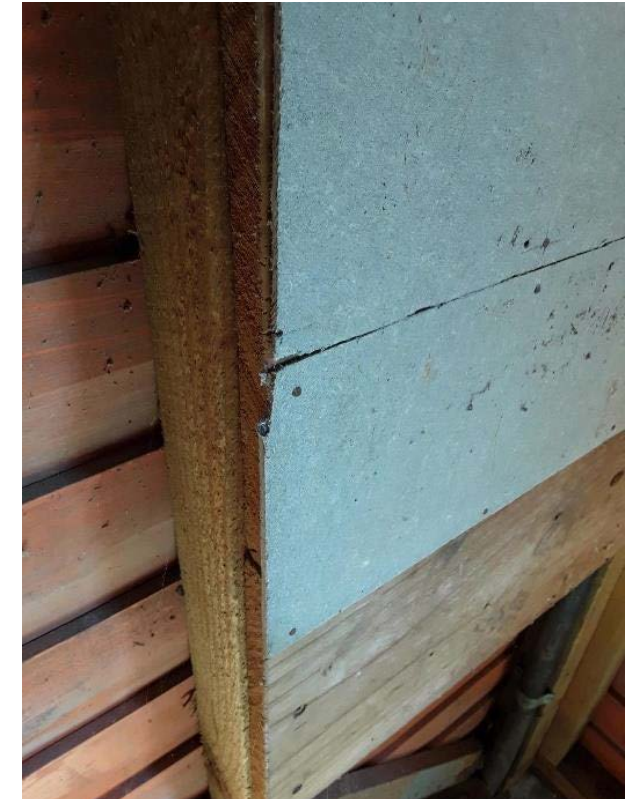
## Asbestos reinforced composite materials

During Site Surveys we identified asbestos in an old cement board in a shed on site.

The material is unsealed and required removal or encapsulation or sealing with paint to prevent further damage or disturbance.  
Removal must be undertaken by a registered asbestos removalist.

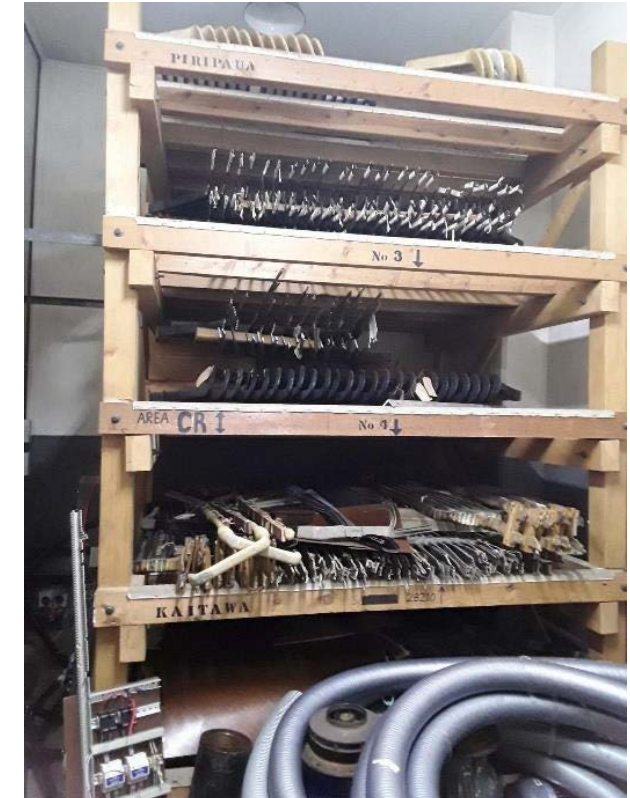
## Spare Stator Windings

During Site Surveys we identified asbestos in spare stator windings.

Where possible the old spares for plant that contain asbestos shall be replaced by non-asbestos contaminated products.

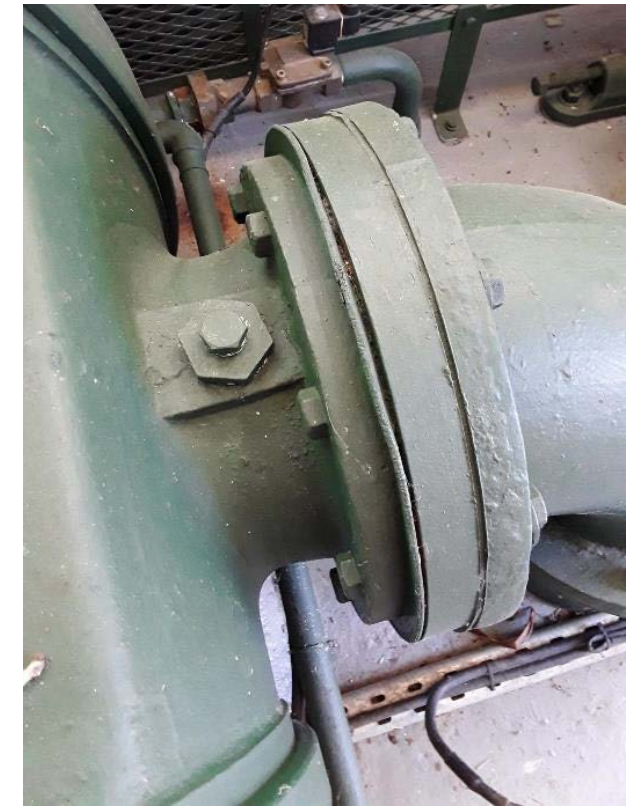
## Chrysotile Gasket

During Site Surveys we identified asbestos in one of our siphon buildings in gasket material.

Until requiring replacement, depending on the condition of the gasket, these gaskets can be managed in-situ and regularly inspected to check for damage or disturbance.

They should be removed by a licenced asbestos removalist.

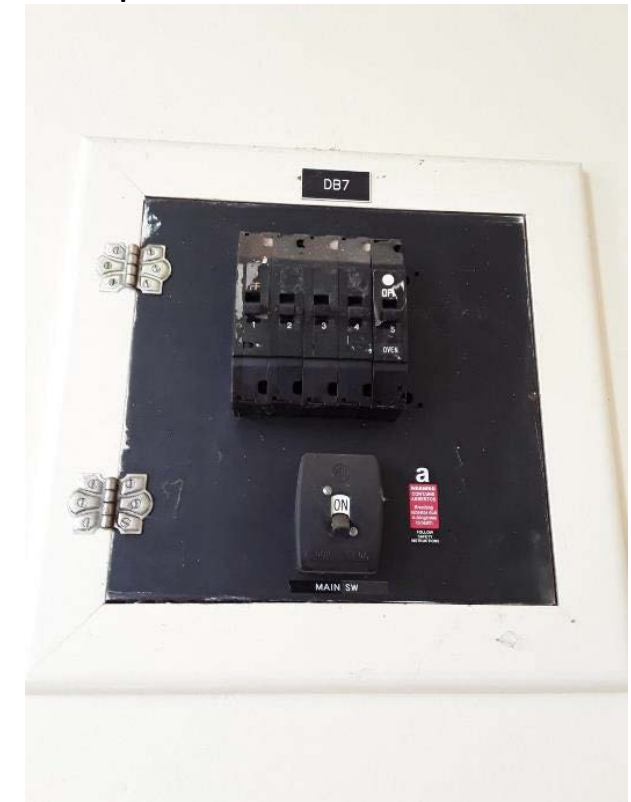
## Black Asbestos Contaminated Plastic product

During Site Surveys we identified Amosite (Brown) asbestos in thermoplastic fuseboard.

Black thermoplastic asbestos product is common across many power stations. The asbestos is within a strongly bound matrix and is non-friable. It poses no risk unless it is damaged through being drilled or cut into.

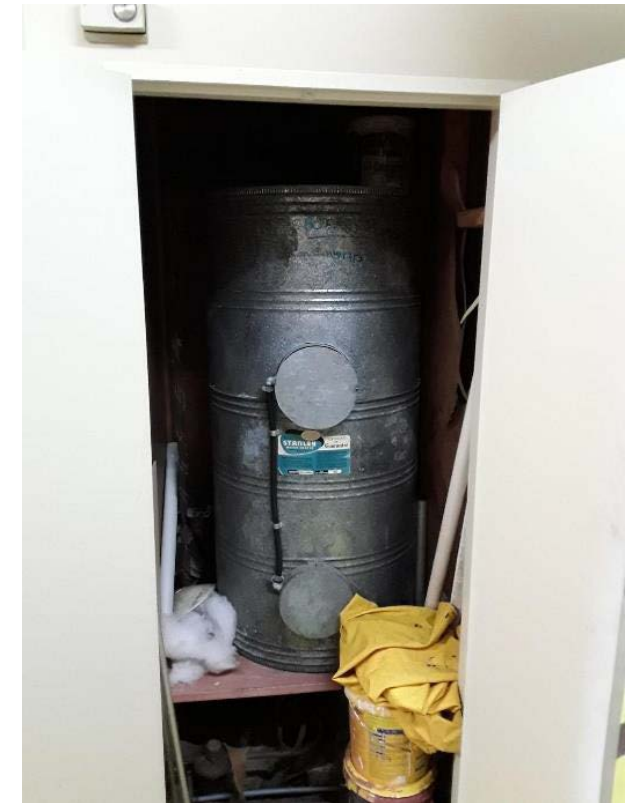
## Hot Water Cylinder

During Site Surveys we identified potential for asbestos thermal insulation hidden within the metal structure of a hot water cylinder.

The asbestos is contained within the structure and poses no current risk. If it is removed or replaced or damaged it should be disposed of whole as asbestos waste.

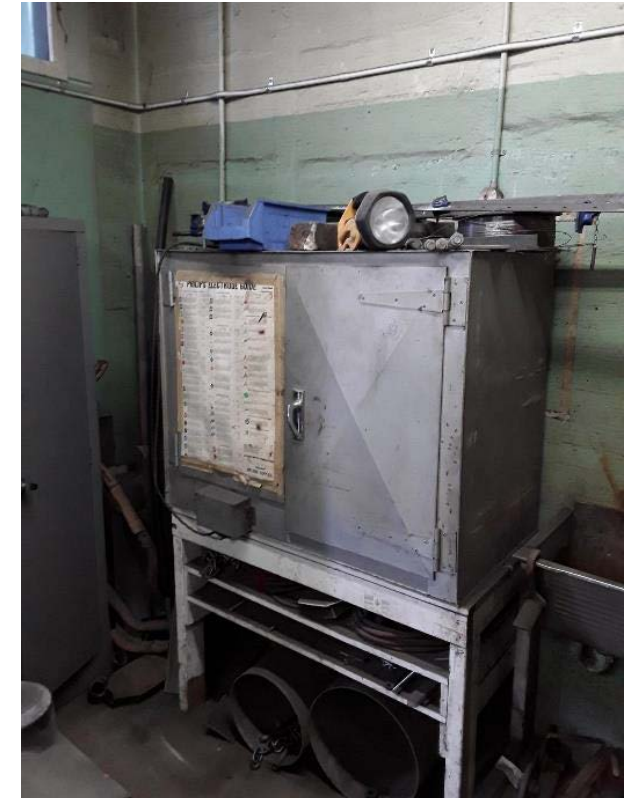
## AIB Millboard, low density insulation

During Site Surveys we identified potential for asbestos thermal insulation hidden within the metal structure of a cabinet used to house welding rods and equipment.

The asbestos is contained within the structure and poses no current risk. If it is removed or replaced or damaged it should be disposed of whole as asbestos waste.

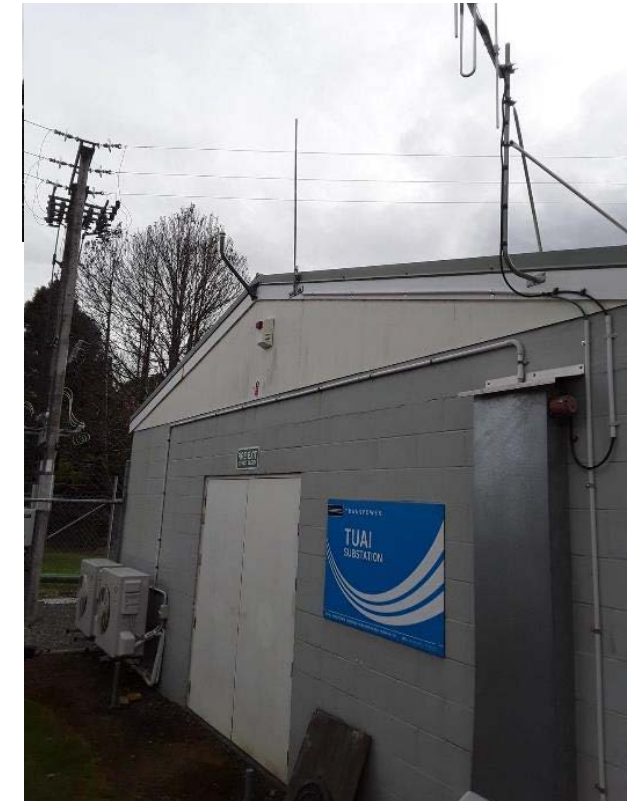
## Asbestos Reinforced Composites

During Site Surveys we identified the gable cladding as asbestos.

Panels are in good condition with a few minor cracks and paint chips.

If in good condition we can manage in-situ and regularly inspect to ensure no deterioration. If damaged or disturbed the panel must be removed by a licenced asbestos removalist.

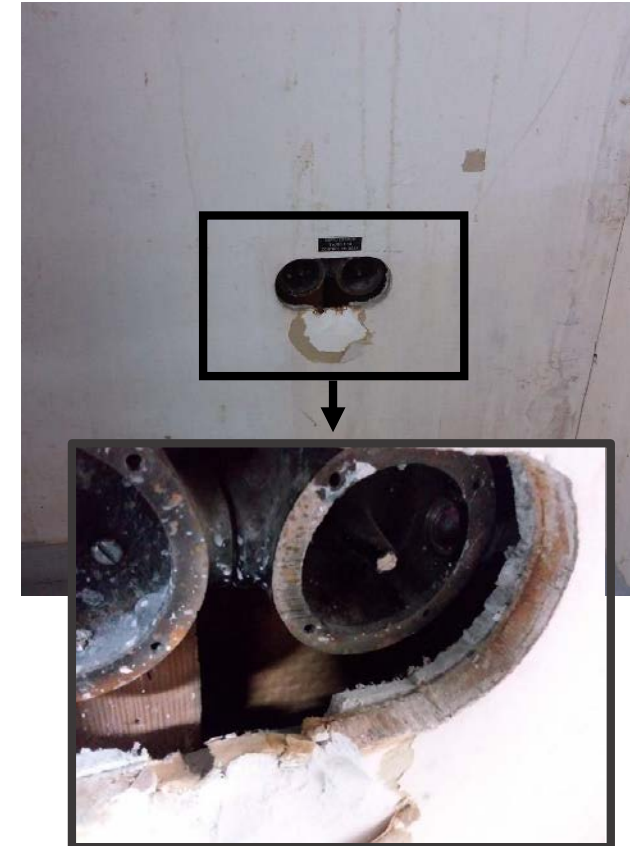
Asbestos Cement Sheet Lining

During Site Surveys we identified the cement sheet lining behind the plasterboard wall in one of our battery rooms to contain both amosite and chrysotile asbestos.

Panels are currently able to be managed in situ with regular inspections for damage and disturbance.

Labels are required to alert people to the hazard.

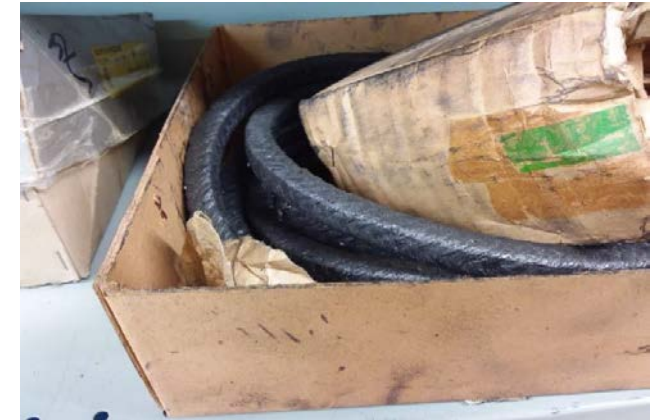
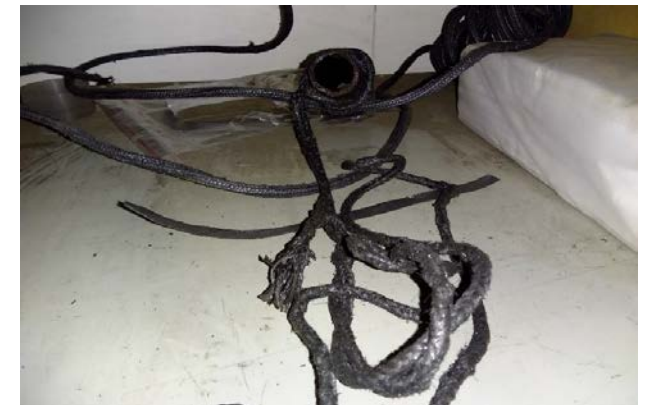
## Asbestos Textile Rope

During Site Surveys we identified an asbestos contaminated textile rope .

Often old spares and stores items can be contaminated with asbestos but because of the type of item haven't been identified as containing asbestos.  
Old items, such as textile ropes, should be checked or replaced to ensure they are asbestos free.

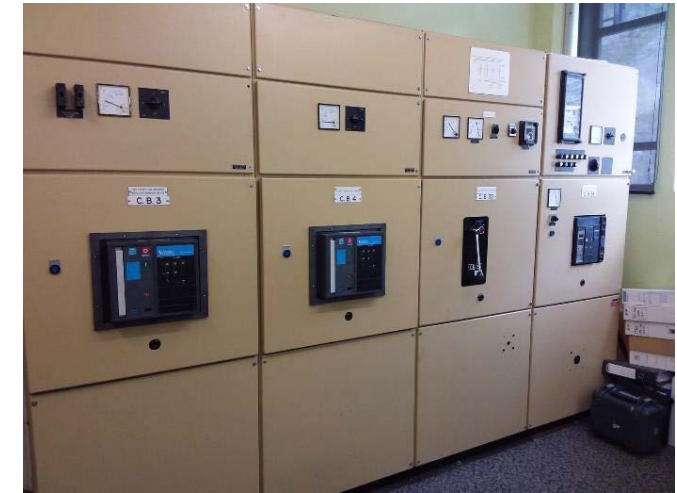
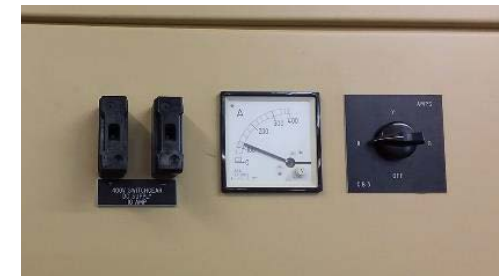
Original Switchboard

During Site Surveys we identified the original switchboards contained black thermoplastic which contains asbestos.

Black thermoplastic asbestos product is common across many power stations. The asbestos is within a strongly bound matrix and is non-friable. It poses no risk unless it is damaged through being drilled or cut into.

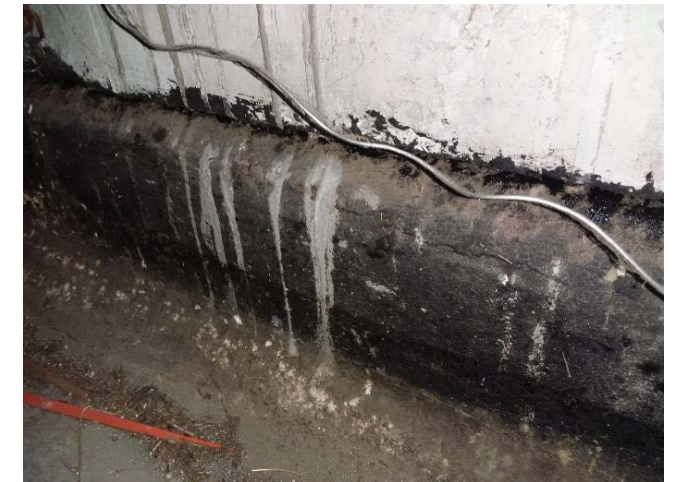
## Bitumen Layer containing Chrysotile

During Site Surveys we identified a bitumen product between concrete layers that contained chrysotile asbestos.

Asbestos can be embedded between layers in a bitumen product.
