Stored Energy

Geothermal

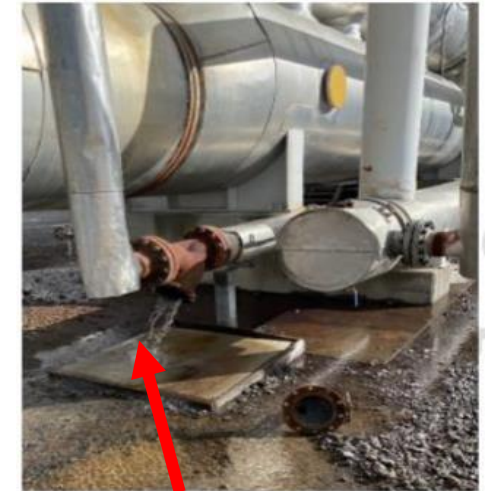
- Isolation valve failed to seal to a safe level.
- The drain was significantly blocked restricting flow out of the drain, masking actual leakage of the isolation valve.
- The isolation valve had been used 1 month earlier for a similar task without incident which gave the impression that the valve was operational, and the blockage was not severe.

Location of blockage

- Update water blasting job plan for potential stored energy behind internal blockages.
- Install an engineered plant brine strainer to reduce the inline strainer blockage issues.

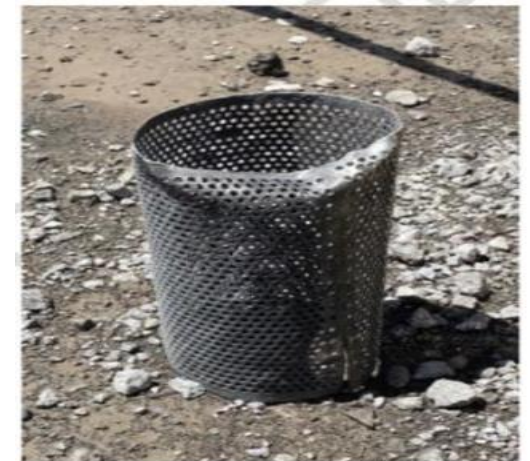
- Contractors were tasked to clear a strainer for debris, during this process they noticed the leakage rate had increased and therefore stopped work.
- The workplace was barricaded off and the area vacated.
- Job reassessed to see how to approach the blockage.
- During this time the blocked strainer was ejected from the housing directly to the ground, due to pressure build up behind the blockage.
- No-one injured during the incident.

Ejected strainer
