Shared Learning

Electricity | Induced voltage Leading to electric shock | Thermal site

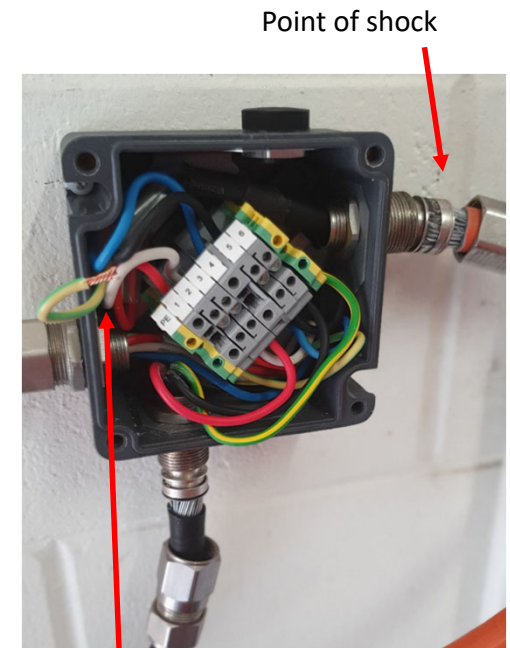
An inspector certifying the work removed the gland fitting between the junction box and the 5 core cable and received a minor electric shock

- That the supply cable earth wire was loose in the junction box meaning the DIN rail Bonding plate and cable glands were no longer earthed.
- Quality assurance post installation is important. This verifies the work done is safe to live in.

Loose earth wire
