Arc Flash – 11Kv Line

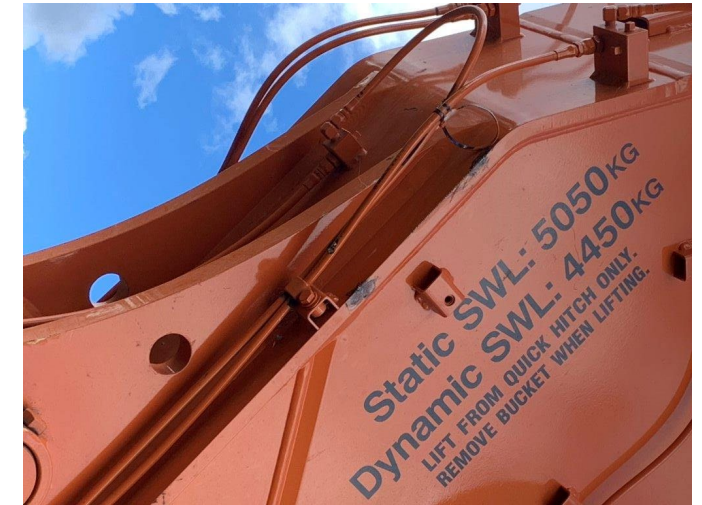
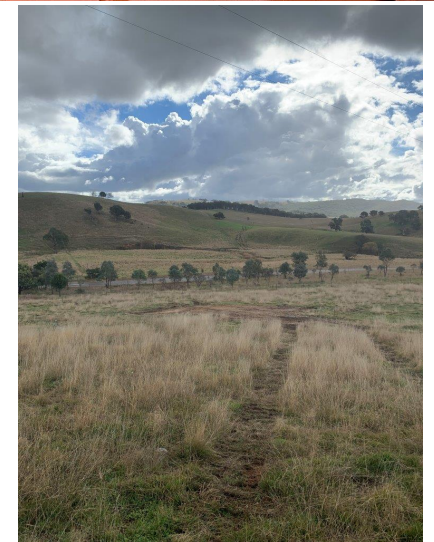
During Geotechnical investigations a 49t excavator has traversed underneath an 11kV overhead powerline and come into close vicinity causing the line to arc. This resulted in minor damage to an auto grease line and the boom of the excavator and caused the fuses to the line to blow causing a power outage to the surrounding area.

The works had been ongoing for a number of days preceding the event with pre-planned routes for access to each test pit location having previously been decided. However, adverse weather on the 5th of May resulted in the Landowners caretaker advising the crew to access the next test pit location via a different route than was planned to avoid causing significant damage to the property. A risk assessment for the change in route was not completed.

1. Newly identified hazards on site were inadequately assessed and associated risks were not fully understood due to a lack of training.
2. Procedures and SWMS don't adequately address or provide reference to working overhead services and hazard assessment to manage onsite changes
3. Poor procedures and instructions: procedural development and clarification required within Company Work Practices and permit system for working near overhead services
4. Safe Work Instructions inadequate: the Safe Work Method Statements (SWMS) utilised for the task didn't adequately address appropriate controls or guidance on working near overhead services
