Shared Learning

Critical Risk: Isolating Energy Sources

Headgate blocks incorrectly installed

Benmore Dam

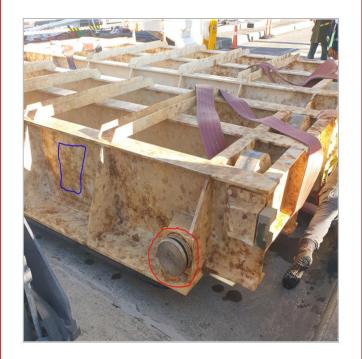
When going to prepare work area and check isolations for the removal of Unit 3 headgate water was observed to be leaking out of the side of the headgate at over 6ft up. Upon checking the contractor observed that the headgate blocks were not in place and gate was completely shut allowing water to back up behind the headgate.

The headgate blocks were positioned under the headgate as part of the Issuer Applied Safety Measures, in a location which the Operator believed was appropriate for the task. The Operator then lowered the headgate. It was at this stage that the Operator noted that the headgate position indicator dial was reading approximately 1.3% open, and that there was a small amount of water flowing downstream of the headgate. It was this information which led the Operator to assume that the headgate was now sitting on the blocks.

When asked if the blocks had been positioned at the `round plates' at the bottom of the headgate the operator tasked with installing the blocks replied that they were not aware of a specific position for placing the blocks, this was found to be the case with other operators as well. Recommended actions

Image of Benmore Unit 3 headgate lower end (gate removed for refurbishment work and lying horizontal), showing the correct/desired position for the headgate blocks circled in Red, and the actual position the blocks were positioned in Blue.

The position indicated in blue allows the headgate to close and seal before contact is made with the blocks.

- Provide clear physical identification of the correct position for installation of the headgate blocks. This could be achieved by painting arrows/brief instructions on the headgate at the specific locations. Other long term options should be considered for providing this identification.
- Add a line to the required Operating Orders to instruct the operator to visually confirm the blocks are in their correct positions after the headgate has been lowered, and that the blocks do indeed provide a gap between the lower end of the headgate and the base of the penstock.
