Shared Learning

Mobile plant and equipment | Dropped concrete block | Geothermal site

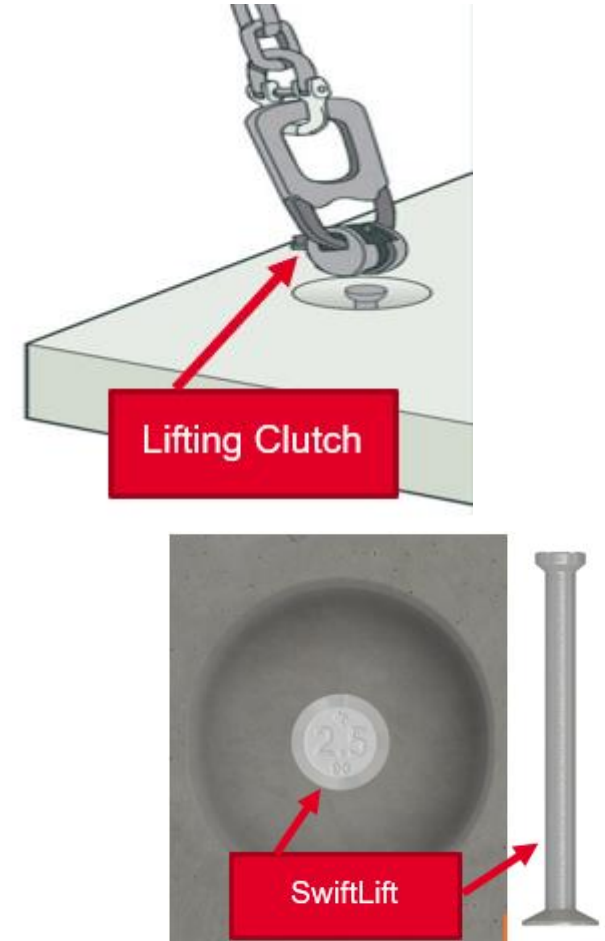
The loader was equipped with the Stinger and the correct “SwiftLift” lifting clutch, when the block was approximately 25cm off the ground the concrete block fell to the ground.

Inspection revealed that the manufactured lift point (Swiftlift) embedded in the concrete block had failed due to a ductile failure.

- The SwiftLift inserted in the block was rated at 1.3 tonne and the block weighed 2 tonne.
- The working load limit (WLL) of any lifting point should never be exceeded.
- It is good practice to visually inspect both lifting point and lifting attachments prior to all lifts taking place.
- Inspect all lifting points to ensure they are correctly rated for what they are lifting
- The crew stood clear from a suspended load while lifting operations took place and were not endangered when it failed.
