# Event 1232895 Te Apiti Dropped Power Cable

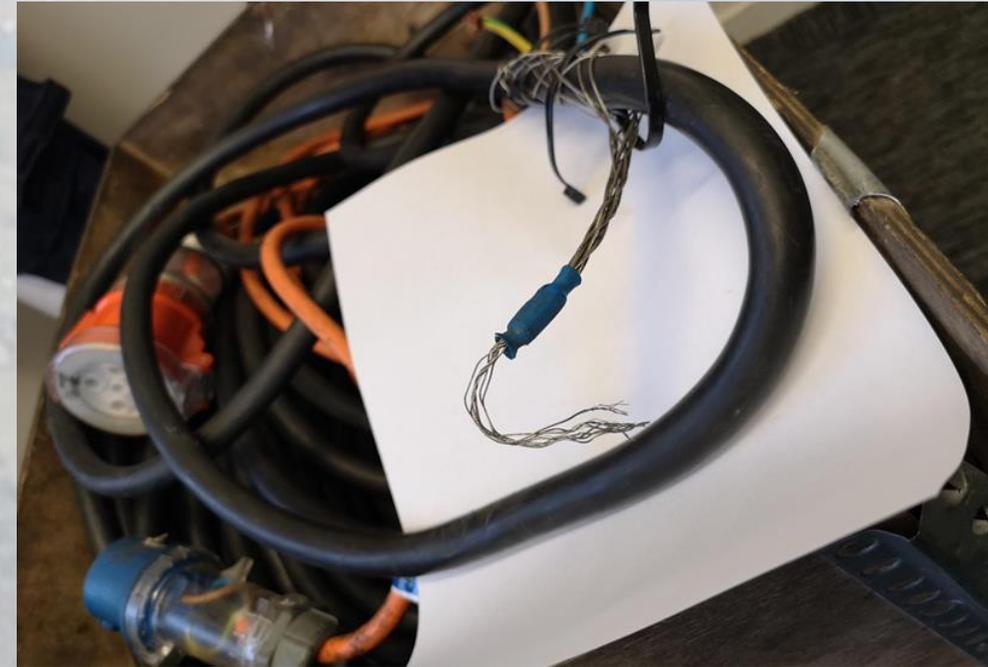
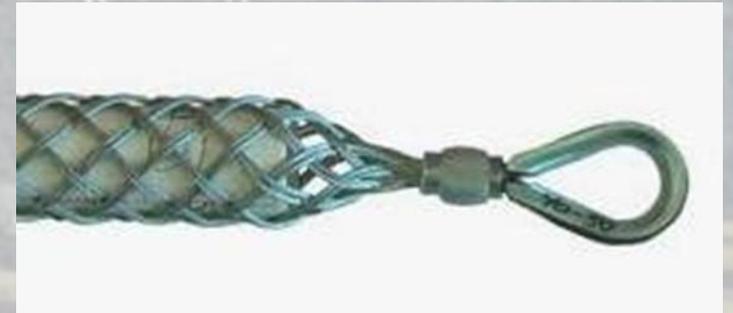
When the technician accessed the Yaw deck the eyelet on the cable failed and it fell to the base of the turbine. The second technician at the base had established a drop zone and was waiting in the safe area to receive the equipment being craned down.

The braided sock and eyelet weren't registered as lifting devices and hence weren't subject to annual inspection.

It also isn't clear if the device was rated for the weight of the cable. While subject to visual checks the heat shrink prevented the integrity of the feral and join from being inspected.

It was agreed the attachment could have failed at any time and that a secondary attachment should be used as a failsafe device once the lead was in place, this would also help with handling the cable once it was brought up. There was discussion relating to the way the permit was managed, should alerts have been raised when TOC (transfer of control) was handed back (this is normally the case), should the permit be able to be retained at the end of the day and general frustrations with the TOC process. The TOC process is currently under review.

All lifting devices must be included in a register, rated correctly and subject to annual inspection and inspection pre use.

When equipment is left suspended it must be subject to a secondary anchoring system.

Due to movement and vibration equipment must not be left in a suspended state if the turbine is operating.

Issue Safety Alert regarding uncertified or makeshift lifting points.
