The Journey to Improve LV Network Efficiency

POWERCO LV NETWORK VISIBILITY AND MONITORING PROJECT

Kevin Chang | 30 / 9 / 2021

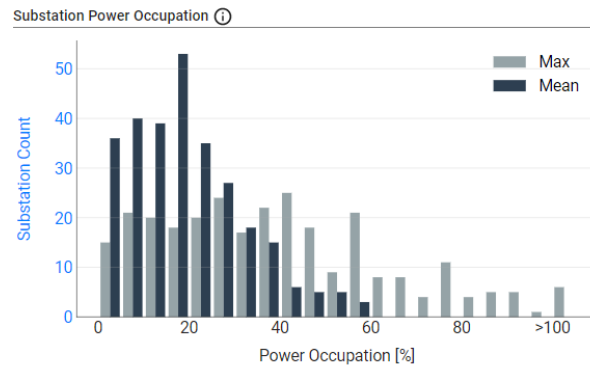
- Power Occupation (%) = Apparent Power / Transformer Nominal Power
- Result: Most of the monitored distribution substations have congestion < 50%.

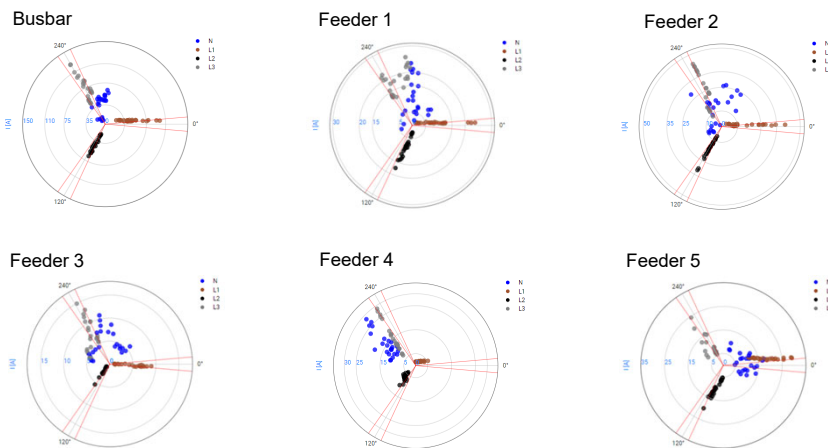
- An example of a transformer's current vector diagrams
- Result: Although the busbar currents are relatively balanced, the feeders are not.

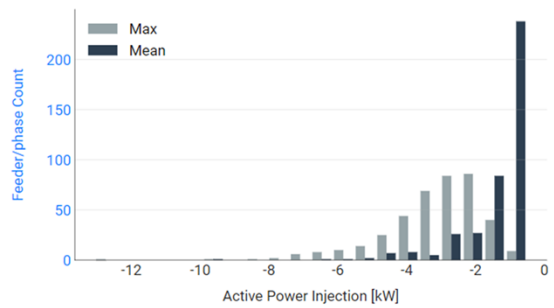
Feeder/phase Active Power Injection

- The PV injection data collected by the monitors were compared with the Powerco's register of distributed generators.
- Result: There were many mismatches. Many feeders were found to have more power injection than the generators' ratings in the Powerco's register. It was suspected to be the monitors' software algorithm issue.

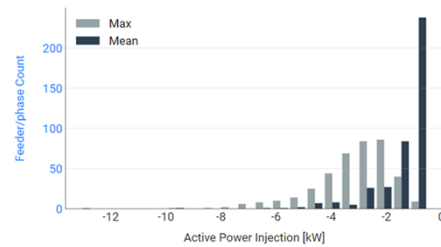
Before the upgrade:

- Eneida is constantly upgrading their monitors' software.
- Result: After a recent upgrade, the PV injection data is now more realistic.

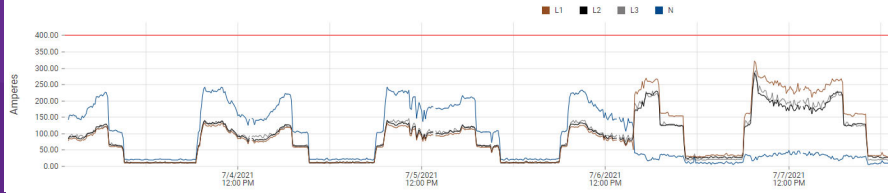
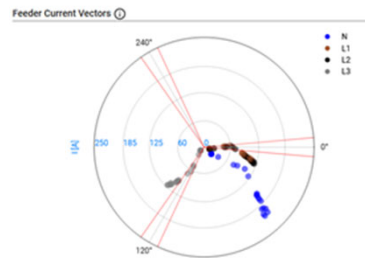
- A feeder was found to have an abnormally high neutral current.
- It was initially suspected to have a 3rd harmonic issue.
- Further investigation: Current vector diagram shows L1 and L2 match very closely in terms of phase angle and magnitude.
- Result: 2 Rogowski coils were somehow installed on the same phase. The issue was fixed after reinstalling.

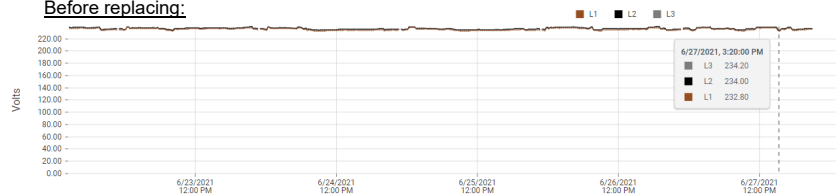
Before replacing:

- A transformer was found to have an overvoltage issue after it was replaced.
- Result: This transformer required to be tapped up. The voltage is normal now after tapping up.

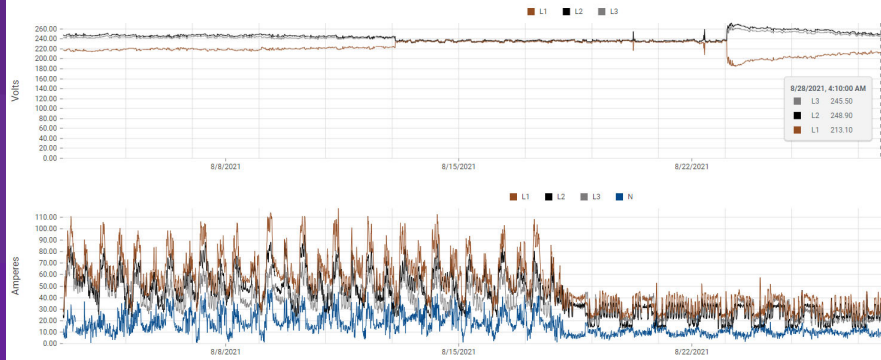
- A transformer was found to have an undervoltage issue on one of its phases (and also overvoltage issues on the other two phases).
- Result: The findings were reported, and further investigation will be conducted.

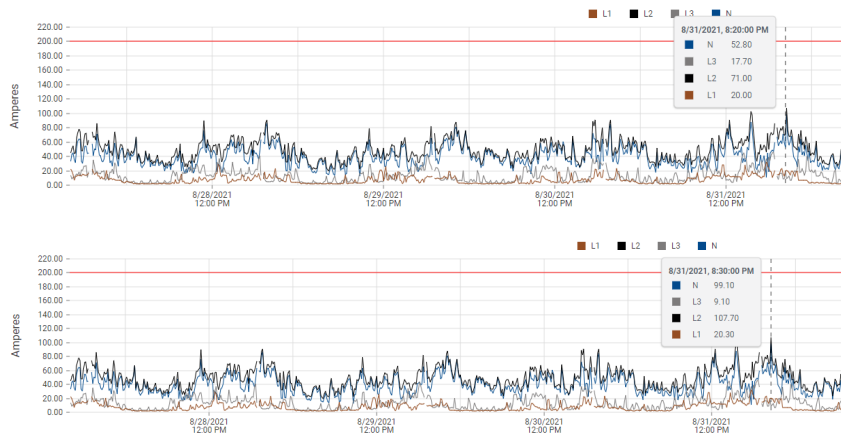
- Some transformer were found to have current imbalance on some feeders.
- Result: The findings were reported, and further investigation will be conducted. The data provides a basis for accurate forward planning.
