## Cable struck by drill

## Location: Waipori

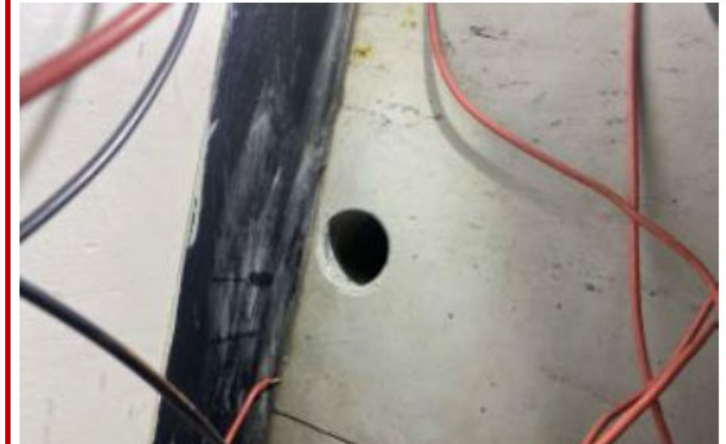
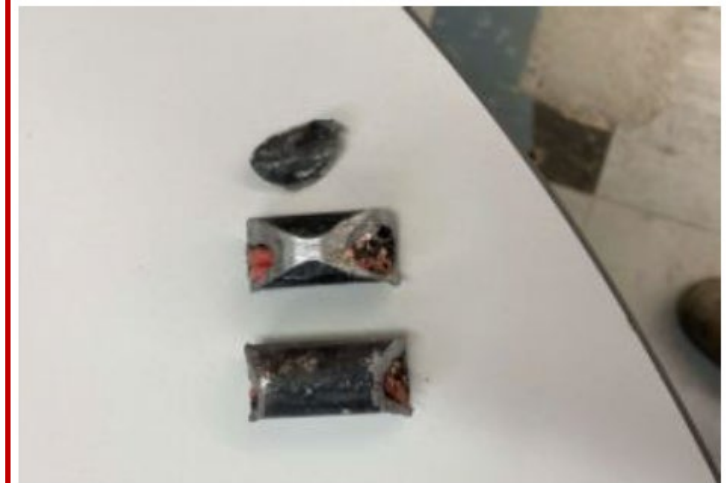
After completing the relevant documentation, the team commenced drilling. At about 200mm the driller felt the drill bite. The driller stopped immediately and advised the supervising electrician they believed they had hit a cable. This was confirmed by the electrician. Worked ceased, and the cable was made safe.

It is unknown why the x-ray did not pick up the cable but suspected either the depth of the cable or embedded metal mesh may have given false readings.

- The team did everything at their disposal to try to locate the cable
- Technology has its limitations
- Use of safety devices, RCD and insulated equipment can provide protection to operators- it must be tested and used
- No matter how much planning is undertaken- expect, plan and prepare for the unexpected
- When using x-ray machines to identify cables- if possible, scan from both sides of a designated drill location
- Use Cable & Services Work practice standard for advice on planning excavations & drilling
