# SAFETY ALERT

## DROPPED OBJECT – HOLE COVER PLATES

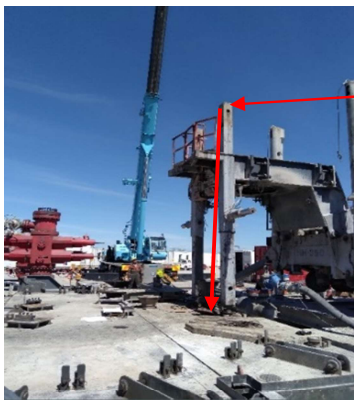
The cover plates fell from this position, approx. 5.5m

The nearest crewman was approx. 6m from the drop zone

Both plates will be fitted with hinges and secondary retention, so will remain in place whenever this task is carried out.
