# SAFETY ALERT

1287740-Strop failure causing load to be dropped

13/07/2022

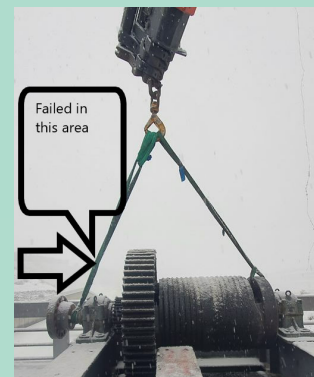
### PHOTO:

During the removal of the winch drum for Gate 19D (Pukaki area), a contractors' lifting strop failed allowing the lift to fall. Due to the shock load on the remaining strop the second strop also failed allowing the winch drum to be dropped onto the plinth and winch housing and then rolling onto the dam deck. The load was about 2 to 2.5 metres in the air when the first strop broke.

1. It was found that the weight provided to the workers on site was incorrect. The calculation that was done included a **human error**. The weight initially provided was 1.97 Ton. The workers then increased the estimated weight for rigging to 2.5 Ton. A breakdown of calculations proved the correct weight to be just under 3.1ton.
2. Rigging was set up to be able to lift 2.8Ton as a Safe Lifting load. The strops both had a Safety factor of 7:1 and should have been able to lift the overload of 300kg with ease. The strops were approx. 6 months old and had been used once before. The strops were greasy from the previous job. The strops were left in a rigged state, outside overnight in snowy conditions.
3. There was confusion around when a documented lift plan was needed by Meridian.
4. The workers practiced good industry standards, they are competent and very experienced.

- The first lifting strop that failed did not make any snapping or tearing noise before it failed. The workers all found it very odd that the strop failed the way it did. It failed in the middle of the strop away from any corners or stitching. It was agreed that the strop will be sent away by the contractor for destructive testing and analysis and report back to Meridian. The serial number of this lifting strop must be kept in case of batch failure.

- The use of mobile lift scales was discussed as an alternative to the calculation of weight. This way the rigging can be adjusted if it was found to be a heavier lift than was anticipated. Meridian engineers will investigate purchasing a load scale specifically for project use.

- Although there was a lift plan in this lift, there is sometimes inconsistency in when we complete one. Meridian Energy needs to be clear on the need for documented lift plans. Meridian Hydro does not have a guideline in place to clarify the difference between a routine lift and a critical lift. It is generally left to interpretation.
