SAFETY ALERT

Shared Learnings

1286921-Minor Electric Shock

7 July 2022 14:30

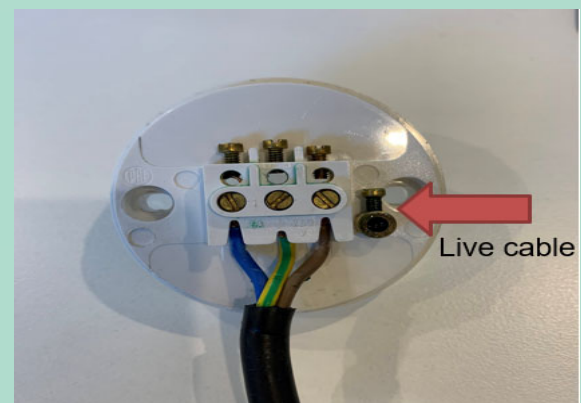
PHOTO:

Finding an issue with the lighting cable it was traced to a ceiling rose inside the roof cavity where the light was connected.

The ceiling rose was opened for inspection. An electric shock was received from the loop terminal. The main feed was looped the ceiling rose to the switch. The circuit was centre fed through the ceiling rose.

- Fully identify circuits before isolating.
- Fully isolate circuits If possible.
- Always test every conductor before touch – even if you think everything has been isolated.
