SAFETY ALERT

Shared Learnings

The importance of effective communication and testing for zero when working on hydraulic systems.

Thursday 19th May 2022

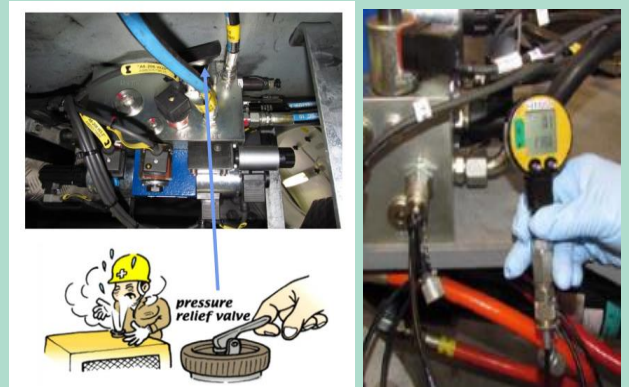
PHOTO:

During annual service, an experienced wind technician team picked up that valve 116 was leaking oil and valve 109 had failed on all three blades. Both these valves were in the hub of a Siemens 2.3 WTG. The authorised tech (AT) work party leader applied the isolations to allow hub access. The hub technician knew he had to bleed all three accumulator valves. Upon bleeding 2 of the 3 valves, it was then noticed that the hand controller was placed on the pig's nose with a potential to fall and some other tidying up was required so the technician changed focus to address this. This distraction led to the 3rd blade accumulator valve to be overlooked. The tech replaced valve 116 on this blade with no issue as this was on a non-pressurised side of the system. When moving onto valve 109 a spanner was put on it and winding out commenced. The tech assumed this had no pressure on it as there was no indication when the tool was applied. When the valve was at its last thread it released a spray of high-pressure oil covering the technician.

The learning team agreed the potential was high for the valve to have released under pressure and hit the technician in the restricted space of the hub. The hydraulic system schematic drawings confirmed the pressure at that valve would have been in the ranges of 120 - 200 bar.

The team discussed how they would always prove test prove before touch if working on electrical systems and compliancy had crept in by not testing for zero pressure before touch on this hydraulic system as per training.

The service AWP did not contain a signature check point to ensure the accumulator blades valves were discharged and to measure with the manometer at the correct test point for zero. This has since been amended.
