Safety Alert

Missing nut on Ratchet strap

25/01/2023

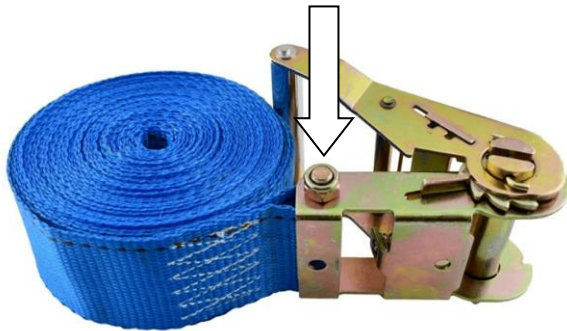
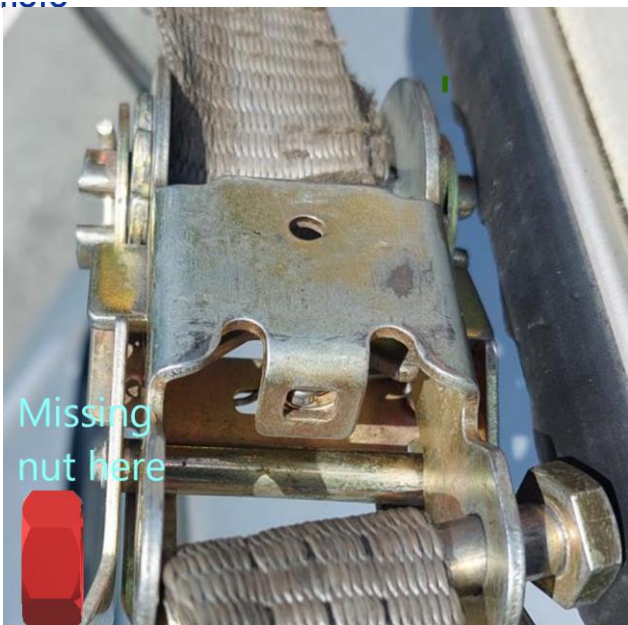
The driver pulled over to the side of the road to investigate and found that the nut for the bolt which secures the webbing to the ratchet was missing and the bolt had come out at one end.

- Pulled over to investigate suspected loose load.
- Ratchet removed from service.
- Waited on the side of the road for a replacement.
- Replacement ratchet brought from Benmore and load resecured.
