SAFETY ALERT

Spill-gate Stoplog Jammed in Slot

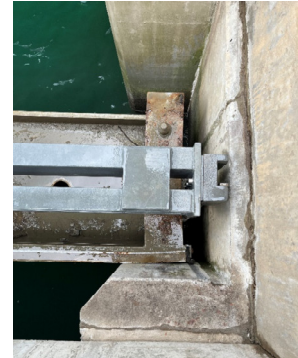
During the routine process of removing 1 of the 8 Spillway stoplog sections from Clyde spillway gate 3, stoplog section No 3 pitched up at one end and jammed in the guides as it exited the water. The sound of the crane motor load increasing alerted the dogman / operator that something was wrong, and the lift was immediately stopped. This resulted in the stoplog becoming bent and damaged at the left bank end.

Top view of lifting beam and stoplog in guides

Reduce crane speed when removing the spillway stoplogs from the gate slots (at the point where the horizontal stoplog girder exits the water) and share learnings with other Hydro Operators.

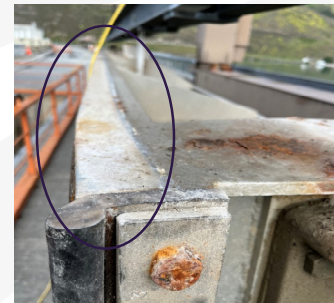
The holes that are cut in the horizontal girders of the stoplog are not large enough to prevent suction on the under side of the beam while it is being removed from the water. The suction released unevenly cause one end of the stoplog to become higher than the other.

Bent Section of the Stoplog post-event

-The crane has two speeds. The higher speed has always been used for the lift with no previous issues. It is believed that if the lower speed was used for this lift, the event would not have occurred. A slower elevation of the stoplog from the water would have allowed time for the water to displace correctly, therefore the vacuum effect that caused the rotation would have been minimised.
