## **SAFETY ALERT**

Struck by falling gas detector while inspecting a Valve Tower

24/05/2023

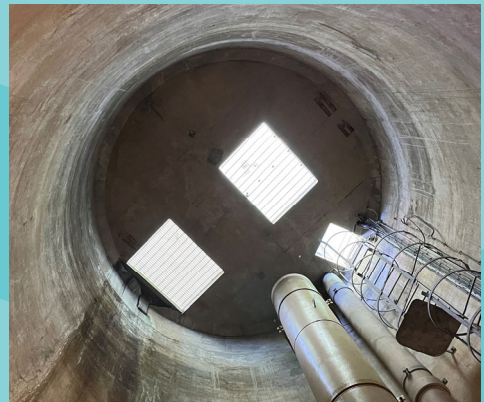
### **PHOTO:**

During the Learning teams a picture was shared that shows the Watercare asset as a Tower inside a dam. The structure has a bridge walkway to the tower and an underground exit that is locked with gates from the bottom of the tower. There is an air flow in the Tower. Watercare classifies the Tower as a Working at Heights Hazard.

- 1, The HS Business partner believes that this structure is a Confined space entry due to a potential of engulfment and the complexness of a robust emergency plan.
2. There was a Time factor. The work had to get done in a set time frame. The workers felt rushed.
3. The rescue plan that was talked about was never recorded so there is doubt if the emergency rescue plan would have been robust enough to save 3 lives with 2 persons at the top of the structure with no rescue gear.
4. A reminder that this type of works is BAU for Watercare staff but not so much for DSI. Proper planning with a Site specific workplan should be done and recorded.
5. An exclusion zone should be allowed for at the bottom of the area where falling objects can potentially land.
6. The gas detector should be held in place in at least 2 places.
7. The person with the gas detector should always decent first.
