Shared Learning

Electricity | Earthquake damage to fire water tank hold down fasteners | EGL GDL site

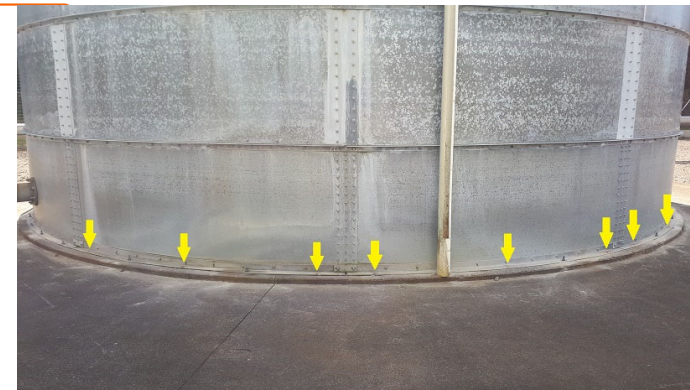
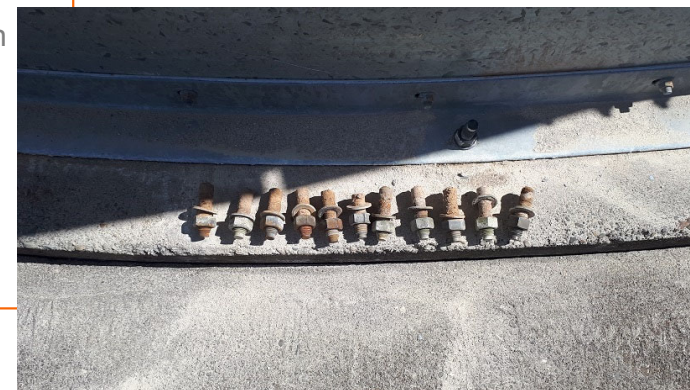
The earthquakes caused minor damage across several sites and caused 2 plants to trip.

During inspections post the event we discovered many failed fasteners on the fire water storage tank foundations as shown in photos.

Standards for construction of some on site structures such as fire water storage tanks have changed in recent years. Some older structures may not comply with current standards. Operators of sites with similar structures may wish to investigate the design of these structures to determine if they are appropriate for the environments where they are installed and compliant with current standards.
