### Platform handrail dropped from height

### Geothermal

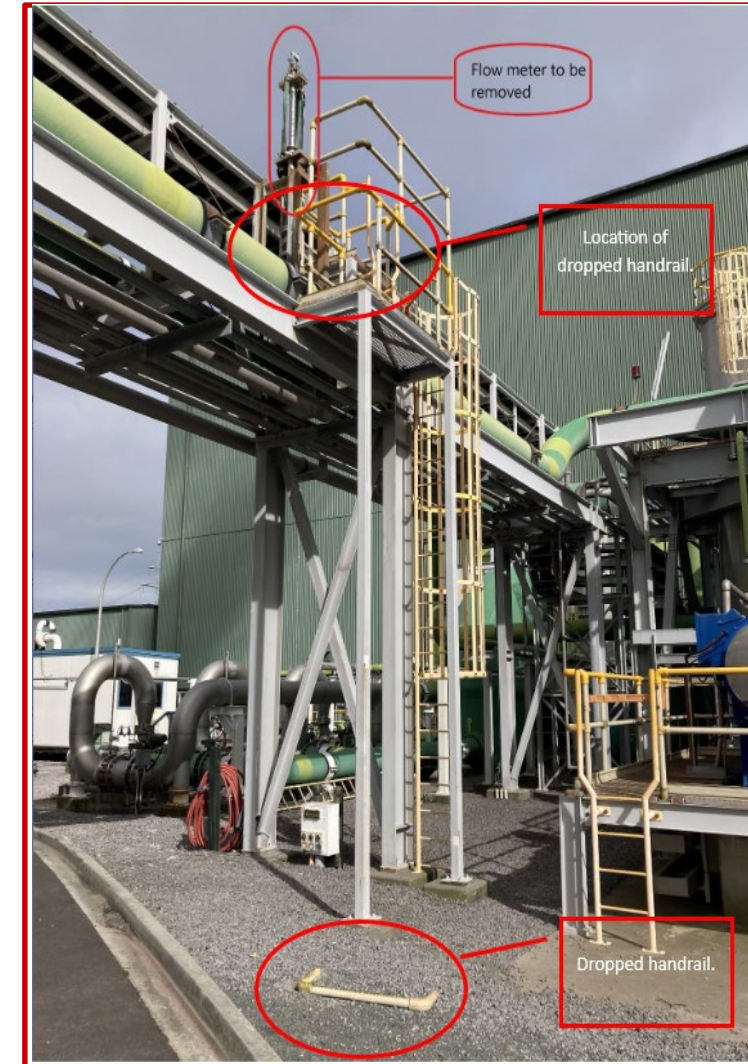
It was at this point the fibre glass lower handrail had come away from the handrail fitting connector dropping 8 meters to the ground. No injuries sustained or workers in the vicinity at the time of the incident.

June 2019 - Epoxy resin coating applied to the top railings due to UV exposing fibres. The lower railing and connectors was not coated as part of the program which eventually failed due to degradation.

Annual maintenance inspection required by the responsible person lacked detail to fill full its responsibility.

Maintenance management system has no inspection instruction that clearly indicates what is to be inspected and how it is to be inspected.
