What went wrong?

While running 30" casing, a worker found a circlip on the rig floor.

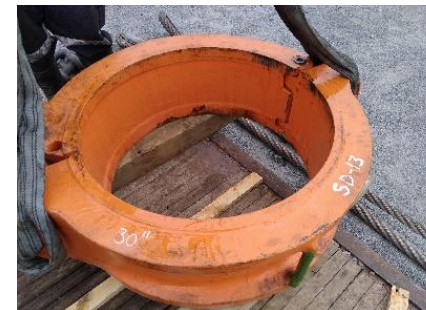
The crew identified the elevator was upside down due to the way it was assembled by a third-party supplier.

Visually the elevator gave the appearance it had been correctly assembled (Photo A).

The elevator was assembled incorrectly by a third-party supplier.

While the hinge pin was correct the latch pins were installed upside down.

- The hinge pin could have dropped out.
- The elevators could have unlatched allowing the casing to drop.

Photo A – elevator received on site

- Ensure QA documents are supplied with all third-party equipment.
- Having a robust process for receiving equipment on-site and using checklist.
- The importance of continued education and training of all staff.

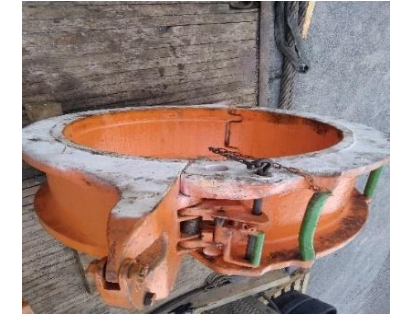
The elevator was reassembled and re-orientated correctly (Photo B).

Photo B – elevator reassembled
