### What Happened?

The Unit Auxiliary Transformers supply 415V power to the auxiliary systems (pumps, compressors etc.) on the main generating units at Clyde. They step down power generated from the Unit at 15.4 kV to 415V. As part of the local monitoring a capillary tube temperature gauge is fitted to monitor internal transformer temperature.

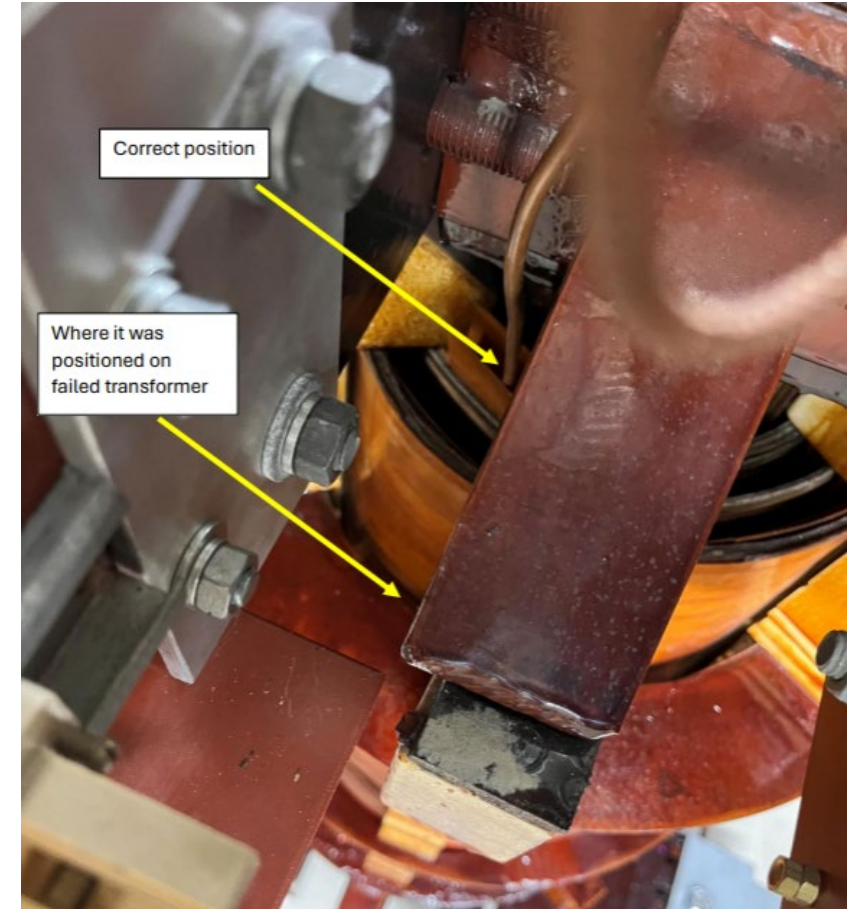
This gauge was suspected of reading incorrectly and was removed as part of for calibration/fault finding. Note: the work order this job was done under did not include this UAT, but the tech thought that as they had the calibration hot box out and the Major Unit was under permit that they would check this probe. During this testing the Probe found to have failed and was replaced with a spare. The spare was inserted in a slightly different position in the transformer to the original location which was placed between two insulated barrier boards (Fig 1). The different position had the probe fitted between the HV winding stack and the internal coil insulation. This allowed contact between the capillary tube and transformer coils.

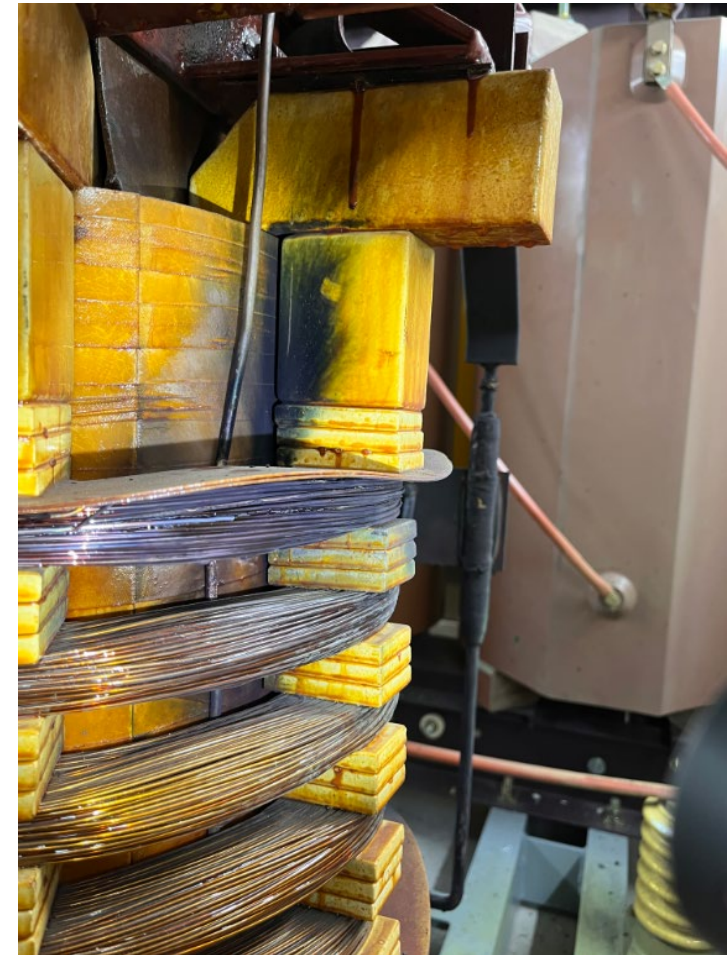
Shortly after unit 2 start up the transformer was energized, the capillary tube contacted a phase winding and subsequently caused a phase-to-phase short, activating the designed electrical protection which de-energized the unit. In addition, the event generated smoke, initiating a smoke alarm resulting in the local fire service attending the station.

**Capillary Tube contacting Tx Windings**

Work was conducted outside the approved work order and permit. Had this work been included on the permit, electrical checks on the UAT would have been included as a QA check prior to returning the unit to service. These checks would have likely identified the defect before the UAT was energized.

The need to maintain permitting and work order compliance has been reinforced.
