Safety Alert

EVE-001336 Electric shock of Gland Plate TLC

24 August 2024

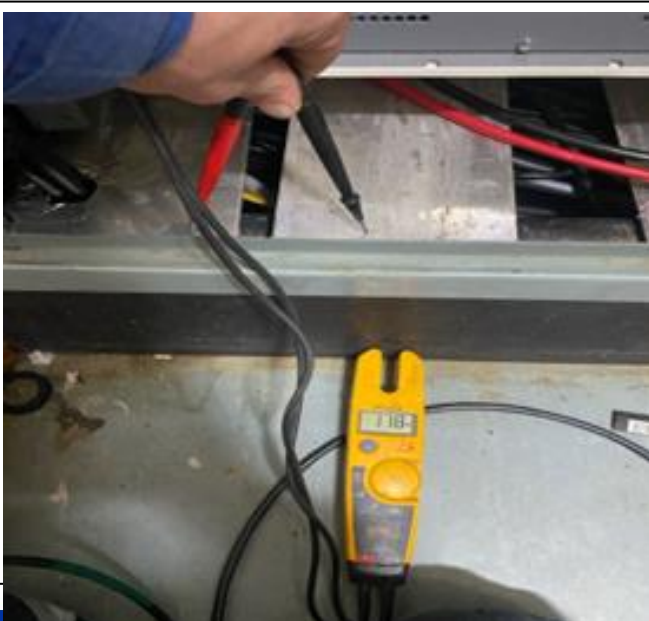
PHOTO

While installing cabling for the gate encoders at Te Anau Control structure (TLC) a contractor received an electric shock from an aluminium gland plate in the comms cabinet. The plug was labelled "In the event of a power failure connect this to another piece of equipment"

While investigating the cause, the team discovered a male cord connector that had 110V across Phase and Earth which was contacting the aluminium plate in the bottom of the comms cabinet. No male plug should be energized without being attached to a female cord connector or a dedicated terminal.

No extension cord should ever have a live male end. A "Suicide" cord must never be used on any Meridian site. Leads were provided with the inverter when installed.

Stopped work, made the cabinet safe and the contractor was taken to Te Anau Medical Centre for an ECG. The contractor was cleared and returned to work that afternoon. Reached out to the engineering team for advice and to share the findings. Further investigation by the Electrical team, a similar installation was found at MLC and all male plugs off the inverters at MLC and TLC have now been removed. An information meeting was conducted to share what was learned with the Mid- and Upper Waitaki Electrical Supervisors.
