Critical Risk: *Dropped Gland Packer*

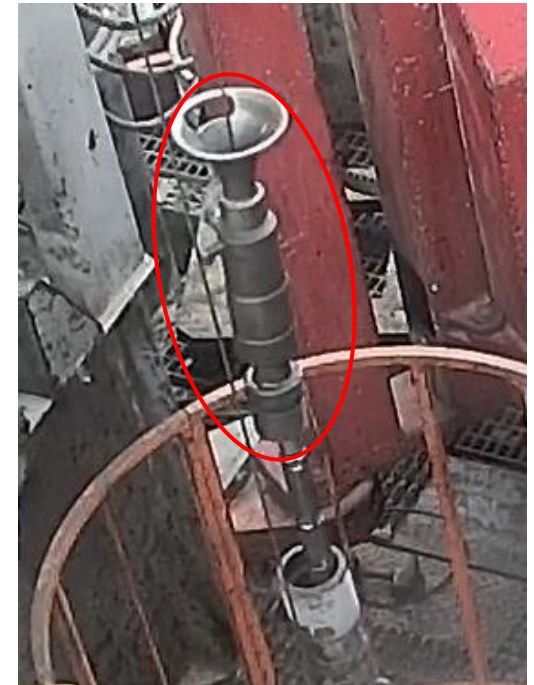
When it was time to remove the wireline tool from the recovery tube, the communication between the driller and winch operator was essential to lift the top drive at the same time as the winch operator was spooling out the wireline. However, due to a synchronization issue, the top drive lifted the tool and an unknown restriction inside the recovery tube caused the line to over-tension as the safety devices were not activated during spooling out. This led to the wireline parting from the dummy drift, allowing the gland packer to fall to the subbase.

- The current process had no secondary retention on the gland packing housing, which would have stopped it from falling into the sub-base area.
- Condensable Gases from the well caused ice to form inside the recovery tube which caused the restriction.
- Greater requirement to identify and complete risk assessments for Simultaneous Operations:
 - Create a matrix for all identified simultaneous operations, this then identifies risk hierarchy.
 - Review existing SWMS for simultaneous operations to identify potential gaps.
 - A bridging JSA to use to manage risk on conflicting SWMS

Photo - Gland Packer unscrewed from recovery with a portion of the tool beneath it protruding from the recovery tube..
