Forklift collision with stationary IBC (Intermediate Bulk Container)

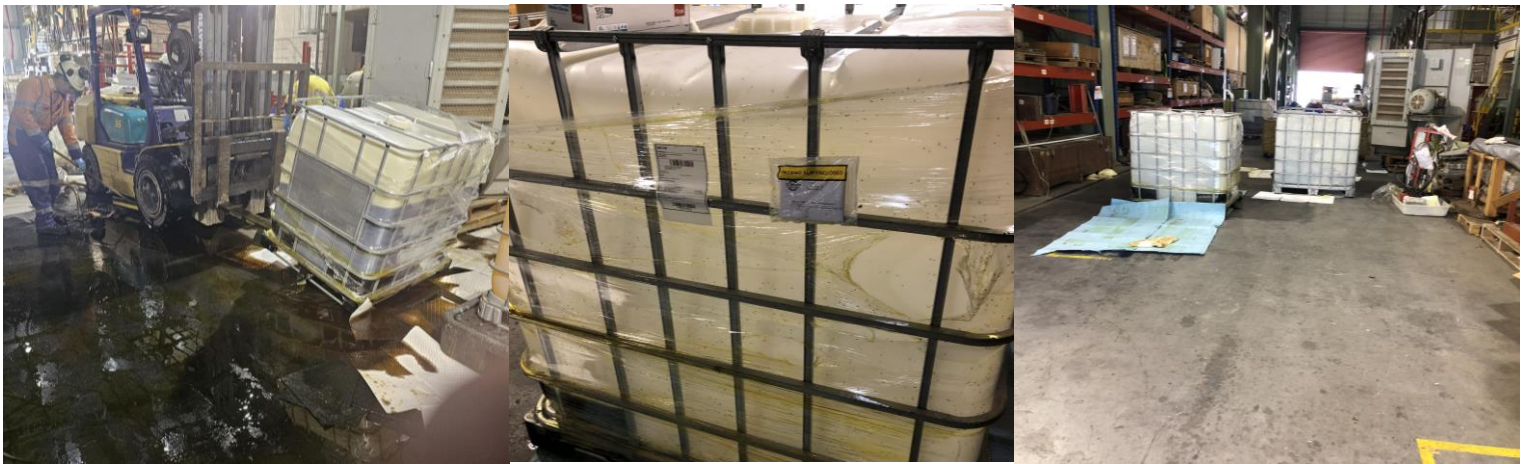
Forklift and driver transporting IBC into TCC turbine hall collided into a stationary IBC containing oil. Forklift forks puncturing stationary IBC causing oil to spill onto the turbine floor.

The delivery point / laydown area in TCC turbine hall has poor lighting and the transition from daylight brightness into a dark hall introduced a visual black spot, forklift navigation was in a congested area (no spotter.) The IBC being transported on the forks which were approximately 300mm above the ground is what hindered visibility of the stationary IBCs, this is when the stationary IBC was hit.

Transporting oil needs to be treated as a medium risk activity which requires pre-planning and good communication.

- Where practicable reduce transporting oil to minimize the risks associated.
- Pre-plan transport route, identify marked out dedicated laydown area for IBC's. Hazard ID, JSEA
- Communicate plan in morning toolbox prior to work activity.
- Assign appropriate resources. Spotter if required.
- During activity step back 5 x 5, check for any additional hazards.
