IP sustained Fracture to ankle

Taranaki

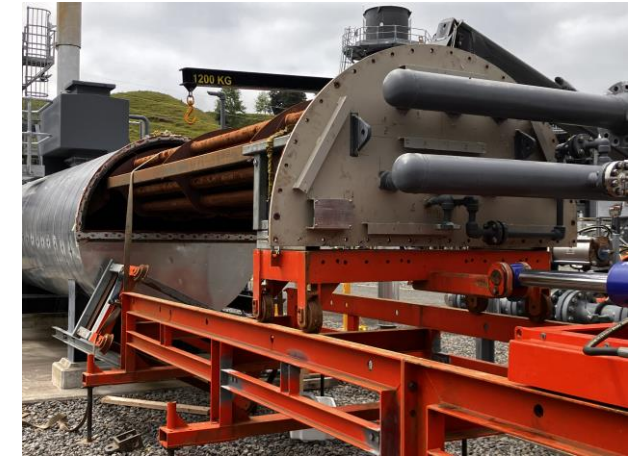
During planned maintenance, a work party had been issued an access permit to remove a water bath heater tube bundle for inspection. The work party were halfway through removing the tube bundle using a purpose-built trolley/rail removal rig, when after a second trolley had been installed and secured with a ratchet tie down, a wheel on the second trolley became jammed due to a misalignment. A worker attempted to lever the trolley into alignment unsuccessfully. The ratchet tie down securing the second trolley was then loosened to allow the trolley to be moved. Another attempt to lever the trolley successfully brought it into alignment. Upon restarting the task, due to the ratchet tie down not being retightened, the trolley rolled off the end of the rails and hit the lower leg/ankle of the injured party who was standing at the end of the water bath heater.

Water Bath Heater Tubing bundle with removal rig

- The operating procedure was revised to include a new method of securing the trolley and additional hazard controls
- A design review of the removal rig is scheduled to identify potential safety improvements.

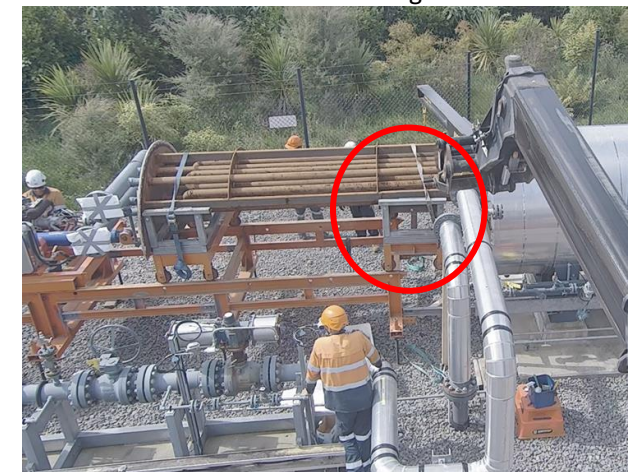
A breakdown in communication across all members of the work party resulted in the contractor operating the removal rig not being aware of IP's position and no one identifying that the tiedown had inadvertently not been re-engaged.

When the trolley jammed a formal Step Back 5X5 to assess the risk was not undertaken

Trolley prior to falling showing position of wheels and tiedown
