11kV Earth Event

Wairakei Station

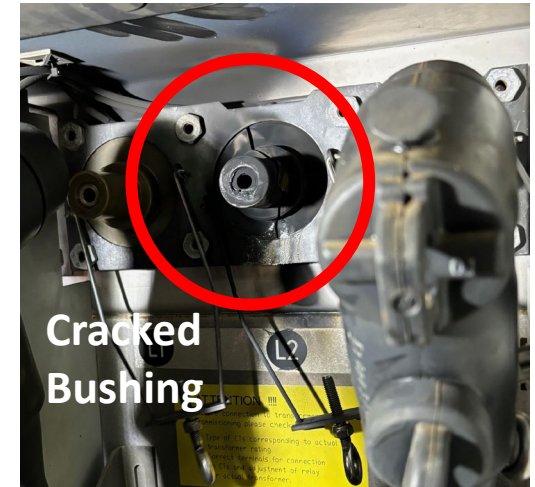
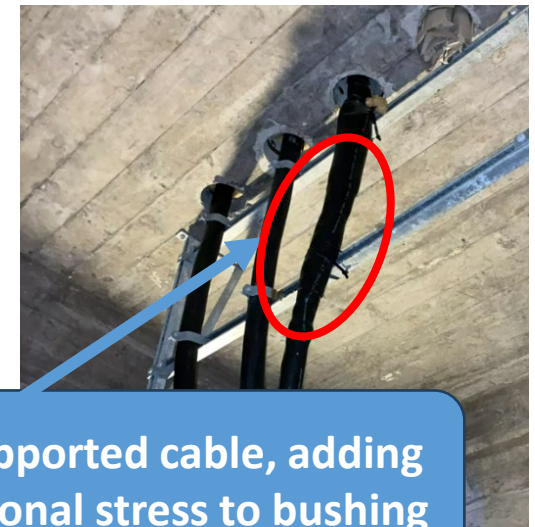
Caused traced to - Failure of insulating bushing supplying a 300kVA - 11kV/400V transformer that provided power to workshops. Failure resulted in a flash over to earth and loss of primary electrical containment. Flash was contained within the switchboard, which was damaged. Upstream electrical protection was activated to clear fault. Poorly supported cable increased stress on switchboard bushing causing early failure.

MoC – While the 11kV/400v transformer was relatively modern the change to the distribution systems for the bio reactor and workshop power supplied were undertaken before the current MoC management system. The quality of this installation was below what was expected (no cable supports)

Aged protection. Achieving good discrimination with older equipment, while achievable is harder, especially as settings in the older systems settings can drift. This event highlighted protection studies for WRK A&B are to be included as part of WRK 2031 project to ensure good discrimination is achieved.
