NER Impact During Bushing Failure

A Calculated Escape

Jichao Chen (AECOM)

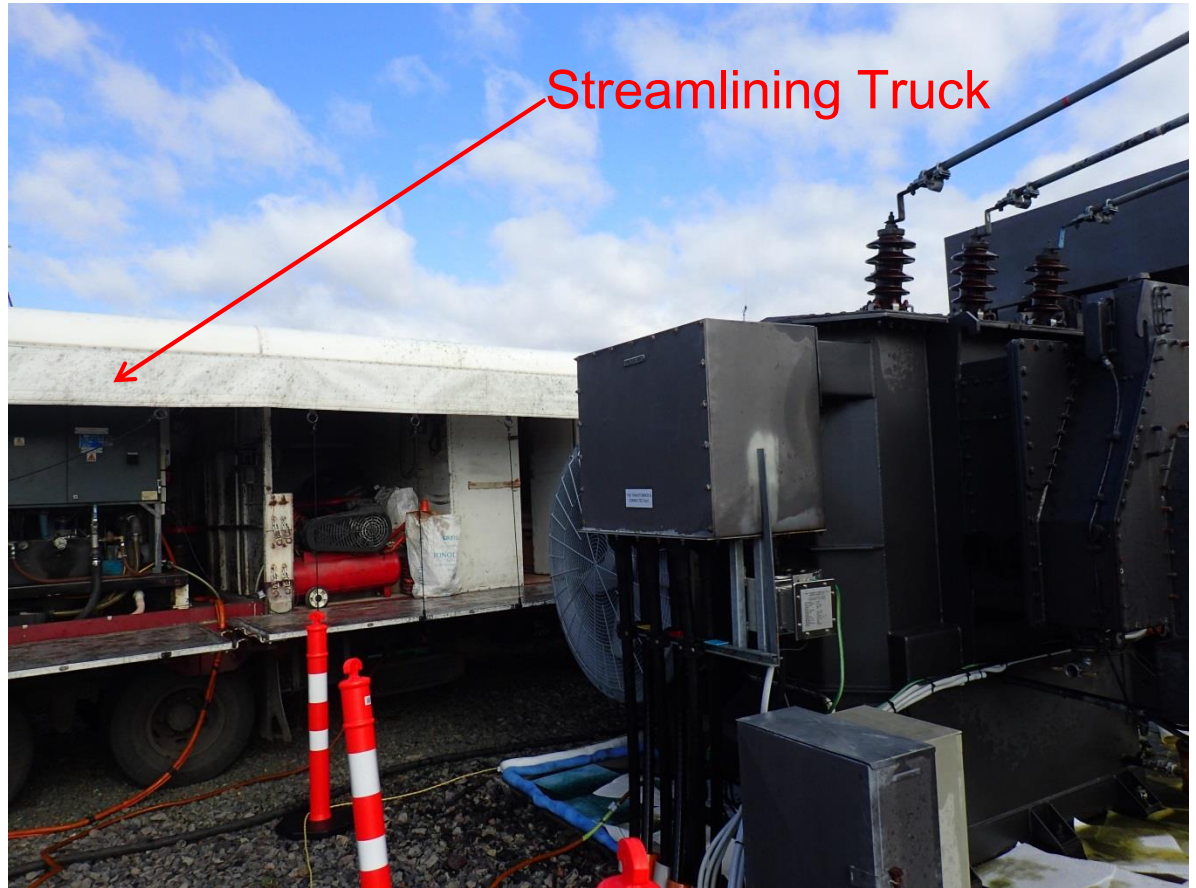
Bushing Failure

- Bucholz trip at 7am, 20th June 2015
- Trip reset
- Bushing failure at 11:30

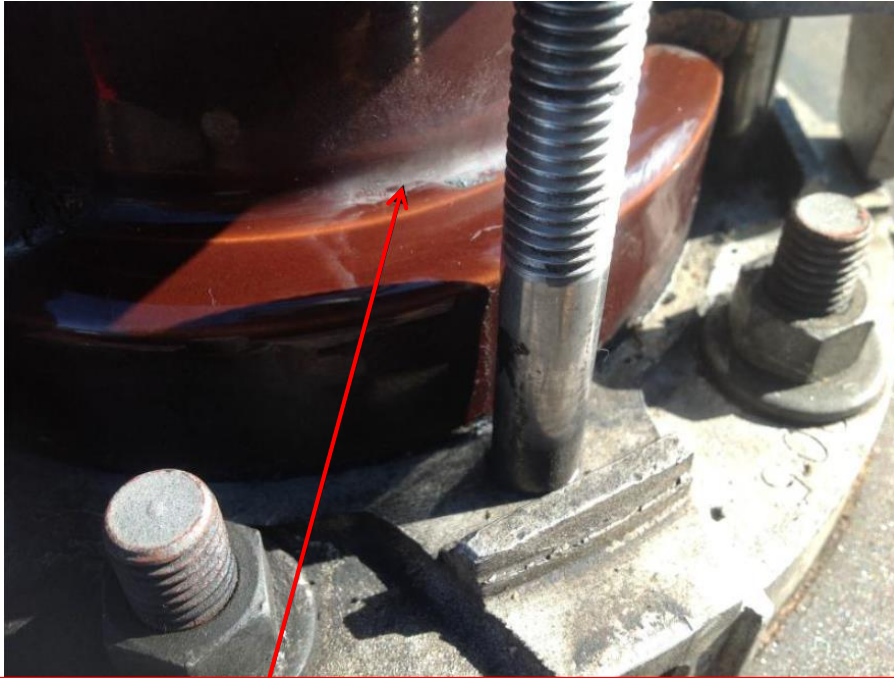
February 2013 Transformer Condition Assessment

- Bushing had been noted as a noisy bushing
- On inspection glazing cracks and marks on clamps and studs
- Bushing was tightened with self-amalgamating tape

Indication of glazing breaking due to tracking

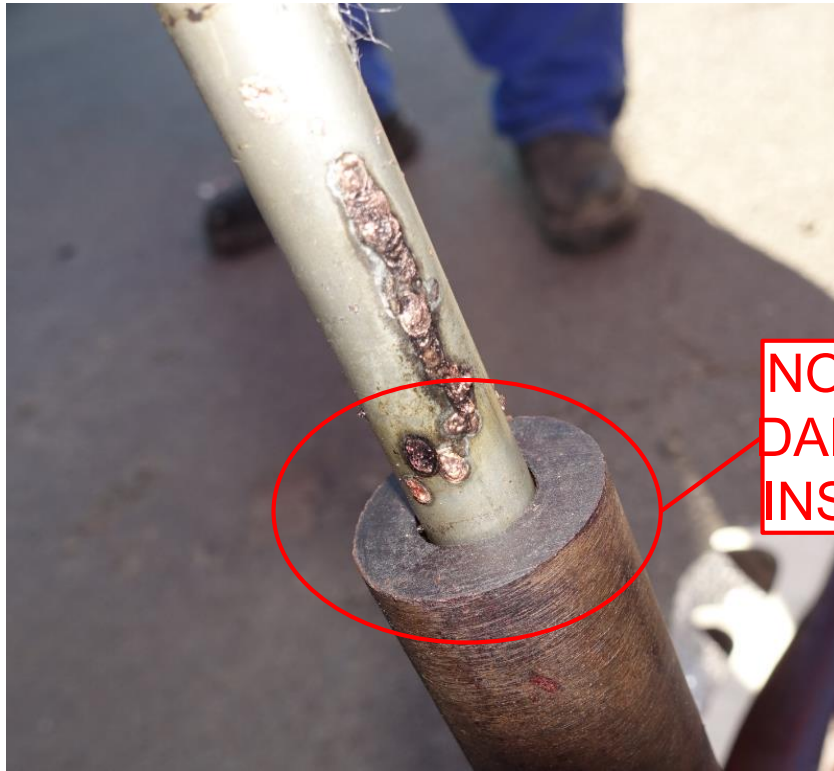
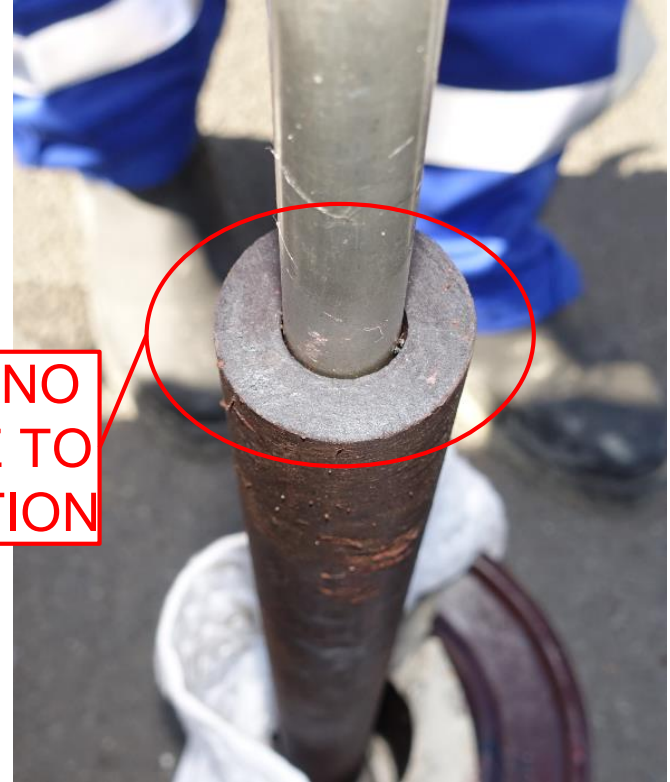
Transformer Bushing Failure – Root Cause

NOTICE NO
DAMAGE TO
INSULATION

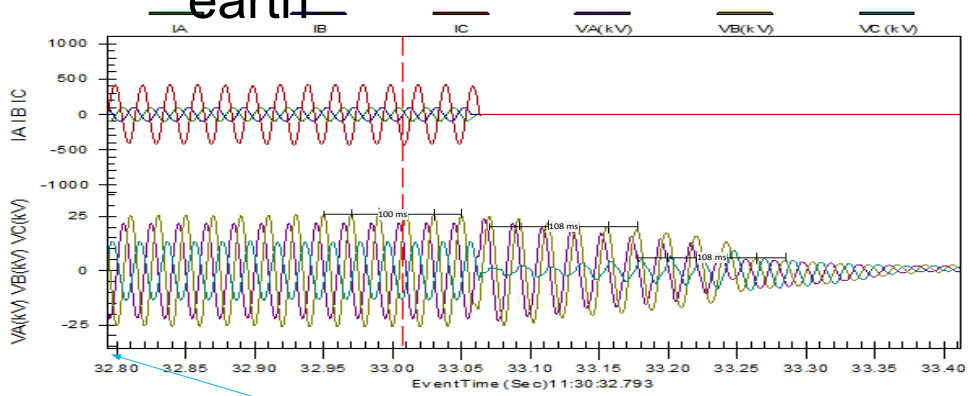
33 kV Simultaneous Cross Country Earth Fault

- Te Rahu fault current normalised once fault cleared at Kope
- High sound phase voltage on Snake Hill indicative of resistive earth

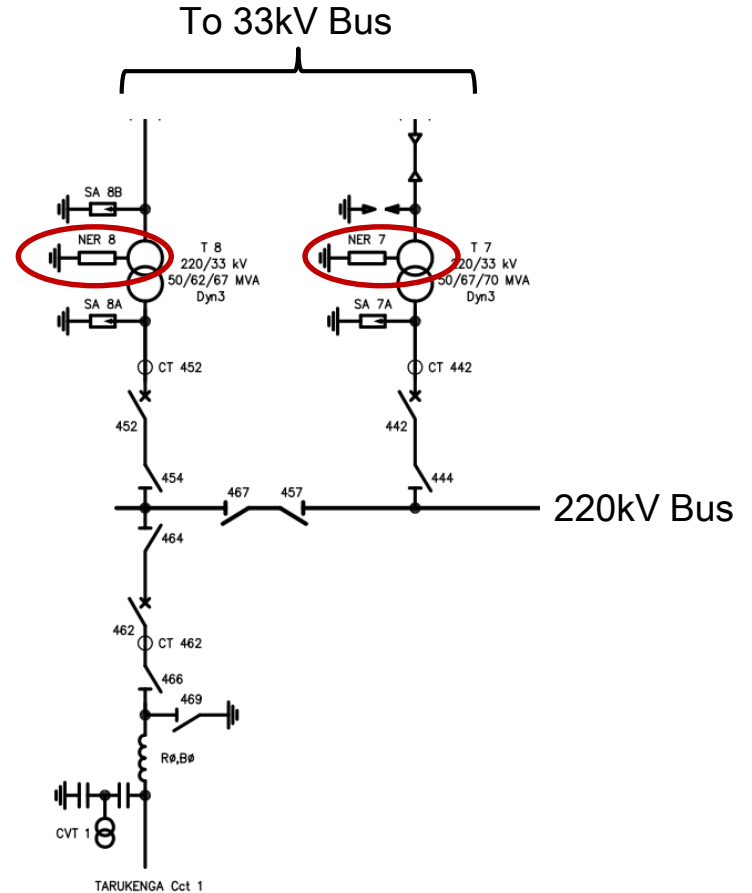
Neutral Earthing Resistor

Two NERs recently installed at Edhecumb by Transpower

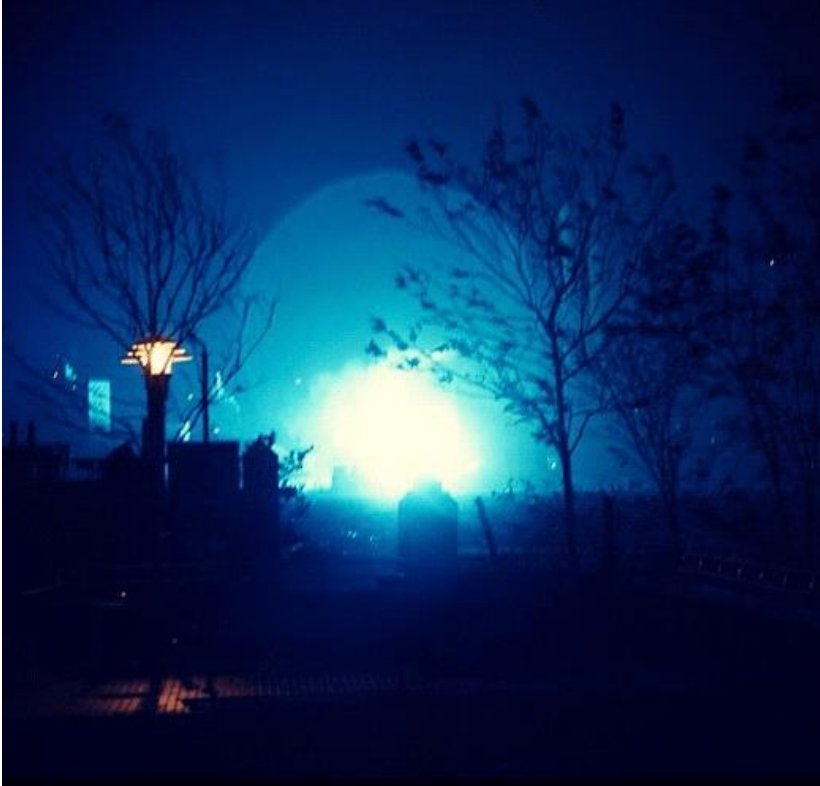
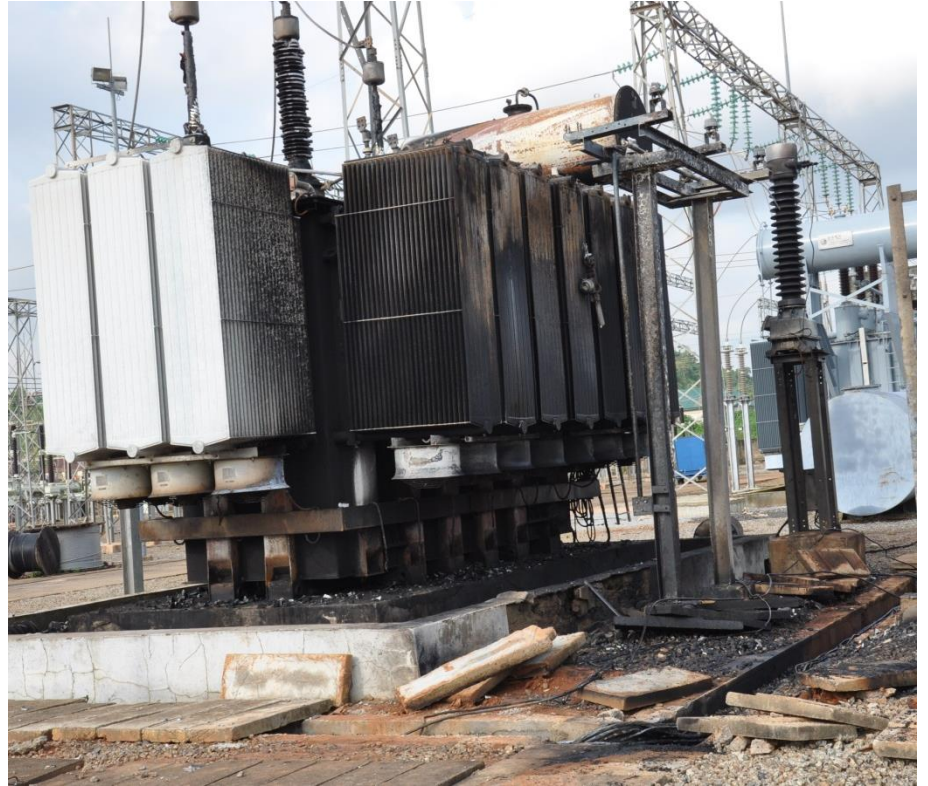
Severe Damages

- Limited Fault Current
 - <1000A with NERs
 - 15 to 20kA without NERs
- Limited Energy Released
 - Could have been explosive or transformer catching fire without NERs
 - Now only cracks on porcelain
