Safety Alert

INCIDENT TITLE: Cable Crushed by Hatch Cover

TIME AND DATE OF INCIDENT: 10 February 2016 - 1830 hrs

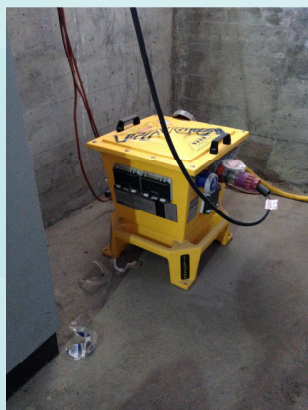
230V RCD

During normal end of day tidy up, a live cable was damaged when it was crushed between a metal hatch cover and a floor grating. The cable was protected by a residual current device (RCD) which prevented the contractor from being exposed to an electrical shock.

The cable had been knocked from its intended position between the concrete and the hatch where it had been safely located.

Safeguard (industrial RCD)

Any works (at home or on site) involving temporary electrical supplies (from socket outlets) should be protected via an RCD to minimise the possibility of an electrical shock if the cable or device is damaged or if conditions are damp.

Adequate protection of cables that pass through doorways, windows, hatches etc. is required. Examples include tying the cable back into a safe location (so it can't get moved) or protecting the cable with a hard barrier like a door stop or piece of hard pipe.

Always use RCDs on portable electrical supplies.

Protect all cables when they pass through an access way or in other situations where the cable could become damaged.

Damaged cable has been tagged out and removed from site.
